ASEC Report ID : 76297
 Name of the Project : Strickland Brothers-Villa Rica
 Project Location : 800 Highway 61, Villa Rica, Carroll County,
 Georgia
 Weather : Cold
 Departure Time : 01/23/2025 13:30
 ASEC Technician Name : Micah Aycock

As requested, the site was visited by our AS Engineering and Consulting (ASEC) representative for the purpose of performing a visual foundation inspection to verify the building foundations (lift pits and continuous wall footings) soil bearing pressure. Testing was performed for the new Strickland Brothers 10 Minute Oil Change facility located at 800 Highway 61 in Villa Rica, Georgia.

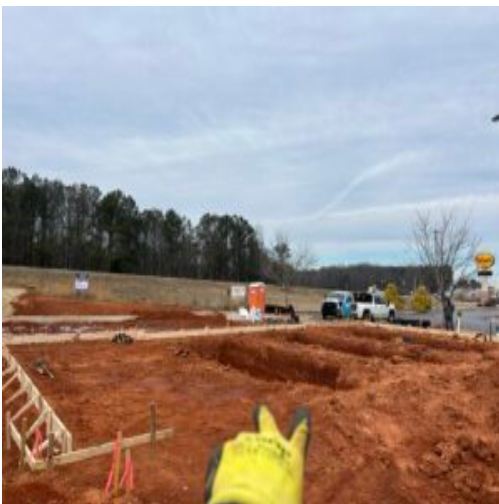
Looking from the southwest corner of building.

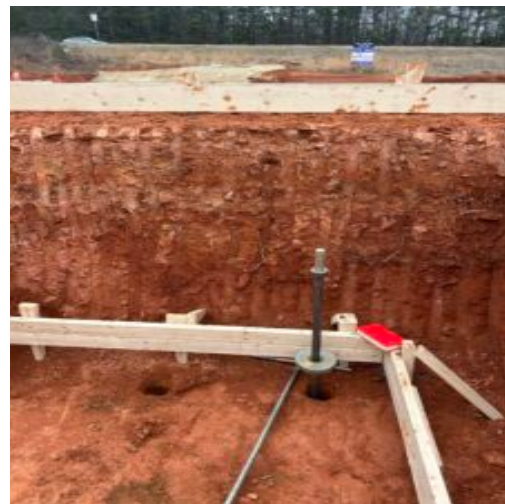
One of the lift pits.

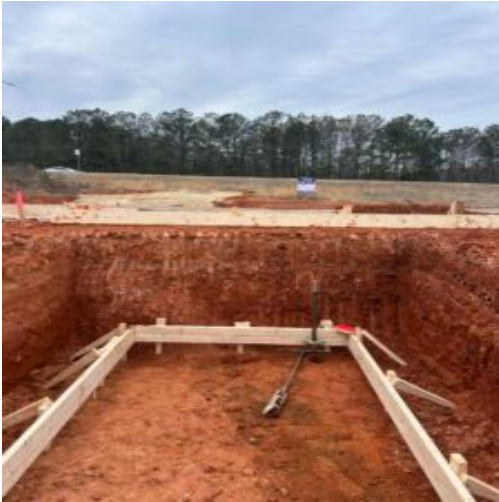
Another view of the lift pits.

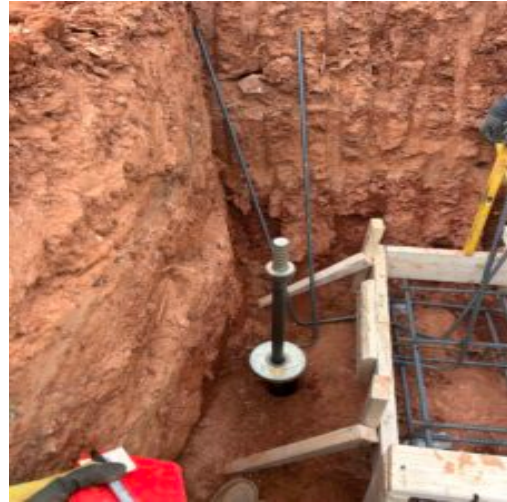
Corner of one of the lift pits.

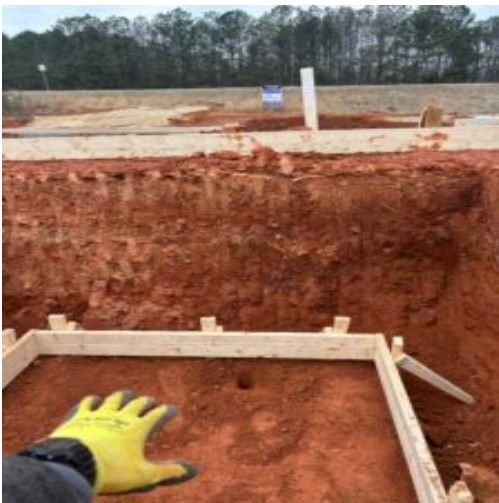
Framing in one of the lift pits.

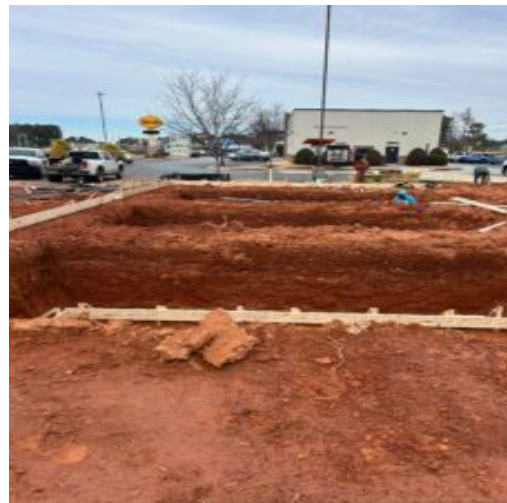
Looking at the lift pits from the south.

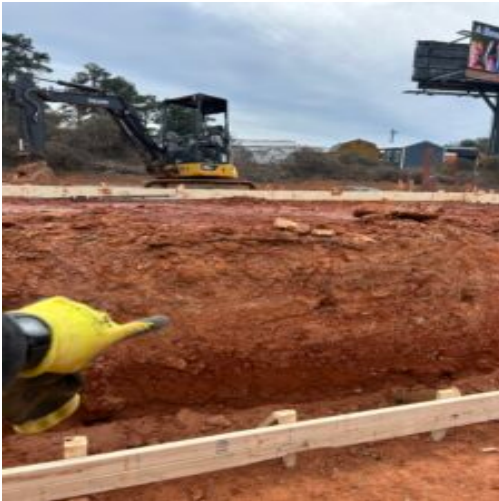
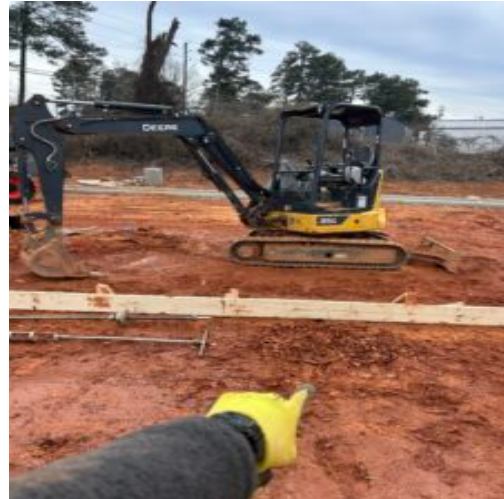
Contractor used excavator to scrape down 1.5 feet of hardened ground from the surface in order to perform hand auger/DCP test.
