Date : 10/15/2024  
Project No : 2024C217  
Client Company : Artisan  
Arrival Time : 10/15/2024 08:03  
Onsite Hours : 9:15

ASEC Report ID : 71699  
Name of the Project : Naturewalk - 7 Hills Amenities  
Project Location : Dallas  
Weather : sunny  
Departure Time : 10/15/2024 17:15  
ASEC Technician Name : Vamsi Polisetty

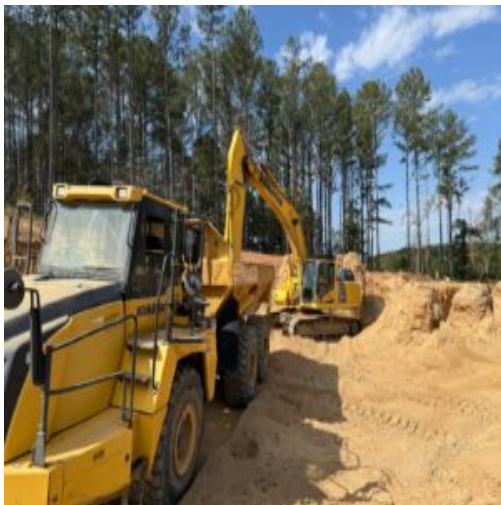
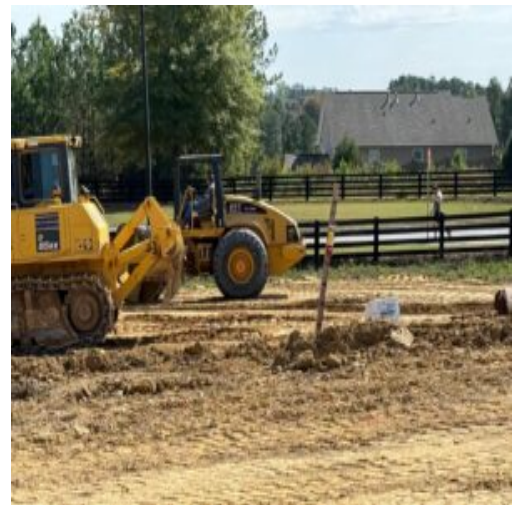
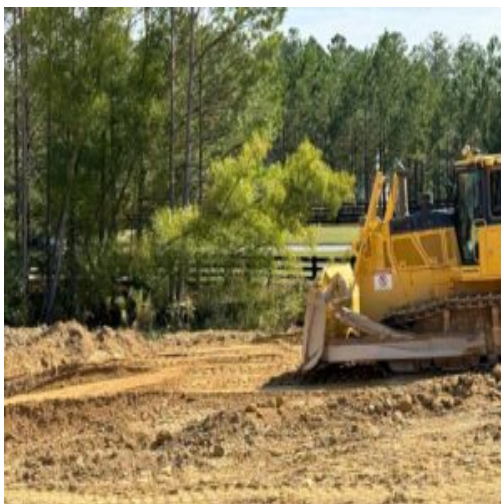
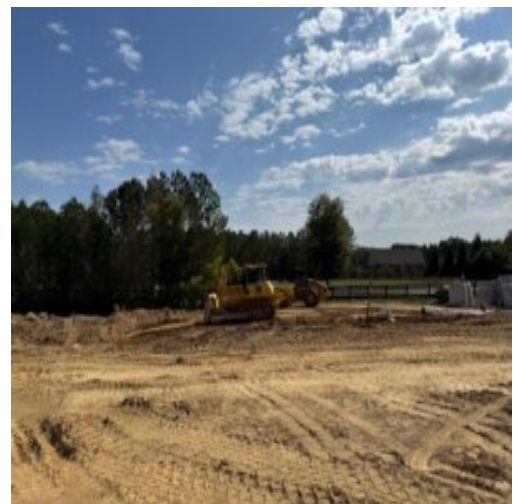
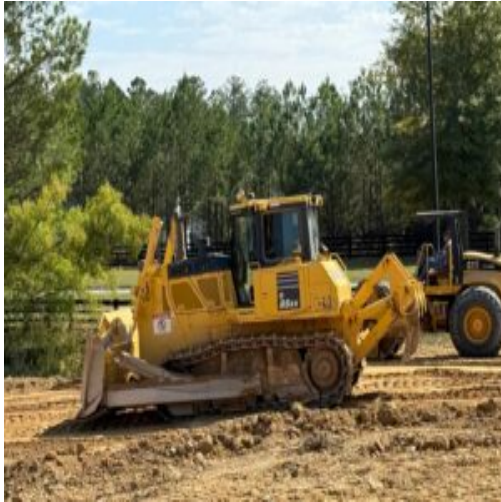
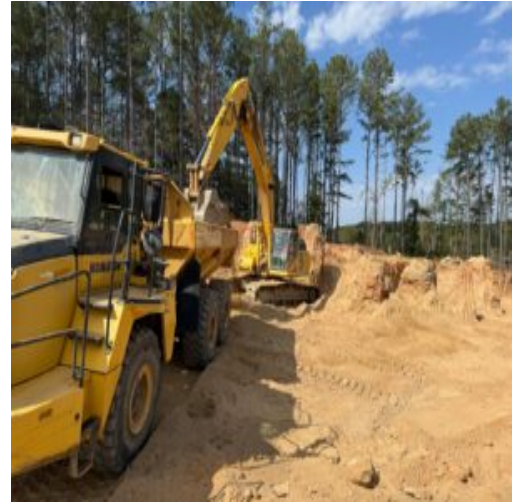
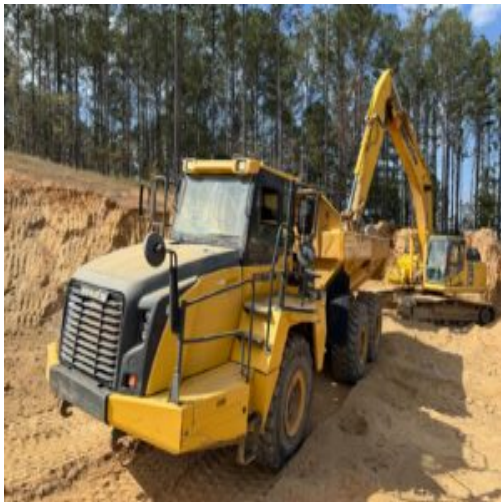
- Upon arrival, the contractor was engaged in excavations using a Komatsu PC 360LC on the west of the project site. Fill was being transported with two tandem dump trucks near the Pickle Ball Court, while dozing was performed with a Komatsu D85EX.
- Boulder fill is being used in backfilling under the tennis court and Pickle Ball court. Because of the boulder fill, proof-rolling was utilized to verify stability in lieu of density testing.
