Date : 03/28/2025
Project No : 2024C217
Client Company : Artisan
Arrival Time : 03/28/2025 12:00
Onsite Hours : 01:30

ASEC Report ID : 79392
Name of the Project : Naturewalk - 7 Hills Amenities
Project Location : Dallas
Weather : Sunny
Departure Time : 03/28/2025 13:30
ASEC Technician Name : Ramchandra Mogulla

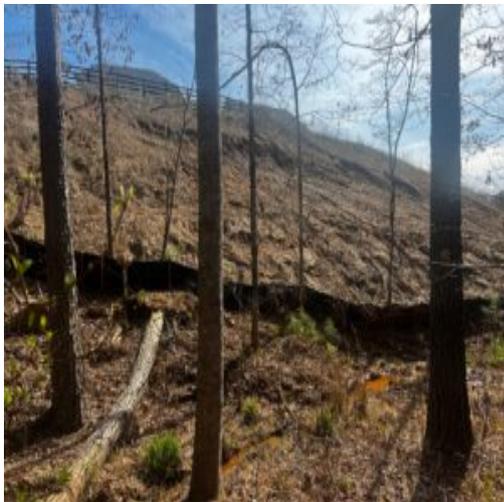
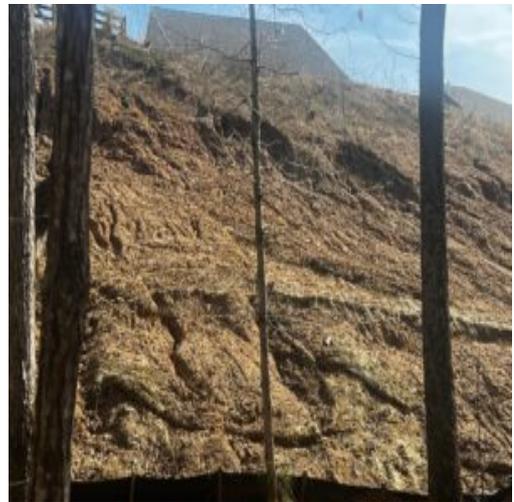
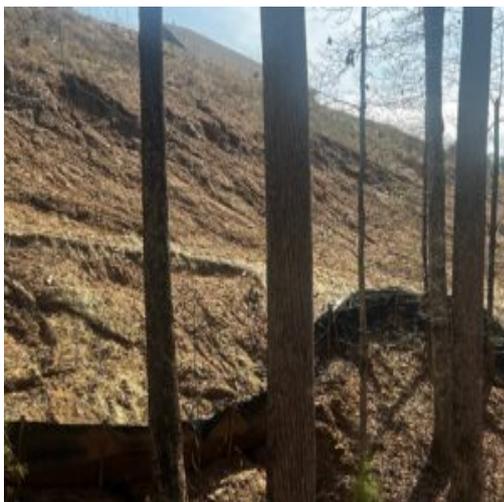
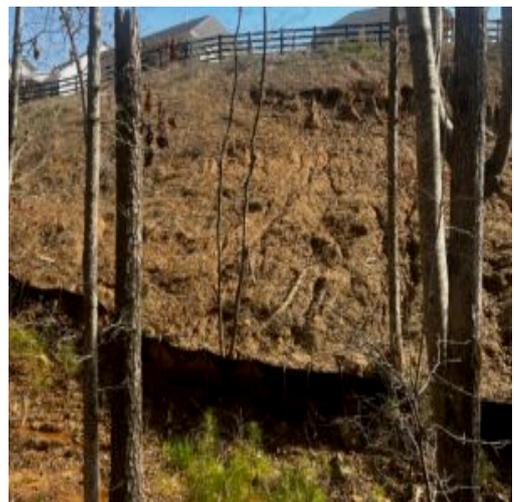
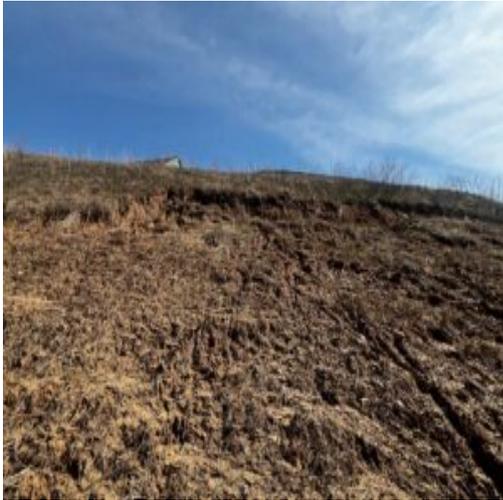
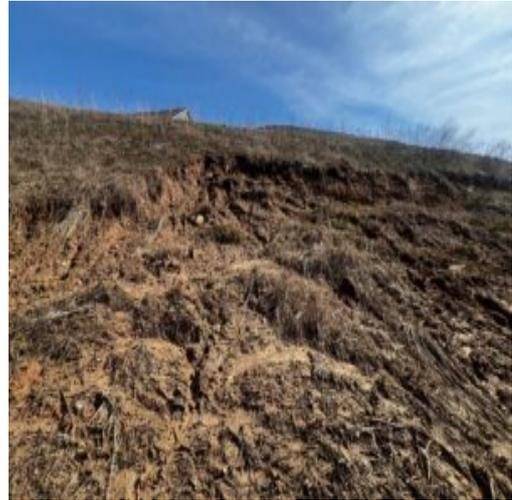
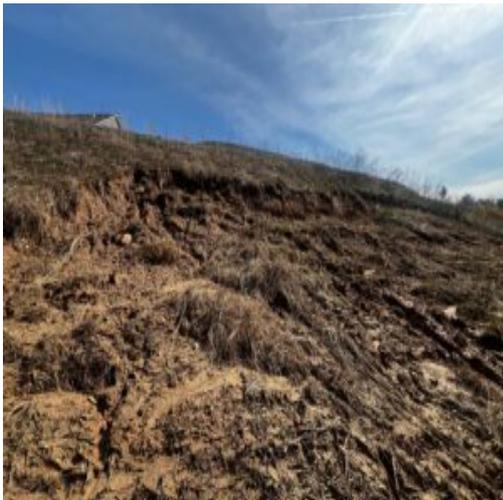
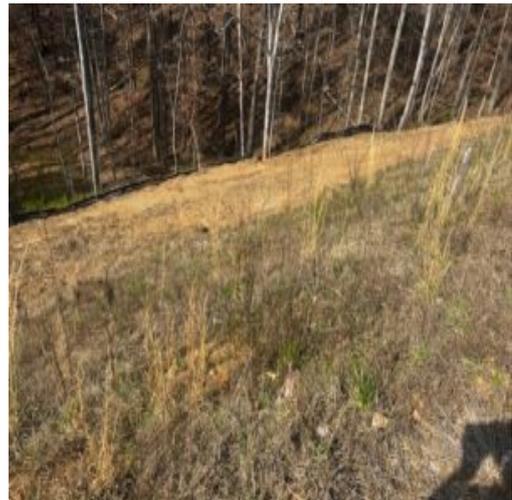
The observed area is located on the slope behind Lots #975 through #979 of the Nature Walk Subdivision Phase 6A. Based on our field observations, we believe the failure observed on the slope did not appear to be due to the quality of the material, but rather due to inadequate compaction along the face of the slope. It appears the material placed on the slope face absorbed moisture (due to the pervious nature of the inadequately compacted material) from recent rainfall and subsequently shifted toward the toe of the slope.

Erosion control measures should be implemented as required by applicable local regulations.

- Clear all vegetation, including trees, grass, brush, roots, and stumps, from wooded and grassy areas.
- Strip topsoil. (Note: Based on visual observations, a moderate amount of accumulated topsoil is expected.)
- If encountered, remove buried structures, underground utilities, and any debris from failure areas.

- All embankment fill should be compacted uniformly to at least 95% of the soil's maximum dry density, as determined by the Standard Proctor compaction test (ASTM D-698).
- Compaction is particularly difficult along slope faces. To address this, construct slopes beyond their design limits and then cut them back, ensuring the exposed slope face is well compacted.
- New fill embankments placed over existing grade should be benched to allow for compaction in horizontal layers. This ties the new fill into the existing grade and helps prevent slippage or slope stability failures at the interface.

- Establish vegetation or apply mulch on slope faces as soon as practical after grading to provide erosion protection.
- Divert rainwater runoff away from the crest of slopes to prevent erosion and saturation.

- All slope construction should be monitored by the Geotechnical Engineer or their designated representative.

- Field density test reports for the embankments should be reviewed carefully by the Engineer to ensure proper compaction and slope stability.
