Date : 04/17/2025
Project No : 2025C150
Client Company : Davidson Homes
Arrival Time : 04/17/2025
Onsite Hours :

ASEC Report ID : 80210
Name of the Project : Riverwood Retaining Wall
Project Location : Dallas
Weather : sunny
Departure Time : 04/17/2025
ASEC Technician Name : Russell Hendrix

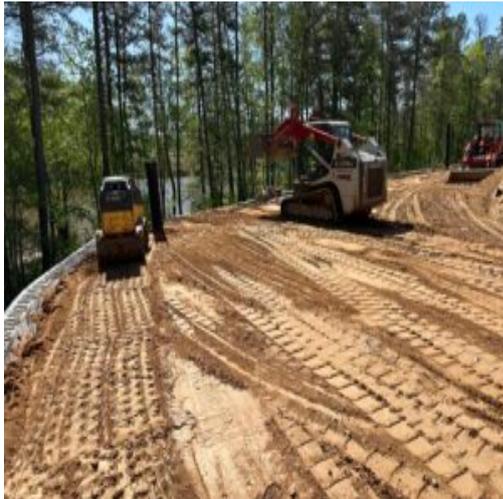
Upon successful compaction of the first lift, the contractor advanced to the next layer of backfill. This subsequent layer underwent the same testing and quality control process. Adjacent to the wall the compaction is carried out with remote compactor BMP8500 for even compaction along the retaining wall.

Compaction along wall

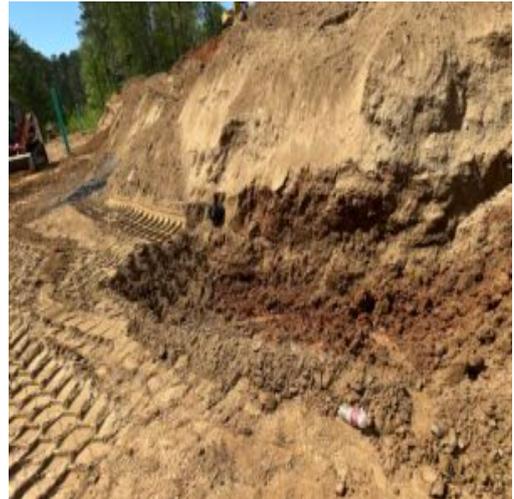
During routine observation of an off-road dump truck operation, a potential soil issue was identified in the area between the retaining wall and the adjacent house pad. Excavation to a depth of approximately 2-3 feet over an area measuring roughly 4 feet by 20 feet revealed soil with elevated moisture content, raising concerns regarding stability and support.

Remediation required area

Based on the recommendation of the grading foreman, a layer of geogrid reinforcement was installed to improve subgrade stability. Additionally, per the recommendation of the on-site ASEC technician, a 6-inch layer of stone was placed over the geogrid to enhance drainage and bearing capacity.

Remedial actions were completed in accordance with field recommendations, and the area has since been stabilized. Supporting photos have been included for reference.

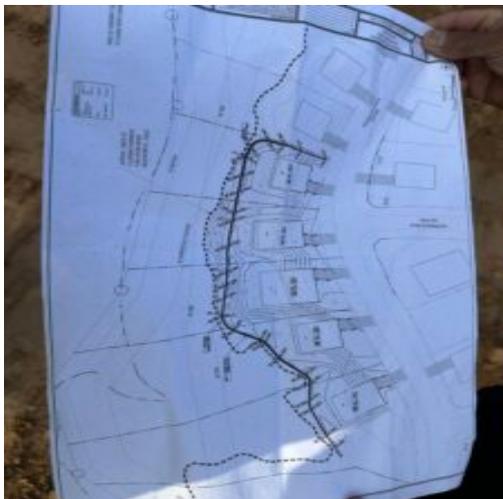
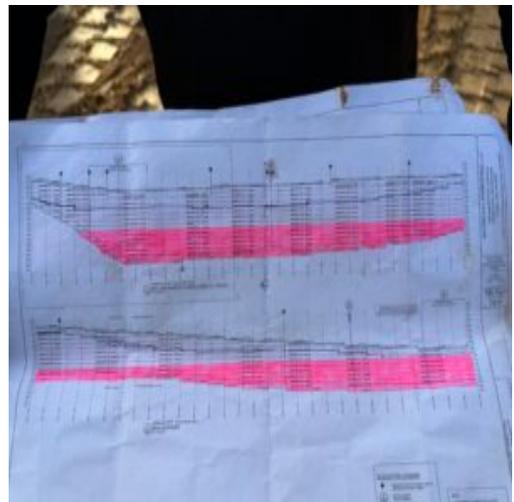
Upon arrival to the retaining wall construction site, the grading foreman, Darwin, communicated that a change to the retaining wall design would be implemented without prior engineering approval. Specifically, the modification involves a reduction in the wall height from the original maximum of 18 feet by approximately 4 to 6 feet. Concurrently, the adjacent slope will be steepened to accommodate this change. Following up on the progress from the previous day, work has continued behind Lots #224-#229.

Wall Changes

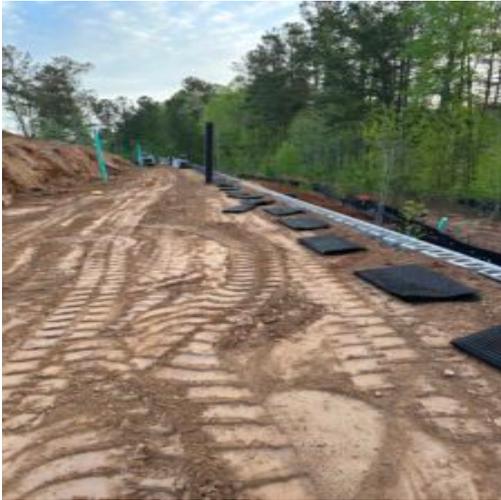
Retaining wall

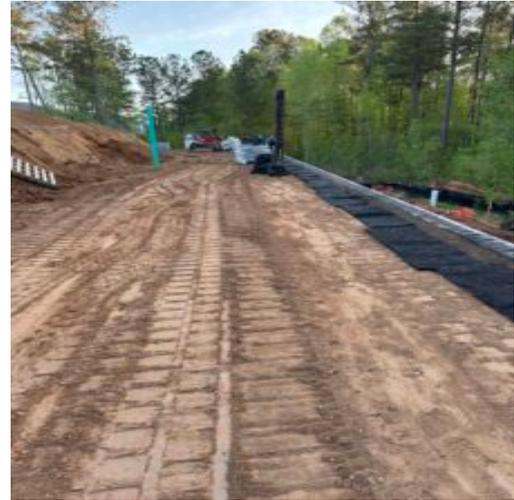
Retaining wall

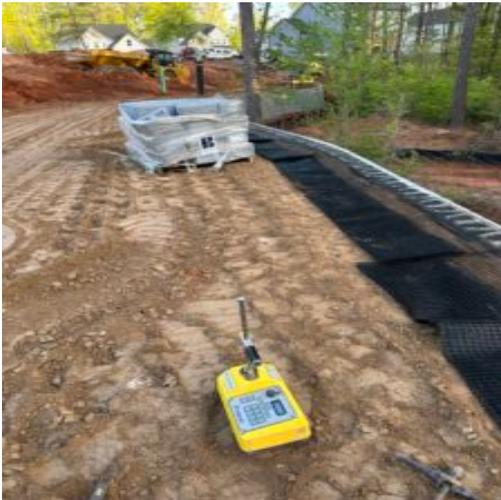
Nuclear gauge density testing with a Troxler 3430 (serial #29588) was conducted on the compacted layer. While testing no elevation available. All testing was performed approximately every 100 feet.

Testing
