Date : 11/21/2025  
Project No : 2025C211  
Client Company : Pulte  
Arrival Time : 11/21/2025 07:45  
Onsite Hours : 07:30

ASEC Report ID : 88099  
Name of the Project : Haley's Bluff - Philadelphia Rd.  
Project Location : Jasper  
Weather : Overcast  
Departure Time : 11/21/2025 15:15  
ASEC Technician Name : Sean Willett

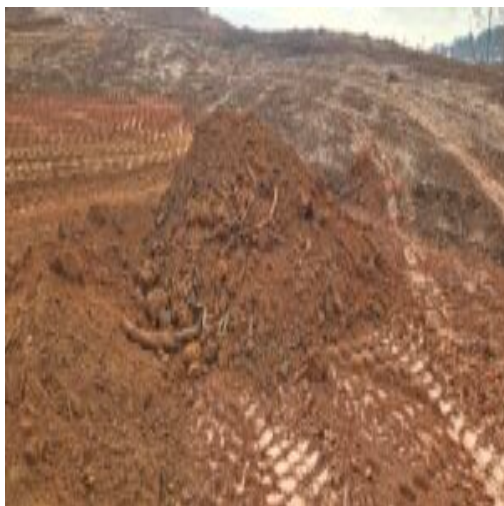
organics present in fill

The contractor continued placing lifts of approximately 8 to 12 inches in thickness across the deep fill area of Lots #8 through #13 and #52 through #60. Lifts were compacted with a sheep-foot roller. Density testing was performed, and test results were provided to the contractor. It was recommended to remove any large organics from fill before compaction. Some of the fill has a large amount of organics. This was pointed out to Daniel (NG Grading) to be addressed. ASEC also went to each excavator and dozer and showed them pictures of the organics and recommended to discard any large organics when loading trucks.

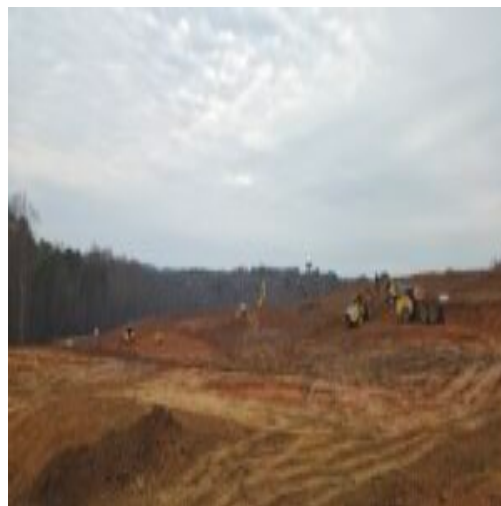
fill on lots #8 - #13 and #52 - #60 area

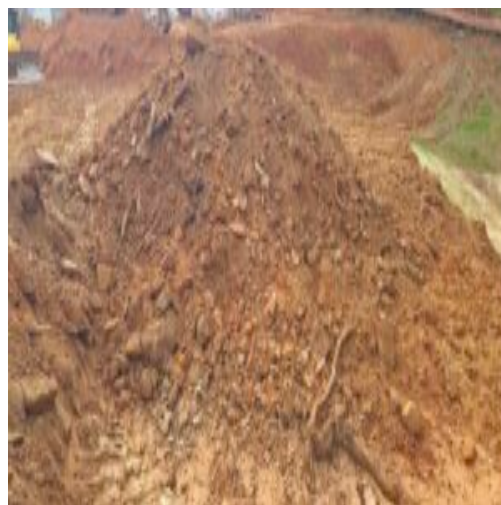
another pile of organics present in fill

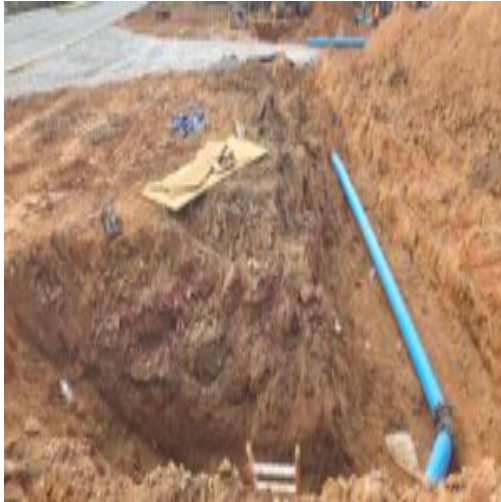
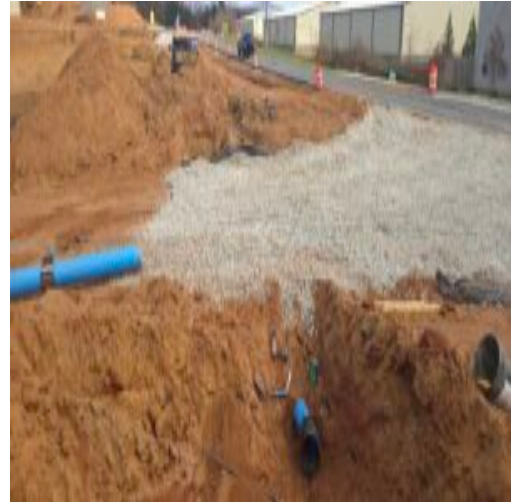
water line in decel lane by lot #1

The contractor began installation of a water line along the deceleration lane near Lot #1. Once this line is backfilled, ASEC will density test the pipeline backfill.

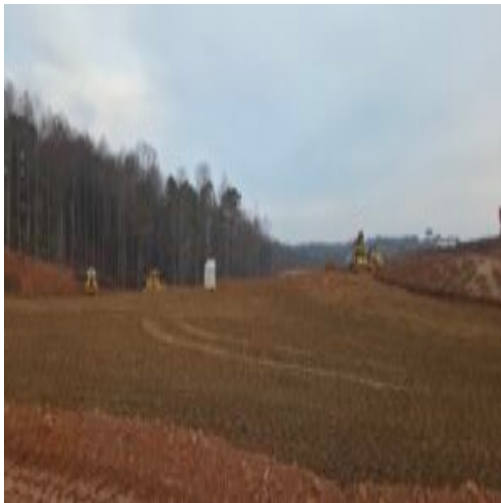
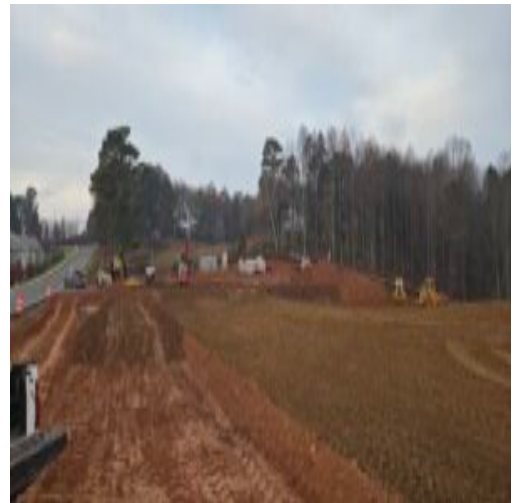
commercial lot area by front detention pond

Our ASEC representative was on site for the observation/testing of the placement of fill/backfill. The contractor continued placing lifts of approximately 6 to 8 inches in thickness across the commercial lots located around the front detention pond. Lifts were compacted with an 815 sheep-foot roller. Density testing was performed, and test results were provided to the contractor. ASEC watched as loaded dump trucks rolled across the lifts to check for stability. There were no signs of severe pumping or rutting present.

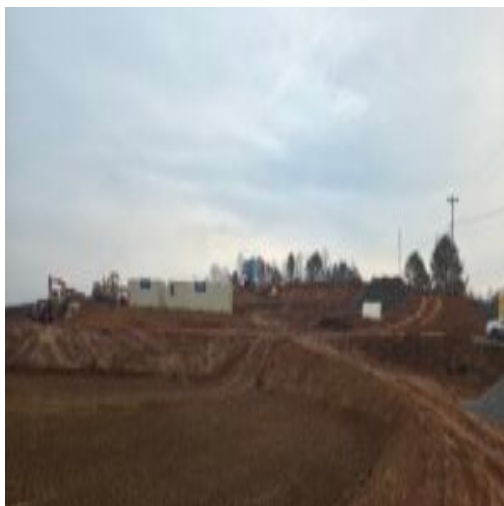
excavation of commercial lots above connexes

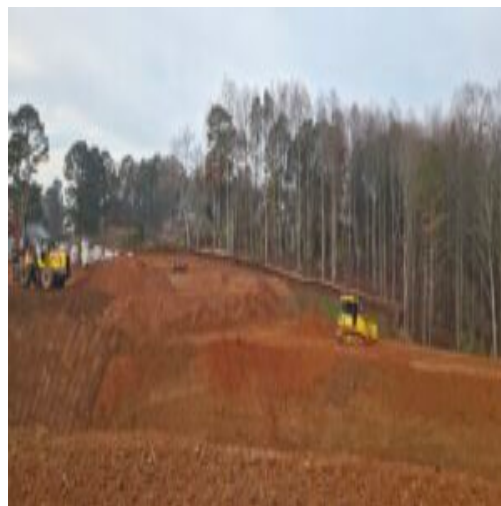
slope of detention pond under lot #4 and lot #5

The contractor continued to build up the slope and roadway in front of Lots #4 and #5. The contractor is attempting to build the bank of the detention pond up above the drainage structure before the forecasted rainfall later this evening and this weekend. Density testing was performed, and test results were provided to the contractor. ASEC watched as loaded dump trucks rolled across the lifts to check for stability. There were no signs of severe pumping or rutting present.
