Date : 04/08/2026
Project No : 2025C211
Client Company : Pulte
Arrival Time : 04/08/2026 07:00
Onsite Hours : 08:30

ASEC Report ID : 92601
Name of the Project : Haley's Bluff - Philadelphia Rd.
Project Location : Jasper
Weather : Sunny
Departure Time : 04/08/2026 15:30
ASEC Technician Name : Sean Willett

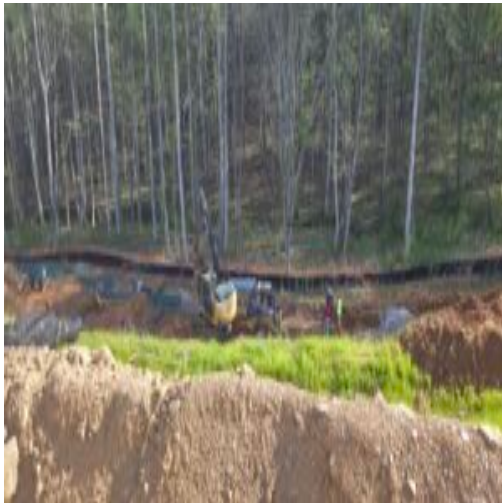
wall 1

The wall crew was on site and spread No. 57 stone and GAB into the remediation area in the footing of retaining wall 1. Due to the over-excavation of the remediation (by the grading crew) when spreading the GAB across the No. 57 stone, the material ran out before covering the whole area. The grading crew became frustrated and tried to blame the wall crew for spreading the GAB too thick. This was not accurate. The grading foreman requested ASEC to change our recommendation to accommodate for another change order to Pulte for the additional GAB. ASEC refused and contacted Mr. Wood to inform him of the situation. The grading crew also did not excavate enough area along the wall for the wall contractors to lay out their geogrid to the spec of the wall. The grading crew excavated approximately 18 feet in width, when the plans of the wall show 26 feet in width in this area. The grading crew is now having to remove this soil before the rest of the wall can be installed properly. The wall crew is installing baskets in the areas where they can properly lay out the geogrid. Density testing was performed and test results were provided to the contractor.

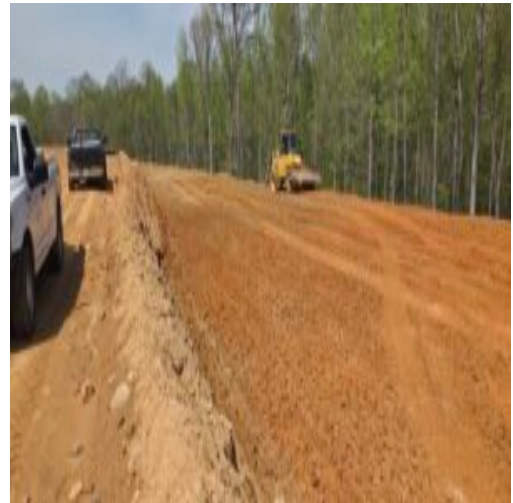
slope on wall 1
