Date : 12/22/2025
Project No : 2025C216
Client Company : Artisan
Arrival Time : 12/22/2025 09:00
Onsite Hours : 05:00

ASEC Report ID : 88771
Name of the Project : NW (Lots) Unit 4 PH 1A & 1B
Project Location : Dallas
Weather : cloudy
Departure Time : 12/22/2025 14:00
ASEC Technician Name : Clyde Smith

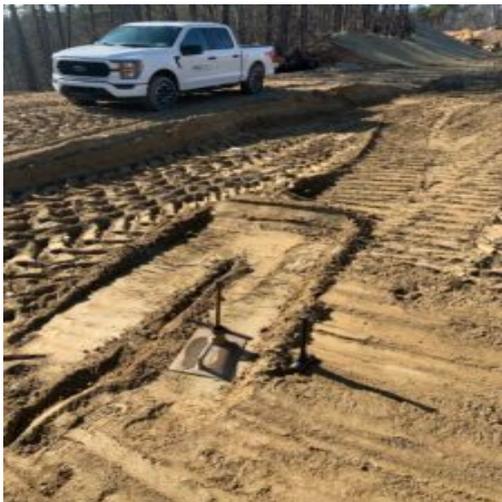
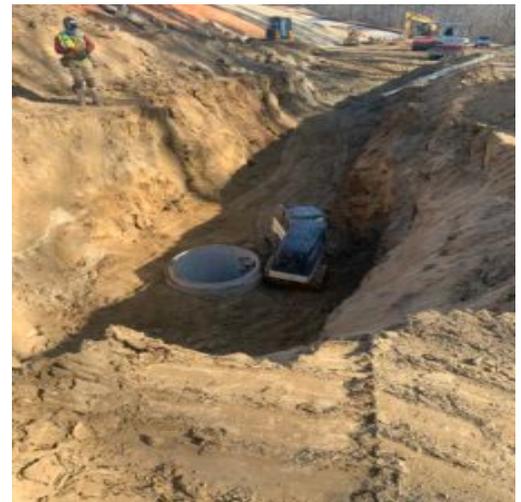
On the above date our representative was on site to observe the pipe contractor continue installing 8" PVC sanitary sewer line between manholes #11 and 12. The pipe was bedded on No. #57 stone, and the sides were also backfilled with No. #57 stone. The writer performed density tests between manhole structures #10, 11 and 12 using a Troxler nuclear gauge model 3440 serial no.91643. Compaction results were in compliance with job specifications.

8" sanitary sewer pipe installation backfill and testing
