**Daily Field Report**

ASEC Report ID : 72374
Name of the Project : Old Griffin Rd - Hawthorne Reserve
Project Location : Dallas
Weather :
Departure Time : 16:30
ASEC Technician Name : Solomon Cherie

Date : 10/29/2024
Project No : 2024C202
Client Company : CCG
Arrival Time : 07:30
Onsite Hours :

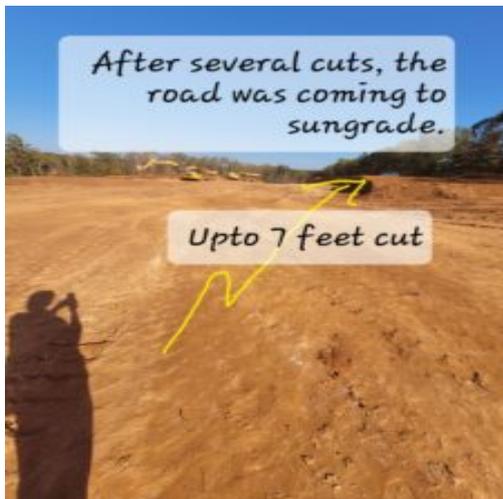
The road at sbgrade

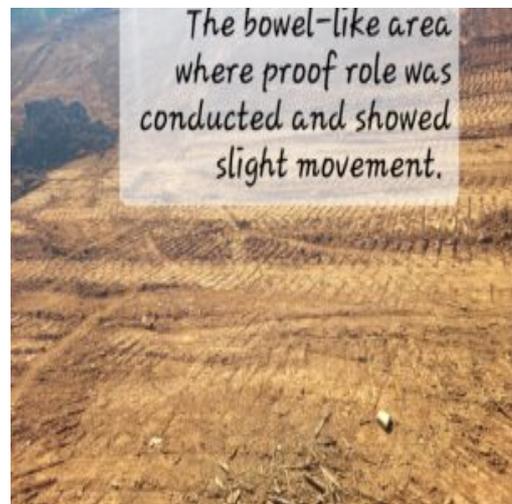
A temporary pond filled with water located adjacent to Lot#70 (and roadway) was observed by Ram Mogulla of ASEC for subgrade stability for further fill placement. A 7-foot test pit displayed unsuitable materials. A proof-roll was also performed and showed pumping and rutting indicating underlying wet soil. Following a discussion with the grading contractor, the grading contractor agreed to drain away excess water, demuck soft soils and then begin fill placement in the specified area. For more detail, please see the attached pictures.

The location after test pit investigation and proof role where backfill was suggested

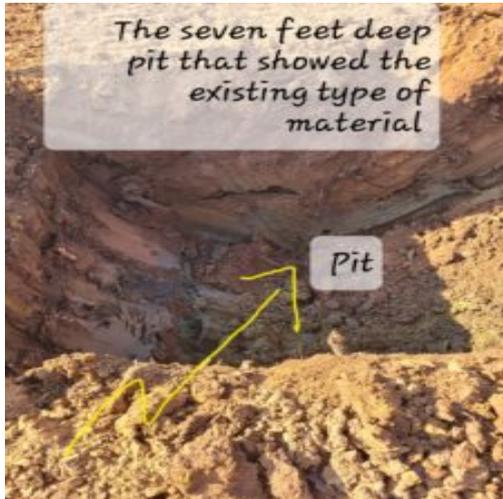
The test pit where unwanted materials were observed
