Daily Field Report

Date : 01/14/2026
Project No : 2025C211
Client Company : Pulte
Arrival Time : 01/14/2026 07:30
Onsite Hours : 08:00

ASEC Report ID : 89275
Name of the Project : Haley's Bluff - Philadelphia Rd.
Project Location : Jasper
Weather : Sunny
Departure Time : 01/14/2026 15:30
ASEC Technician Name : Sean Willett

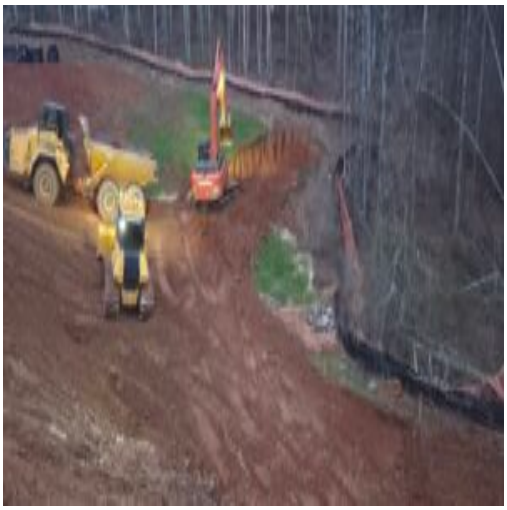
lot 14 and 15

rocky fill material
