Site Visit Report - Retaining Wall Evaluation

ASEC Report ID : 79071
Name of the Project : Riverwood Retaining Wall
Project Location : Dallas
Weather : sunny
Departure Time : 03/25/2025 12:00
ASEC Technician Name : Vamsi Polisetty

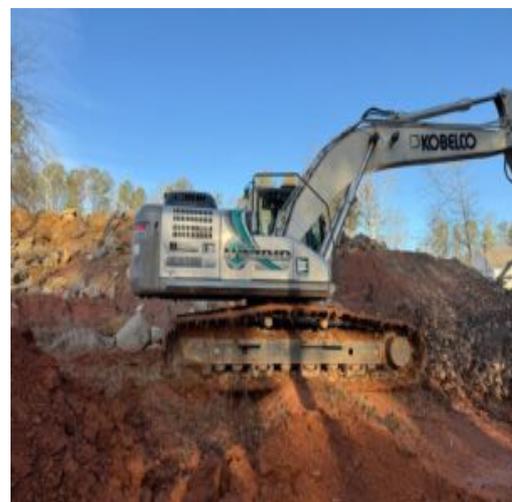
- Test pits behind lots 227 through 230 revealed loosely placed fill within the top 2 to 3 feet. While this material is believed to be located above the proposed retaining wall foundation elevation, remediation may be required before proceeding.

Test pit behind lot 227
