Date : 06/11/2025  
Project No : 2025C160  
Client Company : Artisan  
Arrival Time : 06/11/2025 08:30  
Onsite Hours : 9:00

ASEC Report ID : 82145  
Name of the Project : Rockmart Township - 115 Felton Drive  
Project Location : Rockmart  
Weather : Sunny  
Departure Time : 06/11/2025 17:30  
ASEC Technician Name : Sean Willett

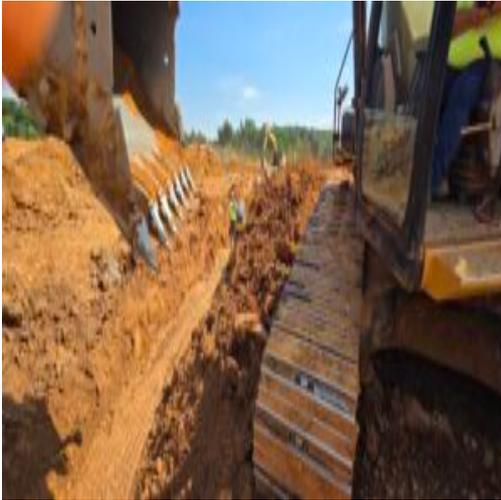
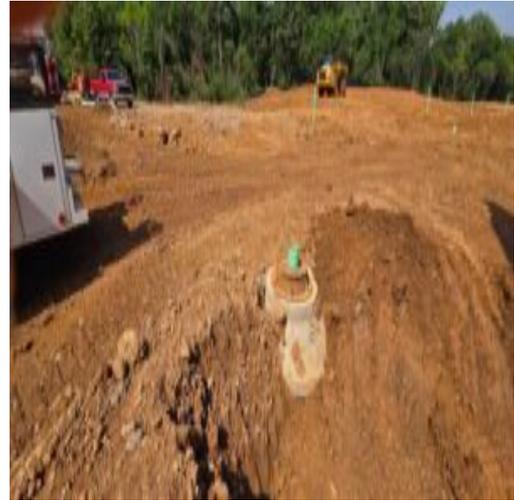
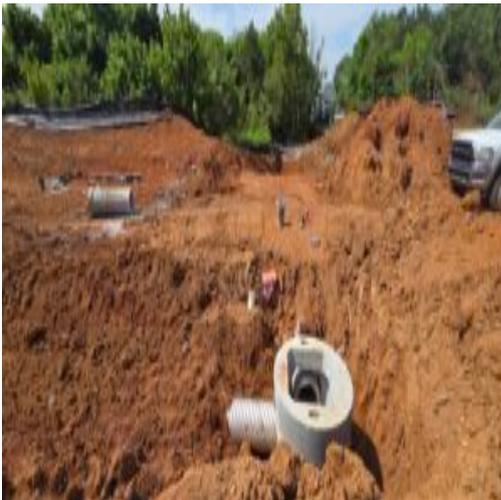
The contractor began backfilling pipeline from SSMH4.3 to SSMH5.0. The technician density tested this pipeline starting 4 feet over pipeline and provided all test results to the contractor. The technician recommended to allow aeration of wet soils to near optimum moisture content before compacting again. The technician probed this pipeline which were found to be not stable at this time. The technician informed the contractor of these results.

The contractor began excavation/installation of BJ3 to BJ4 with a reported elevation of approx. 754.6.

The contractor placed one lift of soil, approx. 8 to 12 inches thick, across Lots #127 through #133. The technician recommended that the contractor allow ample time for soil to dry to near optimum moisture content before compaction. The soil was placed to an elevation of approx. 774.

The contractor began placing lifts on lot #1 in approx. 8 to 12 inches in thickness. The technician density tested approx. every 2 feet. All test results were provided to the contractor. The technician recommended to remove soils that were too high in moisture content and allow ample time to dry. The contractor spread lifts of over saturated soil with a lift of optimum moisture levels over top of the over saturated lifts. The contractor then compacted the lifts via sheepsfoot and rolled in the lifts with a loaded off-road dump truck. The technician watched the roll in of these lots to see any signs of pumping. The technician showed the contractor where pumping was present, and the contractor excavated out these areas. There is a watermain present in the pad of lot #1 that the contractor said will be excavated at a future date. The technician recommended to excavate a 10ft x 10ft area around this main due to poor compaction in this area. There were signs of poor compaction in these lifts via density testing. The contractor still has approx. 2 feet of fill to reach elevation. The technician recommended to allow ample time for the lifts to dry to near optimum moisture content and to recompact this area before placing final lifts.
