Date : 06/19/2025
Project No : 2025C160
Client Company : Artisan
Arrival Time : 06/19/2025 09:00
Onsite Hours : 02:00

ASEC Report ID : 82366
Name of the Project : Rockmart Township - 115 Felton Drive
Project Location : Rockmart
Weather : overcast/raining
Departure Time : 06/19/2025 11:00
ASEC Technician Name : Sean Willett

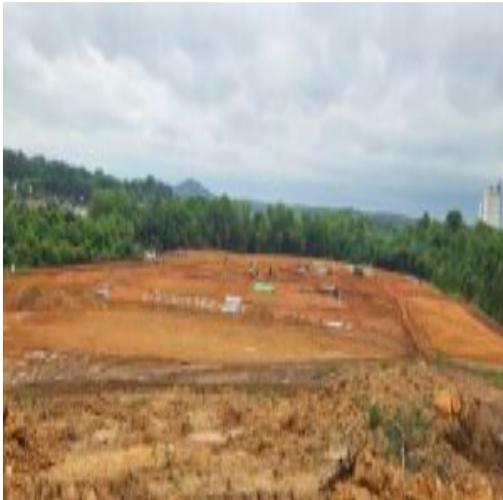
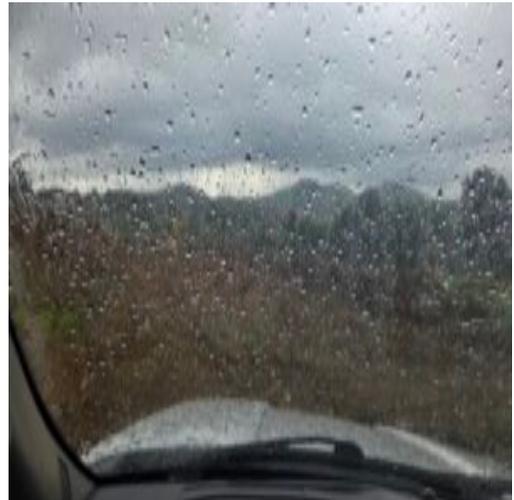
BG5

The technician observed the contractor (Robbie) excavating/backfilling the BG structures pipeline up to structure BG5. The technician moisture checked soils placed directly over pipeline. Moisture content was approx. 27%, which is well above the optimum moisture content range. The technician recommended not to backfill with this oversaturated material. The contractor proceeded to backfill anyways, against the technician's recommendation.
