Date : 01/05/2026
Project No : 2025C211
Client Company : Pulte
Arrival Time : 01/05/2026 07:30
Onsite Hours : 06:30

ASEC Report ID : 88989
Name of the Project : Haley's Bluff - Philadelphia Rd.
Project Location : Jasper
Weather : Sunny
Departure Time : 01/05/2026 14:00
ASEC Technician Name : Sean Willett

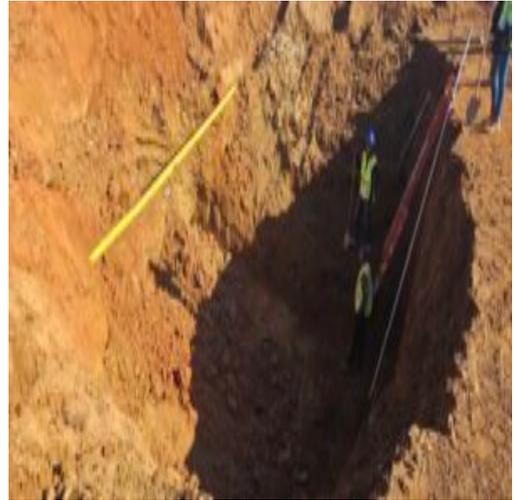
wall footing

The wall contractors began excavation of the wall footing. There was no rock present on site to begin backfilling of the footing. The wall crew left the site for the day and will begin tomorrow when the material is present on site.
