Date : 10/03/2025  
Project No : 2025C245  
Client Company : Bearing Engineering  
Arrival Time : 10/03/2025 08:00  
Onsite Hours : 06:00

ASEC Report ID : 86506  
Name of the Project : Dunkin Donuts 2025  
Project Location : US 29, Palmetto, GA  
Weather : Sunny  
Departure Time : 10/03/2025 14:00  
ASEC Technician Name : Sean Willett

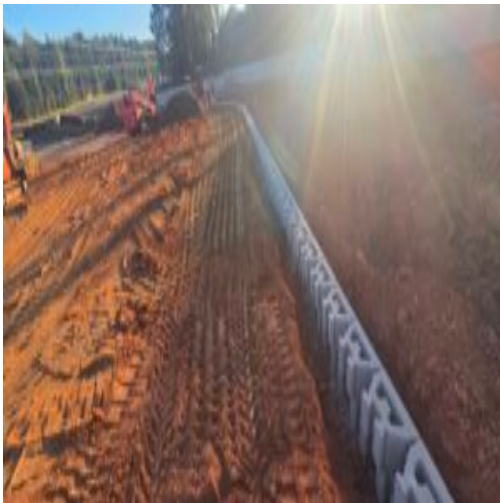
The fill that was already onsite was tested by our ASEC lab for a proctor that displayed a max dry density of 115.6 pcf and an optimum moisture content of 12.7% (after rock correction). The fill in place was moisture checked and displayed an in-place moisture content of approximately 18-19%.

retaining wall and fill already on site

These results were provided to the contractor, and the contractor was informed that both materials were not within the optimum moisture content range for proper compaction (+3 to -3 above/below optimum moisture content). There is no water truck available on site. The contractor began hauling buckets of water with a skid steer and trying to actively mix water into the new fill material to bring it up to proper moisture range. A decision was made to wait for the soil that was already on site to dry and try to bring it down to a proper moisture level. Our representative left the site.
