Date : 12/01/2025
Project No : 2025C260
Client Company : Artisan
Arrival Time : 12/01/2025 09:30
Onsite Hours : 05:30

ASEC Report ID : 88376
Name of the Project : NW (PHASE 2) Parkway Extension
Project Location : Dallas
Weather : cloudy
Departure Time : 12/01/2025 15:00
ASEC Technician Name : Clyde Smith

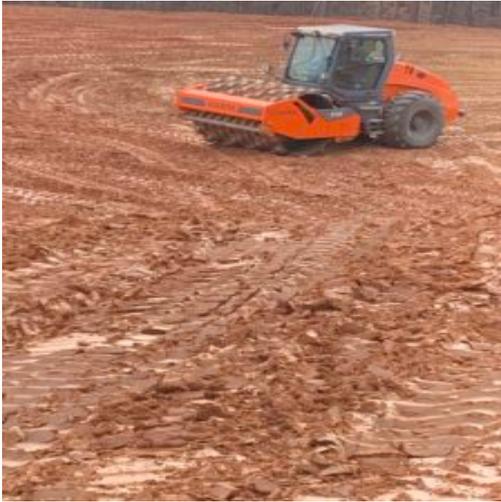
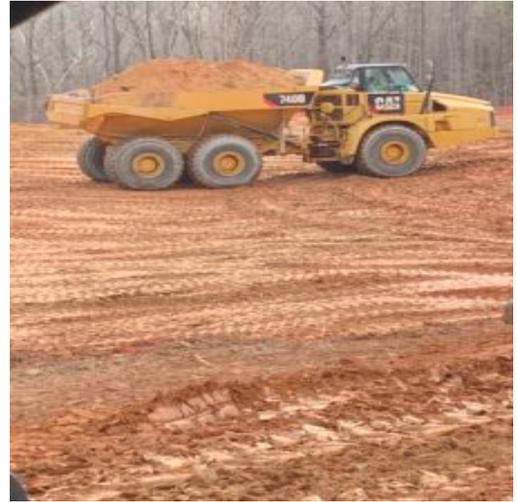
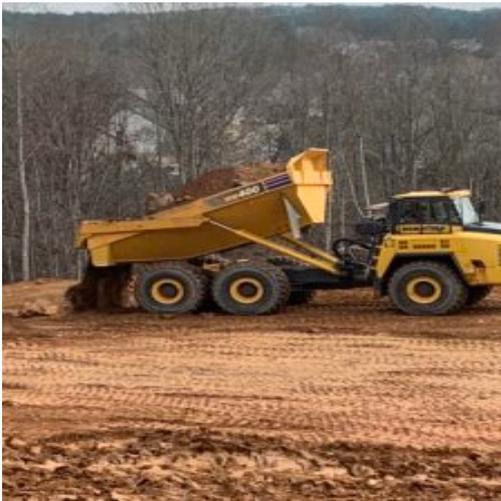
Our representative was on site to observe site conditions at Parkway Ext Phase 2 for base stone placement following a rain event. There was no standing water on the subgrade, however, subgrade soils were saturated where base stone was to be placed today. The grading contractor however continued rockfill placement at the slope embankment. The fill was placed in recommended compacted lift thickness as is suitable for site requirements.
