Date : 12/17/2025
Project No : 2025C260
Client Company : Artisan
Arrival Time : 12/17/2025 15:00
Onsite Hours : 02:00

ASEC Report ID : 88594
Name of the Project : NW (PHASE 2) Parkway Extension
Project Location : Dallas
Weather : cloudy
Departure Time : 12/17/2025 17:00
ASEC Technician Name : Clyde Smith

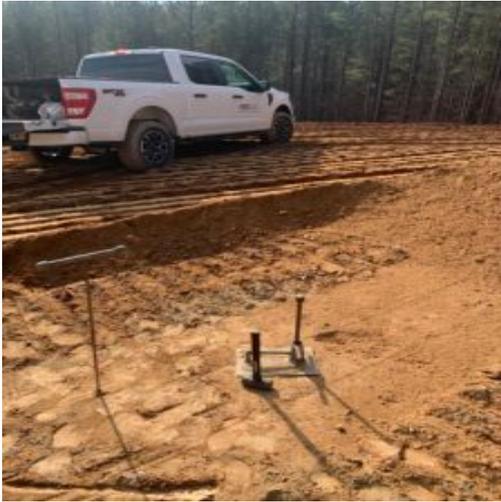
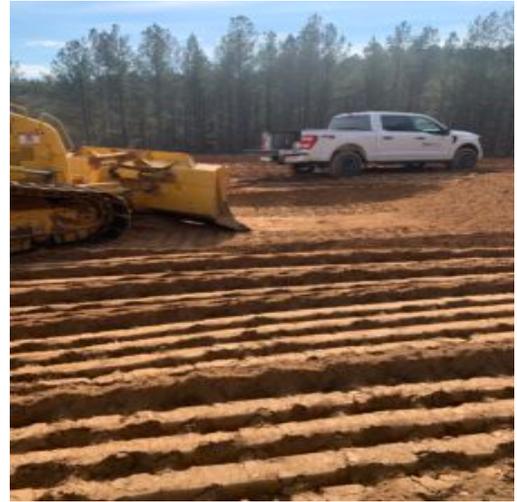
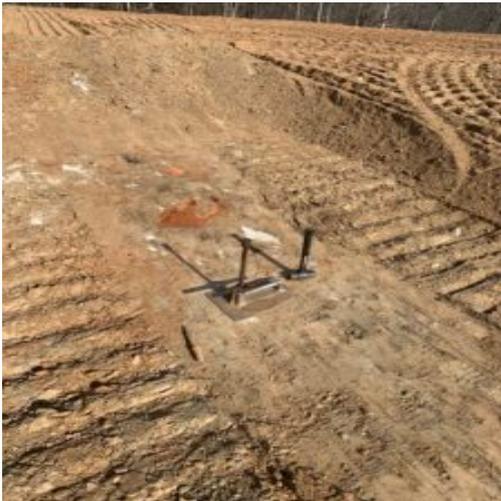
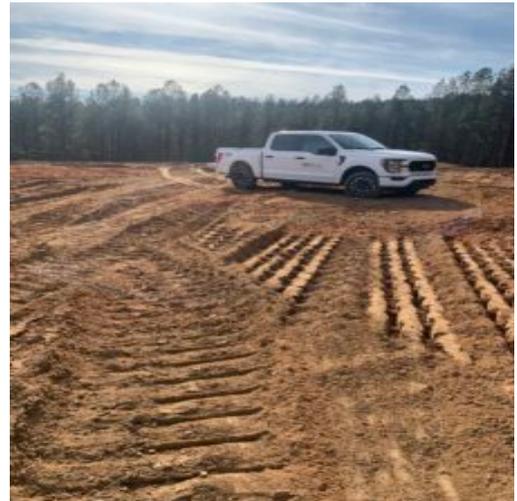
On the above date our representative was on site to observe the grading contractor continue to place fill for the cul de sac building lots including spreading and compacting in recommended lifts. The fill was observed by proof-rolling and probing using a 3/8" diameter steel rod. Compaction efforts were suitable as per job specifications. Fill placement today was observed at elevation 861 and 859 having approximately 18' of remaining fill to be placed.

Fill placements and observation at cul de sac lots
