Date : 02/10/2026  
Project No : 2026C103  
Client Company : Artisan  
Arrival Time : 02/10/2026 14:30  
Onsite Hours : 03:00

ASEC Report ID : 90210  
Name of the Project : NW PH 2, UNIT 4  
Project Location : Dallas  
Weather : sunny  
Departure Time : 02/10/2026 17:30  
ASEC Technician Name : Clyde Smith

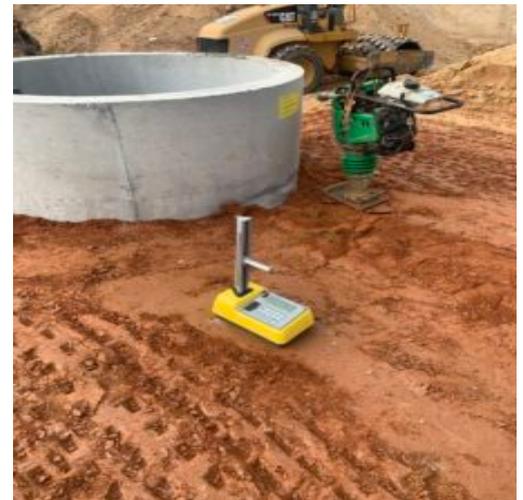
On the above date our representative was on site to observe backfilling of the 48" RCP storm line between the OCS and headwall#3 at Unit 4 phase 2 water quality pond, performing density tests using a Troxler Nuclear gauge model 3430, serial no. 91643. The writer observed the anti-seep collars in place prior to backfilling which appeared to be in compliance with site documents. Compaction results were in compliance with job specifications.

Performing density tests at 48 " rcp storm line between OCS and headwall #3
