Date : 03/04/2026
Project No : 2026C103
Client Company : Artisan
Arrival Time : 03/04/2026 07:30
Onsite Hours : 10:00

ASEC Report ID : 91073
Name of the Project : NW PH 2, UNIT 4
Project Location : Dallas
Weather : sunny
Departure Time : 03/04/2026 17:30
ASEC Technician Name : Clyde Smith

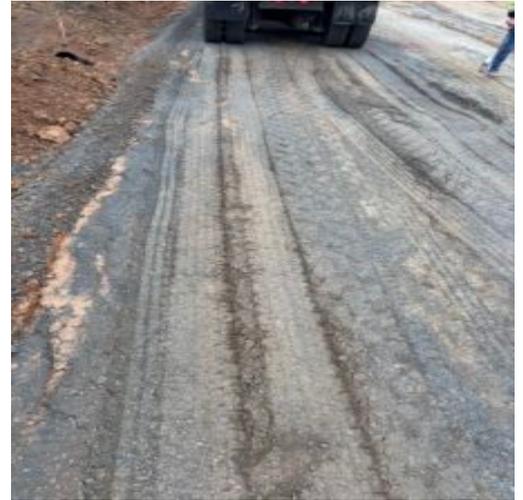
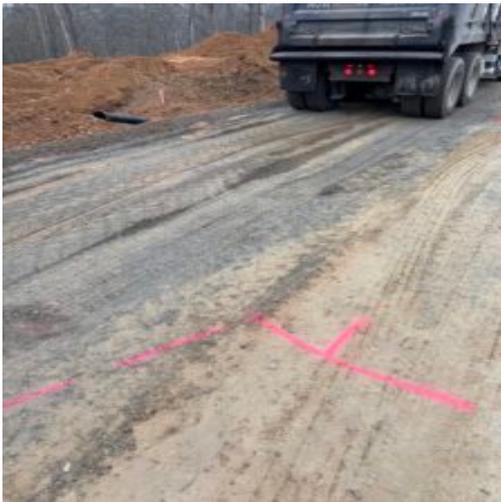
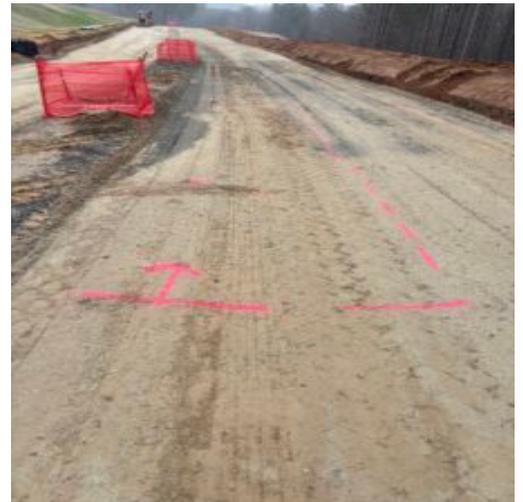
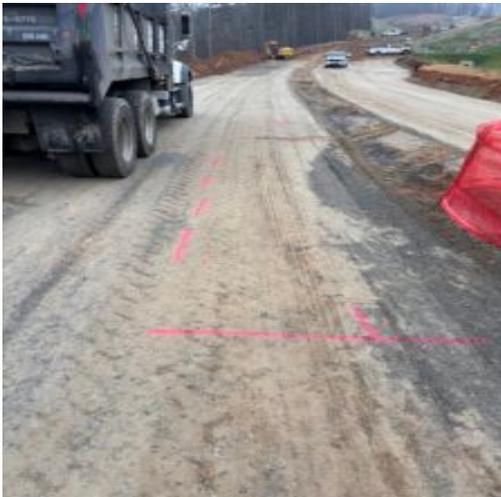
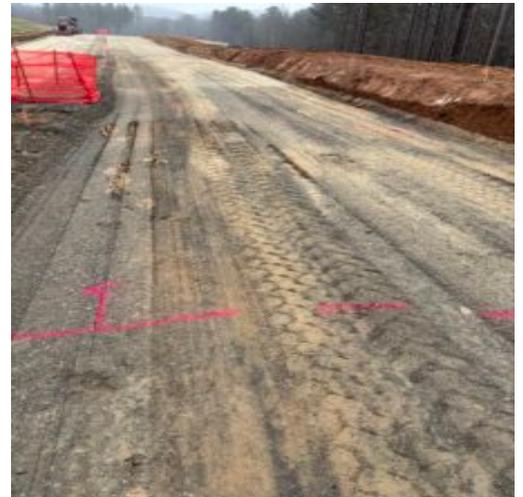
The pipe contractor continued installing 8" ductile iron sanitary sewer line between manholes # B-2 and B-4 (and backfilling). Density tests were performed using a Troxler Nuclear gauge model 3430, serial no. 91643. Compaction results were suitable for job specifications.

Backfill at storm line between B2 and B4.
