Date : 04/25/2026  
Project No : 2026C103  
Client Company : Artisan  
Arrival Time : 04/25/2026 08:30  
Onsite Hours : 03:30

ASEC Report ID : 93477  
Name of the Project : NW PH 2, UNIT 4  
Project Location : Dallas  
Weather : cloudy  
Departure Time : 04/25/2026 12:00  
ASEC Technician Name : Clyde Smith

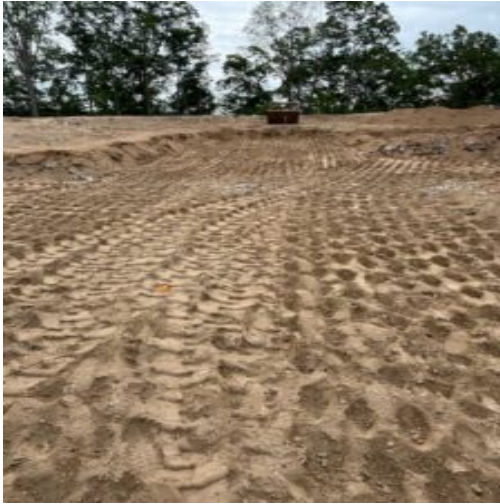
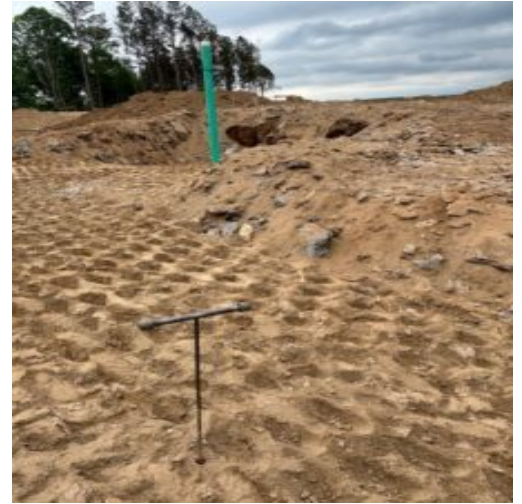
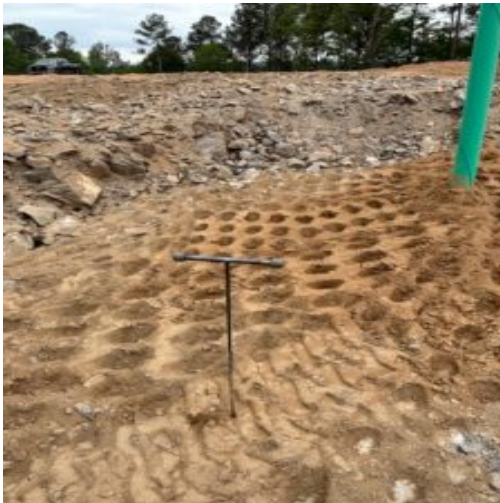
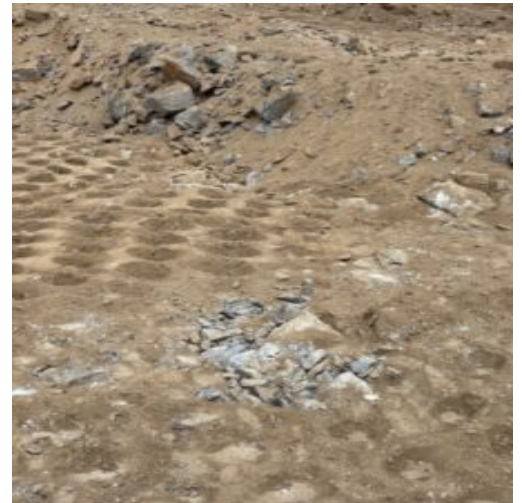
On the above date our representative was on site to observe the pipe contractor continue backfilling 8" PVC sanitary sewer line between manholes #14, 15 and 16 along B line. The backfill consisted of smaller rockfill fragments from the recent blast. The rockfill was placed in suitable compacted lifts with finer soils mixed and compacted using a vibratory sheep-foot roller. The fill placement was probed using a rounded end steel rod and appeared compacted suitable for rockfill placement. The fill placement was observed at elevation -4.5 feet and approved for additional lift placement.
