ASEC Report ID : 76297
 Name of the Project : Strickland Brothers-Villa Rica
 Project Location : 800 Highway 61, Villa Rica, Carroll County,
 Georgia
 Weather : Cold
 Departure Time : 01/23/2025 13:30
 ASEC Technician Name : Micah Aycock

As requested, the site was visited by our AS Engineering and Consulting (ASEC) representative for the purpose of performing a visual foundation inspection to verify the building foundations (lift pits and continuous wall footings) soil bearing pressure. Testing was performed for the new Strickland Brothers 10 Minute Oil Change facility located at 800 Highway 61 in Villa Rica, Georgia.

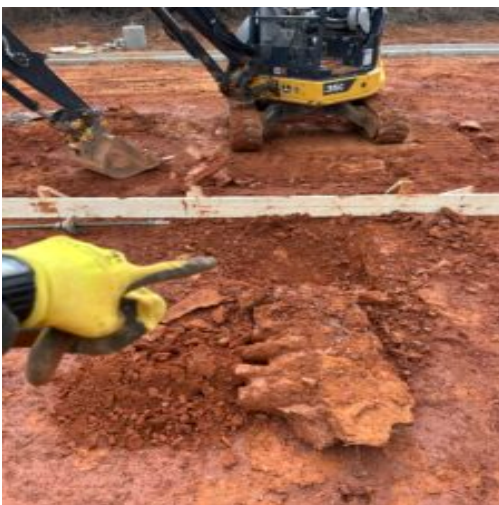
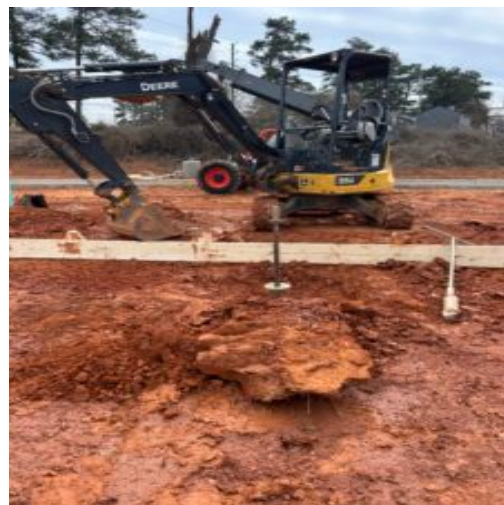
Contractor used excavator to scrape down 1.5 feet of hardened ground from the surface in order to perform hand auger/DCP test.
