ASEC Report ID : 77222  
Name of the Project : Enclave at Parkway Village  
Project Location : Union City  
Weather : cloudy  
Departure Time : 02/10/2025 15:30  
ASEC Technician Name : Vamsi Polisetty

Nature walk: Footings Inspection (Lot #65-Mono Slab Inspection)

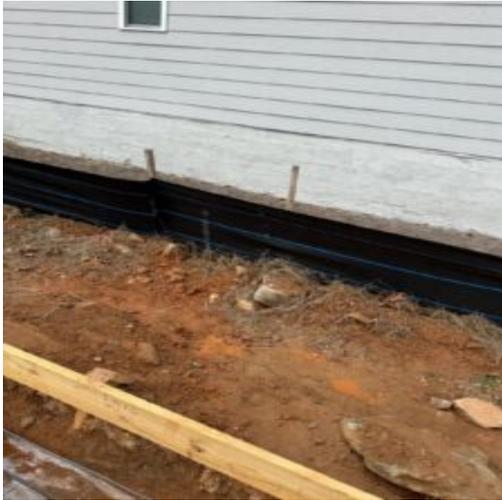
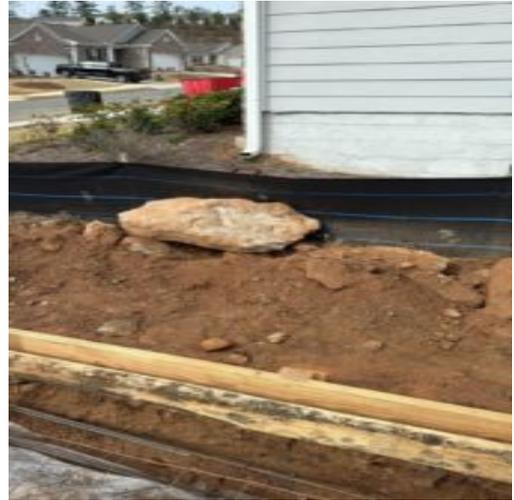
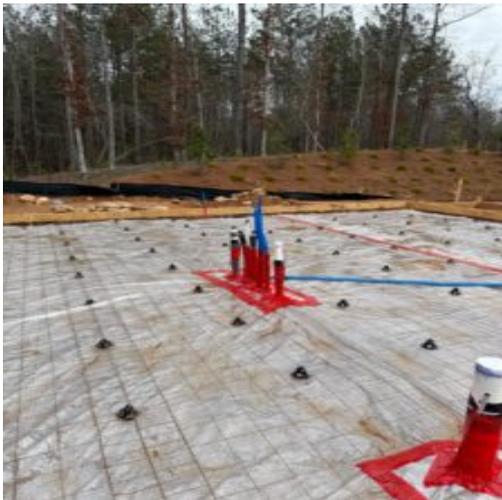
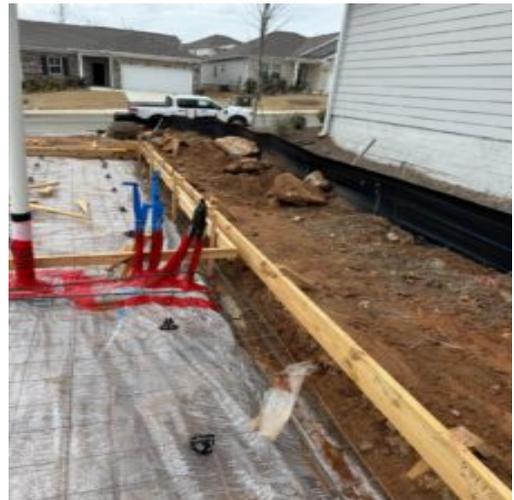
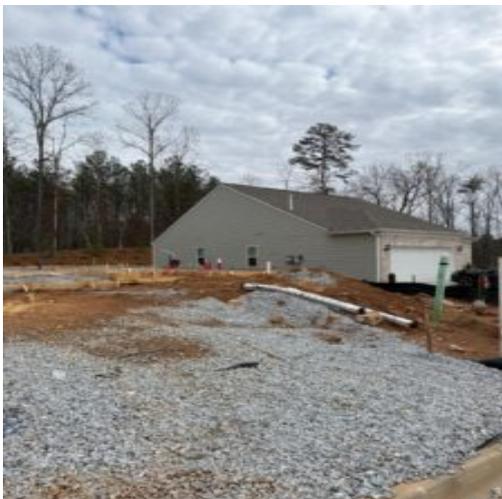
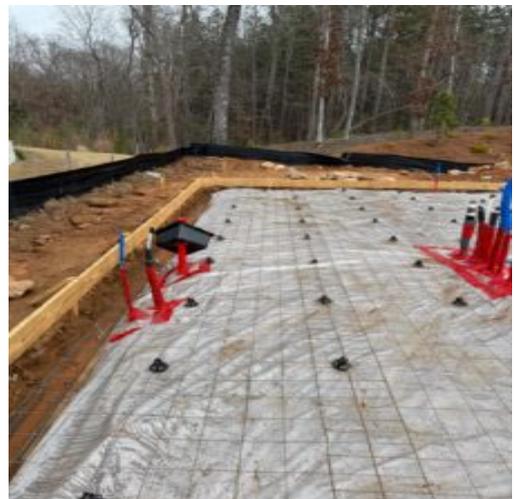
A Dynamic Cone Penetrometer (DCP) test was performed on two sides of Lot #65, revealing the presence of small stones and rocks, which resulted in auger refusal at relatively different depths.

The probe appears to be in good condition rock Boulders and stones are seen in the backfill and probe area. Minor recommendations include removing dirt from the corners of the beam. The reinforcement appears to be in satisfactory condition.
