ASEC Report ID : 83768
 Name of the Project : Enclave at Parkway Village
 Project Location : Union City
 Weather : sunny
 Departure Time : 07/23/2025 12:00
 ASEC Technician Name : Aminullah Azimi

This report provides a reassessment of the footing excavations for Lot #98. The assessment includes excavation dimensions, depth, cleanliness, and the results of soil testing using a hand auger, Dynamic Cone Penetrometer (ASTM STP-399), and general probing tests.

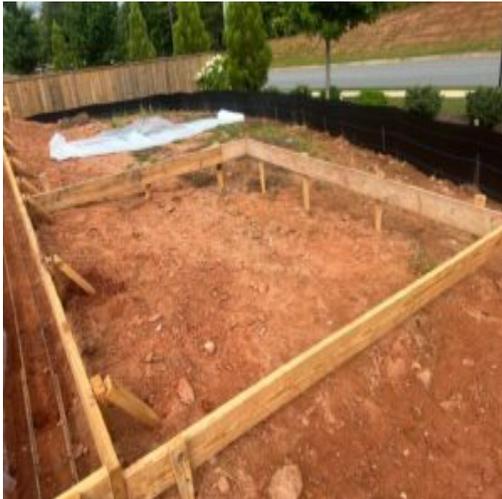
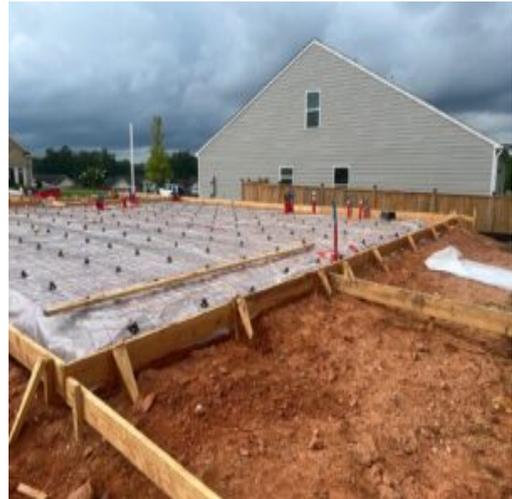
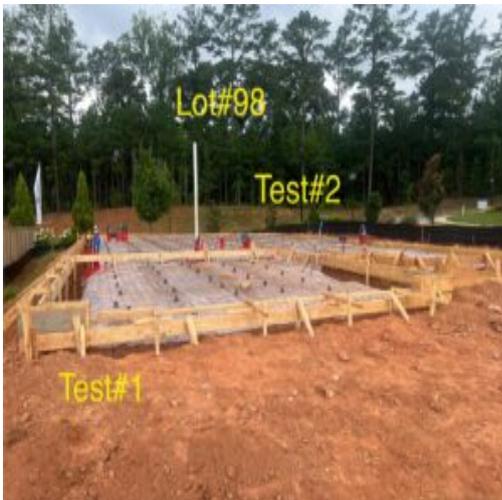
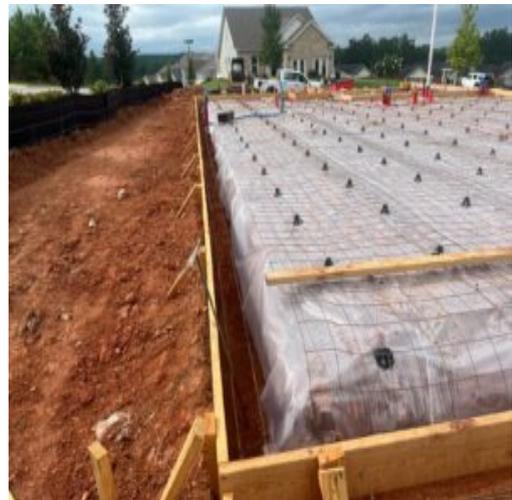
The footing excavations were noted to be in general accordance with the project drawings with respect to size and depth.

Additionally, it was observed that the footing excavations were generally free of loose soil, debris, and water.

General probing using a 3/8” diameter probe rod found surficial soils in the base of the footing to be suitable for concrete placement.

Note: A wall footing to the side of the building was found to exhibit soft soils. Recommended to the contractor to undercut 6 inches and replace with No. 57 stone or suitable material, (location shown by yellow line).
