Date : 10/14/2024
Project No : 2024C217
Client Company : Artisan
Arrival Time : 10/14/2024 09:00
Onsite Hours : 08:30

ASEC Report ID : 71697
Name of the Project : Naturewalk - 7 Hills Amenities
Project Location : Dallas
Weather : sunny
Departure Time : 10/14/2024 17:30
ASEC Technician Name : Vamsi Polisetty

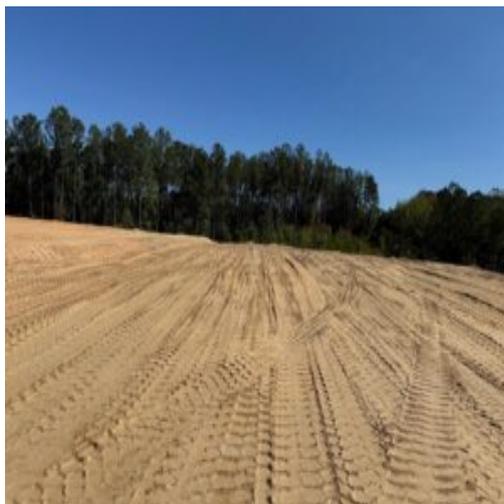
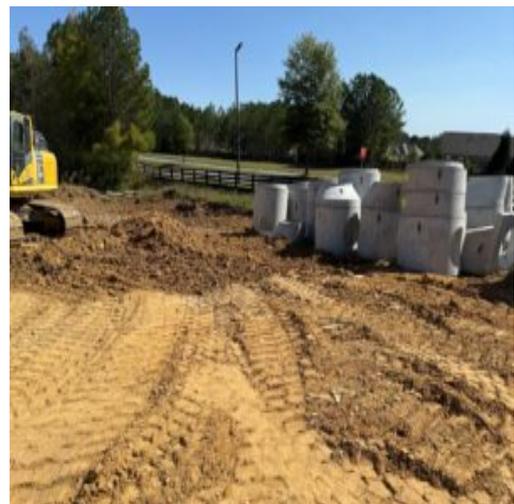
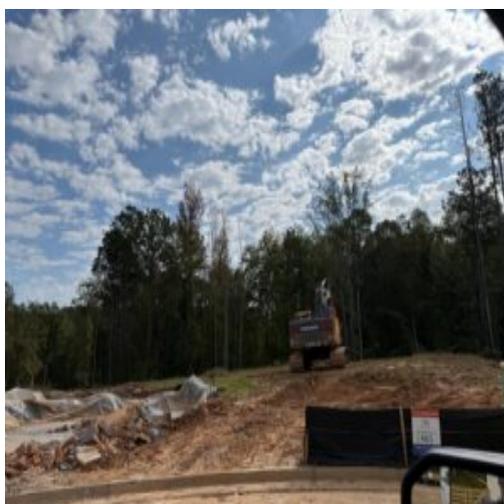
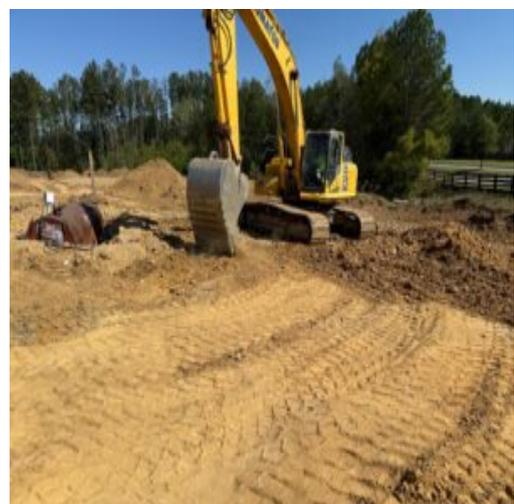
- Upon arrival, the contractor was engaged in excavations using a Komatsu PC 360LC on the west of the project site. Fill was being transported with two tandem dump trucks near the Pickle Ball Court, while dozing was performed with a Komatsu D85EX.
- Boulder fill is being used in backfilling under the tennis court and Pickle Ball court. Due to the boulder fill, proof-rolling was used to verify stability in lieu of density testing.
