ASEC Report ID : 78591
Name of the Project : Heritage Pointe - Footing Inspections
Project Location : Villa Rica
Weather : sunny
Departure Time : 03/07/2025 17:00
ASEC Technician Name : Vamsi Polisetty

Heritage Pointe Villa Rica: Footing Inspection (Lot #66)

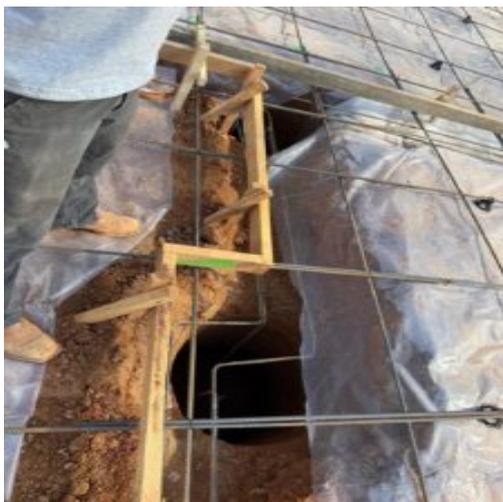
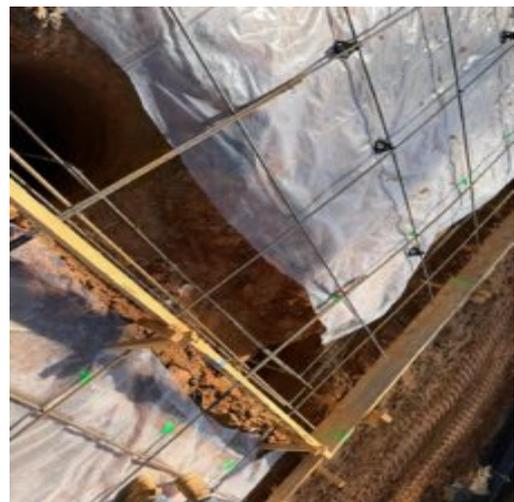
Some of the core cuts were performed to a depth of 4 feet, while others were extended until a hard layer was encountered. Reinforcement bars were properly placed within the core cuts in preparation for the concrete procedure. On-site observations confirm that the reinforcement was correctly installed, and a plastic sheet was placed beneath the reinforcement to ensure proper procedure adherence. Minor suggestions were made for the removal of loose dirt from the corners of the beams and from the pits.

On February 21, 2025, the Dynamic Cone Penetrometer (DCP) test was conducted on both sides of Lot #66, with the report (ID: 77815) subsequently provided to the contractor. Based on the results, the contractor was advised to perform core cutting along the tie beam of the building, both at the front and the side, with a dimension of 2 feet in width and 4 feet in depth. A total of 19 core cuts were carried out along the sides and front of the tie beams/footings.
