ASEC Report ID : 76523  
Name of the Project : Cottages at Villa Rica - Rock Blasting  
Project Location : Villa Rica  
Weather : cold  
Departure Time : 01/25/2025 13:00  
ASEC Technician Name : Mahendra Mylabathula

The aforementioned AS Engineering and Consulting (ASEC) representative visited the Cottages at Villa Rica site to monitor drilling and rock removal operations. The contractor performing the work was Precision Blasting. The following observations were made on-site:

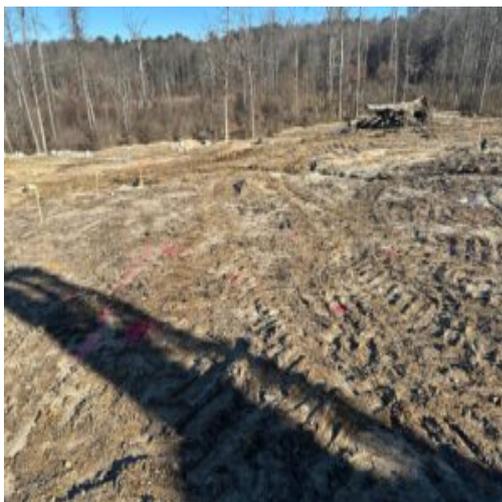
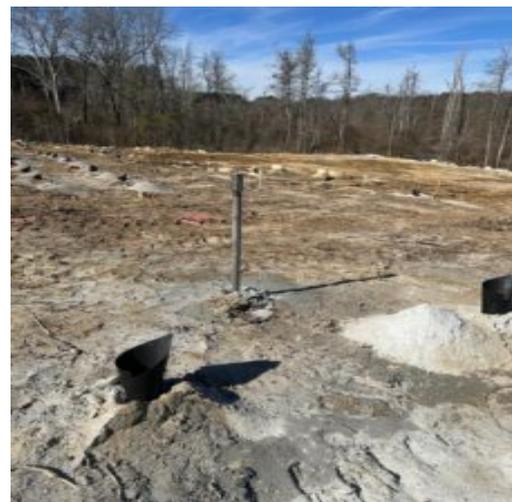
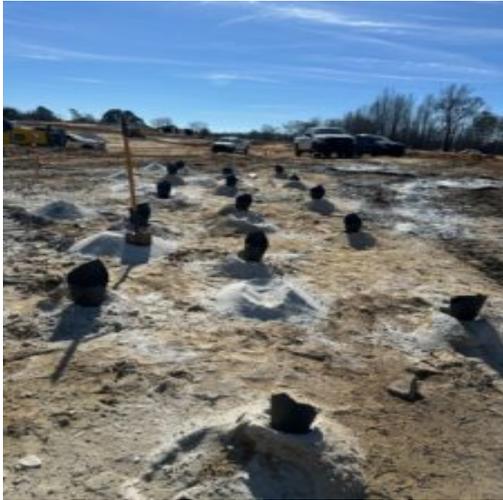
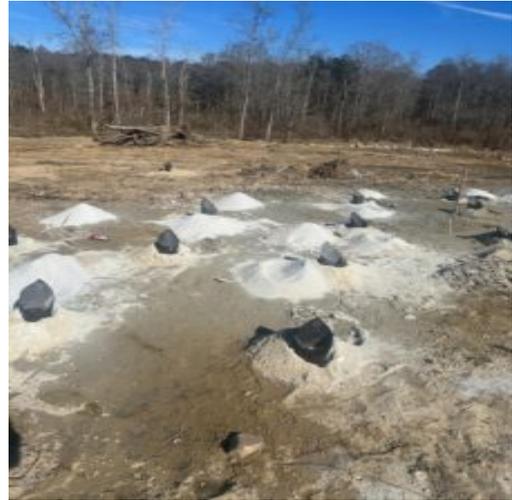
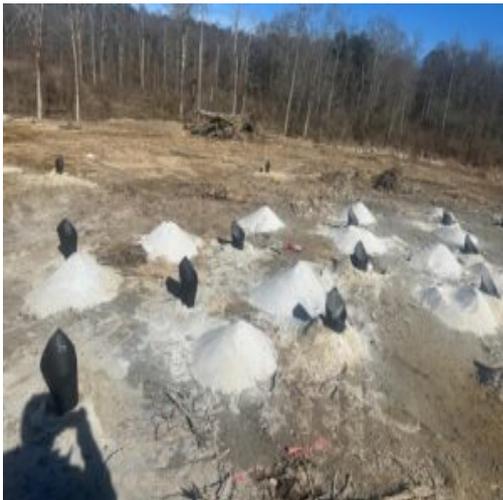
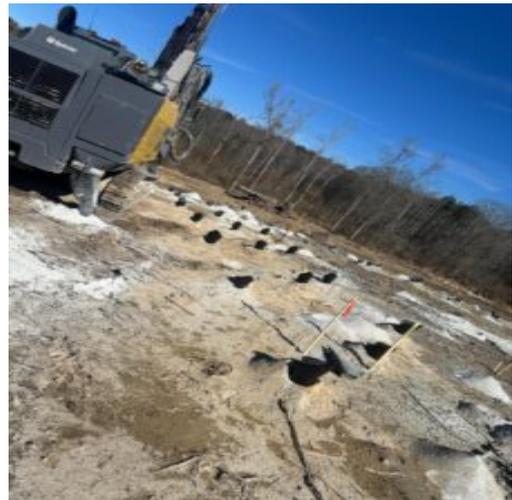
The drilling operation began at Lateral 124, located north of Lot 124 and south of Lot 45. During the drilling process, rock formations were encountered at a depth of approximately 13 feet in 13 out of the 15 holes. Drilling in this area was conducted in three rows, with rows spaced approximately 6 feet apart and drilling locations spaced 8 feet apart within each row.

Each hole was carefully inspected after drilling to ensure the correct depth was achieved. However, after completing 14 holes, an issue arose with the drilling equipment: the drill rig was unable to extract the drill steel from one of the holes. As a result, the team decided to halt operations to address the equipment malfunction.

A layout drawing showing the approximate area where drilling was performed on this day is attached to this report.
