ASEC Report ID : 76848
Name of the Project : Cottages at Villa Rica - Rock Blasting
Project Location : Villa Rica
Weather : Sunny
Departure Time : 02/01/2025 14:30
ASEC Technician Name : Micah Aycock

The aforementioned AS Engineering and Consulting (ASEC) representative visited the Cottages at Villa Rica site to monitor drilling and rock removal operations. The contractor performing the work was Precision Blasting. The following observations were made on-site:

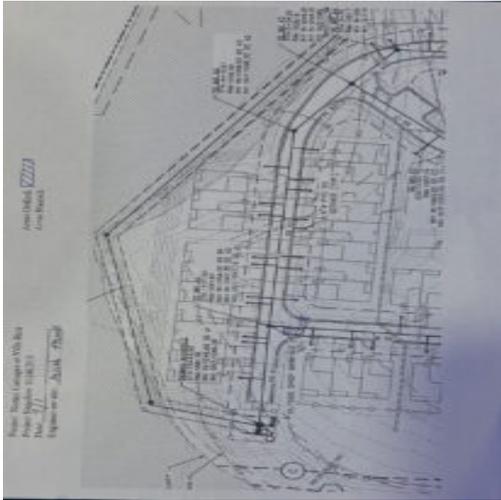
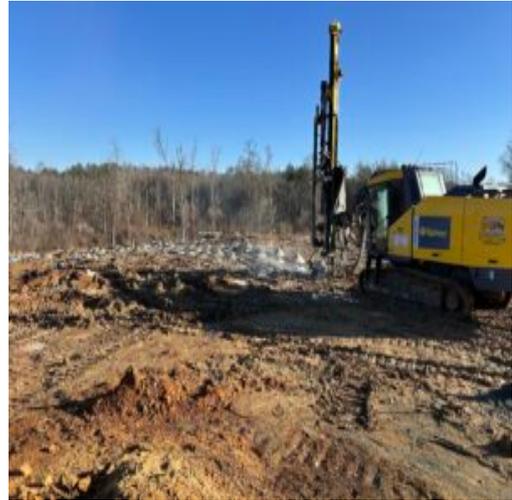
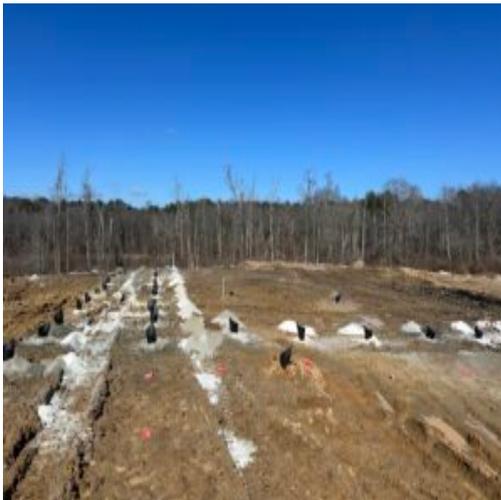
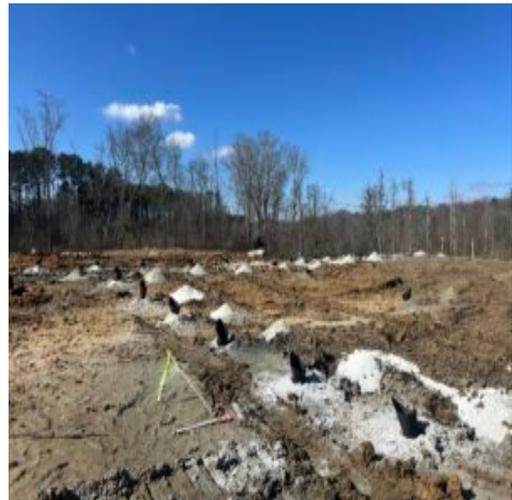
Today the drilling continued south of manhole A1 as this was where the contractor had ended operations on the previous day. The drill was making contact with rock around the 14-to-16-foot range on average. Hole spacing was 6 feet with approximately 8 feet between each drilling location. The contractor then transitioned drilling to lateral 123 just west of Lot #124. In this location the drill made contact with rock on average at 10 feet, but in two locations at a depth of 3 feet. Drilling was visually inspected for straight path drilling.

A layout drawing showing the approximate area where drilling was performed on this day is attached to this report.
