Date : 02/24/2025
Project No : 2024C315
Client Company : J. Chapman Const.
Arrival Time : 02/24/2025 09:00
Onsite Hours : 07:00

ASEC Report ID : 77963
Name of the Project : Cottages at Villa Rica - Rock Blasting
Project Location : Villa Rica
Weather : Sunny
Departure Time : 02/24/2025 16:00
ASEC Technician Name : Micah Aycock

The aforementioned AS Engineering and Consulting (ASEC) representative visited the Cottages at Villa Rica site to monitor drilling and rock removal operations. The contractor performing the work was Precision Blasting. The following observations were made on-site:

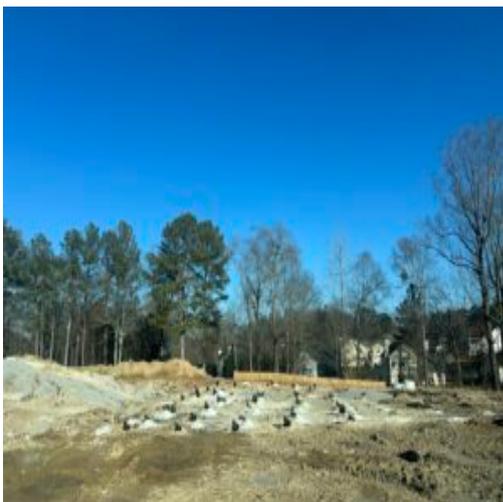
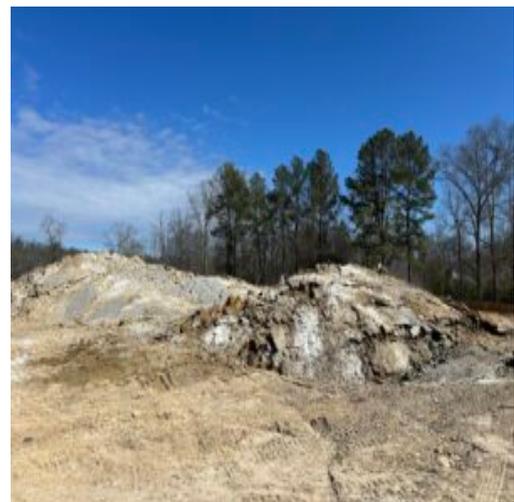
The holes that were blasted today consisted of a small trench pattern in the middle, with two mass rock patterns on either side. The location of this blasting was in-between lot #185 and lot #61, running down the main sewer line. A total mass rock area blasted was 1188 square feet with an average pay thickness of 6.67 feet. The calculated volume of the mass rock blasted was 293.33 cubic yards. The total trench area blasted was 432 square feet with an average pay thickness of 7.29 feet. The calculated volume of trench rock blasted was 116.71 cubic yards.

The drilling continued northwest of manhole A1, just south of lot #41. It followed a trench pattern and was reaching depths of 26ft, top of rock was around 6ft on average. This is where today's operations concluded.
