ASEC Report ID : 78440  
Name of the Project : Cottages at Villa Rica - Rock Blasting  
Project Location : Villa Rica  
Weather : Cloudy  
Departure Time : 03/05/2025 15:30  
ASEC Technician Name : Micah Aycock

### Site Visit Report - Cottages at Villa Rica

An AS Engineering and Consulting (ASEC) representative visited the Cottages at Villa Rica site to monitor drilling and rock removal operations. The contractor performing the work was Precision Blasting.

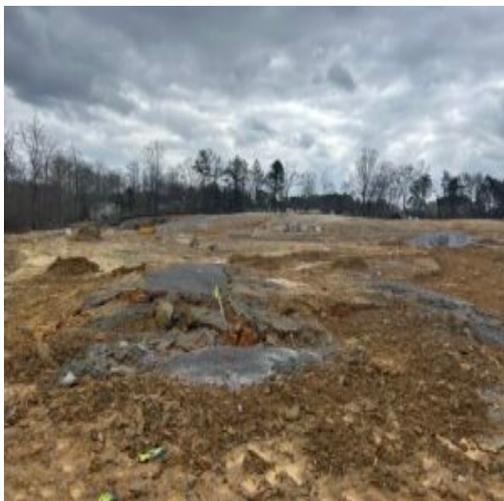
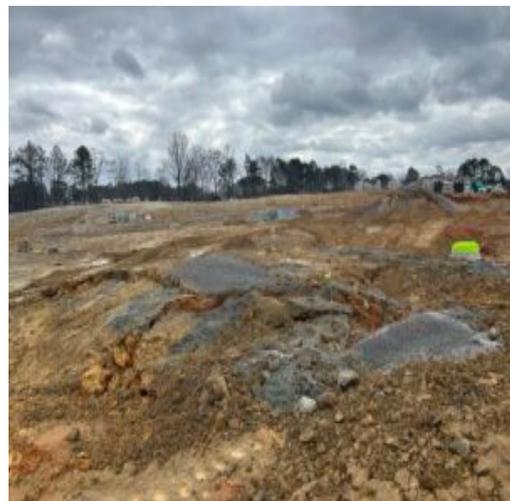
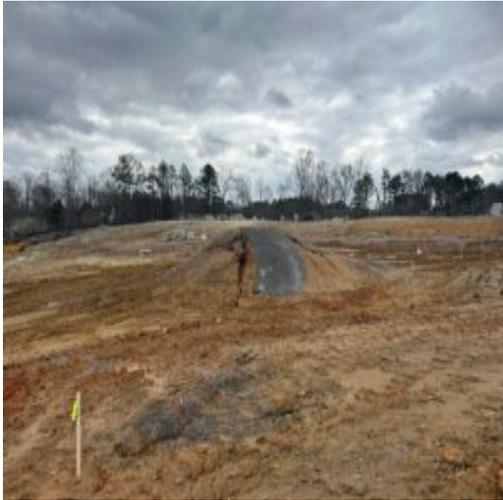
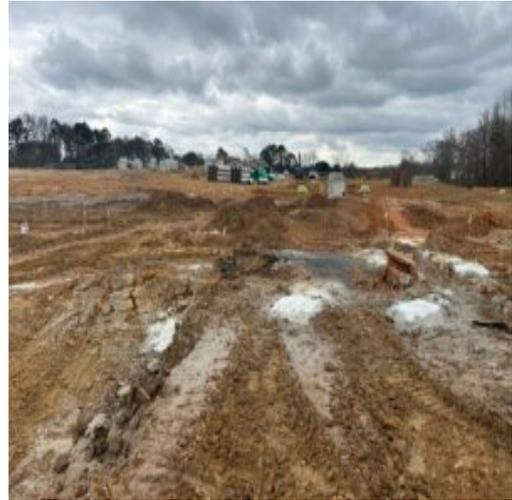
Blasting operations took place today in the northwest corner, south of Manhole A1. A total of five laterals between Lot #40 and Lot #37 were blasted in a trench pattern. The total blasted area for all trench laterals was 912 square feet, with a calculated trench rock volume of 323.59 cubic yards. The average drilled hole depth was 9.58 feet.

These efforts are part of Precision Blasting's ongoing work to break up the trench rock section in the northwest corner of the development. All drilling and blasting proceeded according to plan and met production standards.
