Date : 04/16/2025
Project No : 2025C160
Client Company : Artisan
Arrival Time : 04/16/2025 08:00
Onsite Hours : 06:30

ASEC Report ID : 80027
Name of the Project : Rockmart Township - 115 Felton Drive
Project Location : Rockmart
Weather : overcast
Departure Time : 04/16/2025 14:30
ASEC Technician Name : Sean Willett

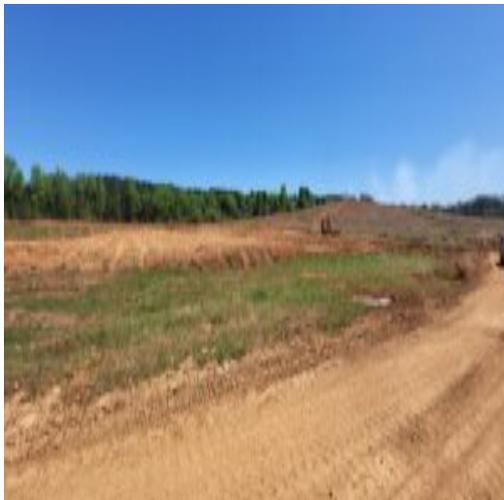
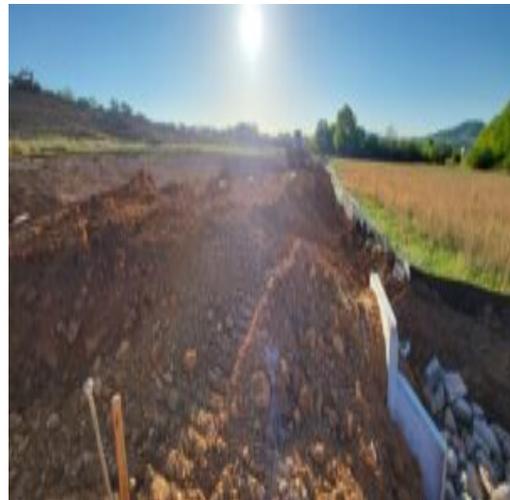
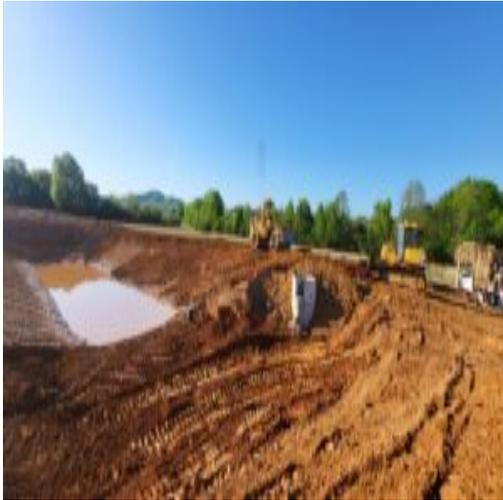
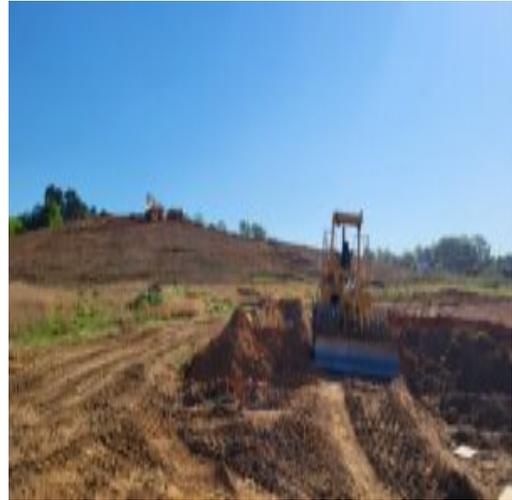
Our ASEC representative was on site as requested by the contractor (Wilbanks) for the observation/testing of the placement of soils. The technician observed the contractor place 1 lift approximately 8 inches in thickness over Lots #121 through #125 and #112 through #117. Fill materials tested were found to be much higher than optimum moisture content and was left to aerate in place to reduce in-situ moistures prior to compaction.

The contractor placed 8-inch lifts along the retention pond and OCS by Lot #140. The fill thickness today was placed up to 4 to 5 feet. The compaction results were 95% to 98% and within optimum moisture content range (3 percent above and below optimum). All test results were provided to the contractor.
