Date : 07/07/2025
Project No : 2025C160
Client Company : Artisan
Arrival Time : 07/07/2025 07:30
Onsite Hours : 05:30

ASEC Report ID : 82881
Name of the Project : Rockmart Township - 115 Felton Drive
Project Location : Rockmart
Weather : sunny
Departure Time : 07/07/2025 13:00
ASEC Technician Name :

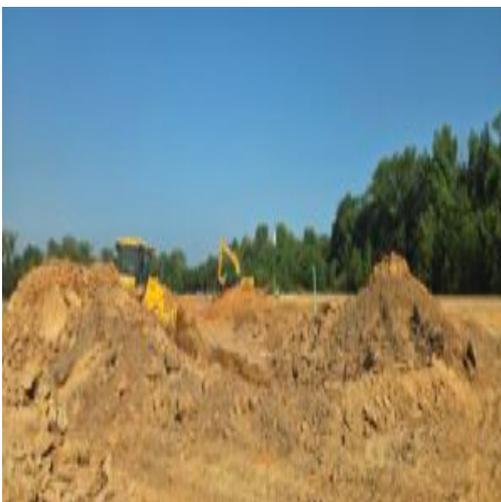
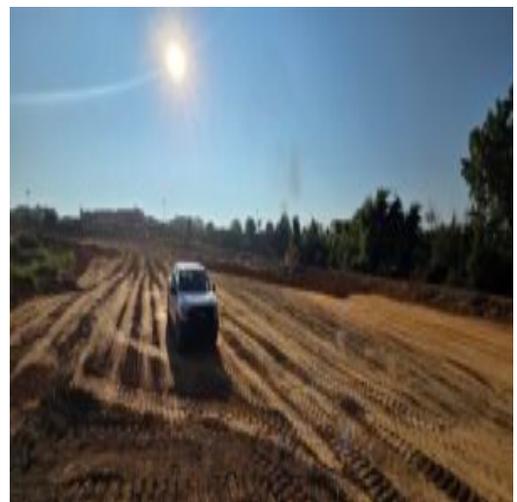
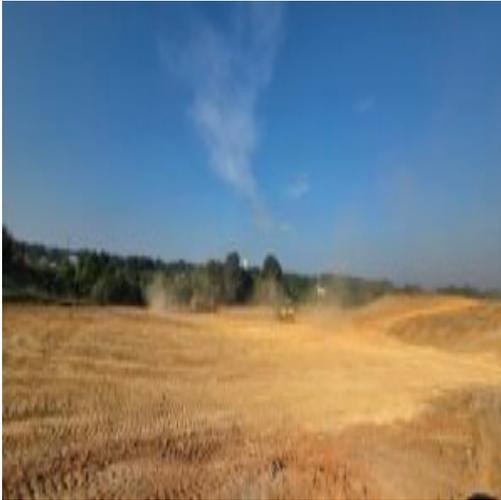
Our ASEC representative was on site as requested by the contractor (Wilbanks) for the observation/testing of the placement of fill/backfill. The technician observed the contractor spread one lift, approximately 8 to 12 inches in thickness, across the approximate location of Lots #65 through #75. The lift was compacted using a sheep-foot roller.

The technician performed a proctor point check in the roadway near SSMH2.0 for the previous workday tests. The technician provided the test results to the contractor. All roadway tests were found to meet job specifications for phase 1.
