Date : 08/01/2025
Project No : 2025C160
Client Company : Artisan
Arrival Time : 08/01/2025 08:30
Onsite Hours : 05:30

ASEC Report ID : 83739
Name of the Project : Rockmart Township - 115 Felton Drive
Project Location : Rockmart
Weather : overcast, wet site
Departure Time : 08/01/2025 14:00
ASEC Technician Name : Sean Willett

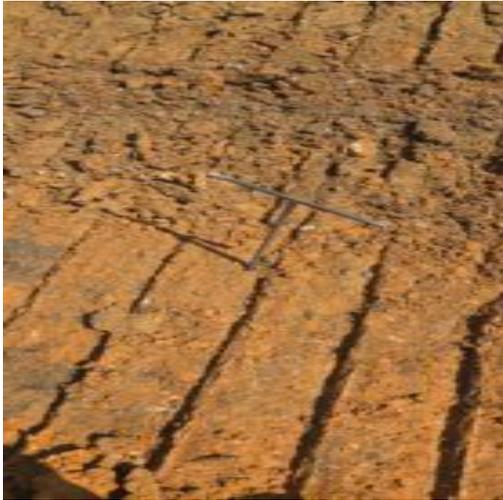
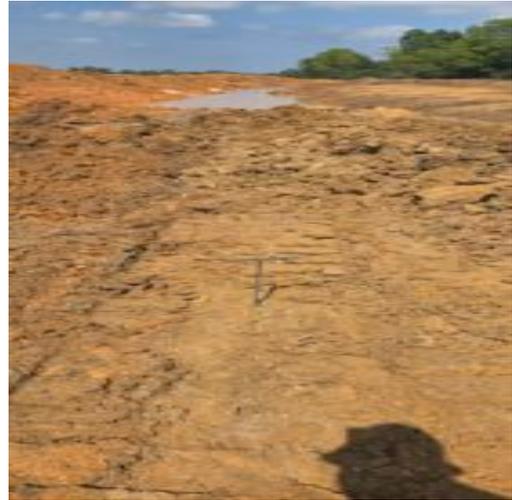
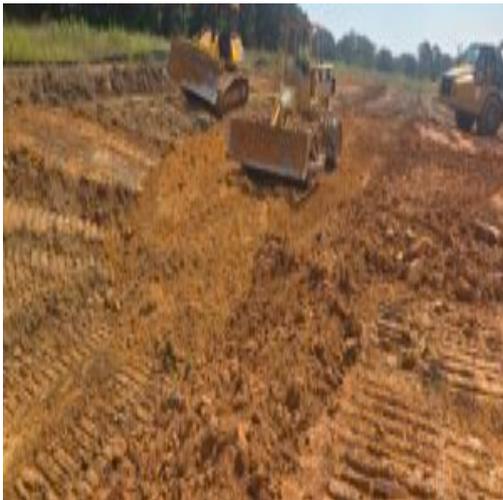
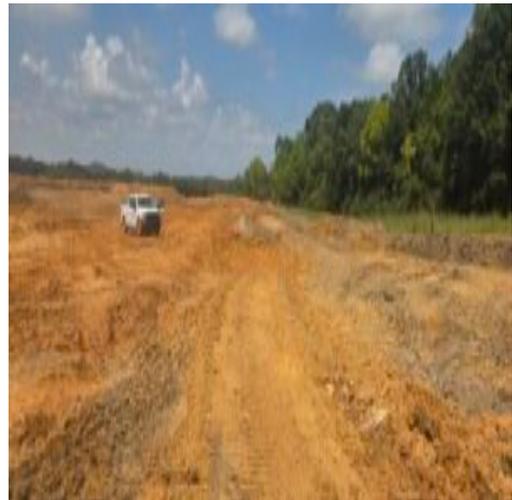
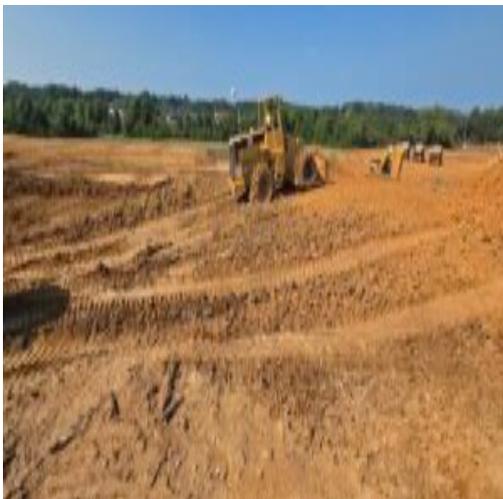
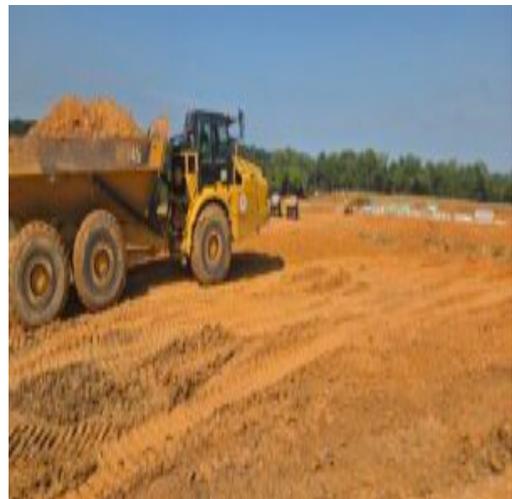
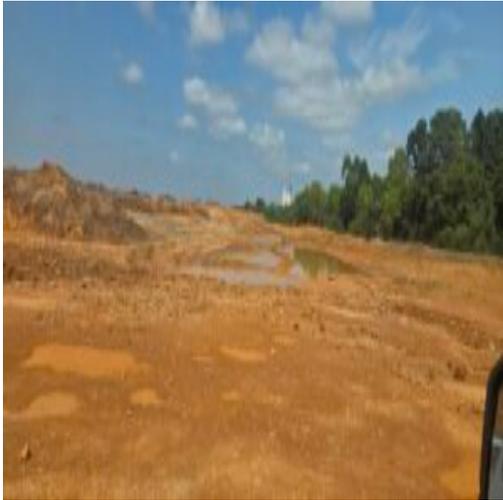
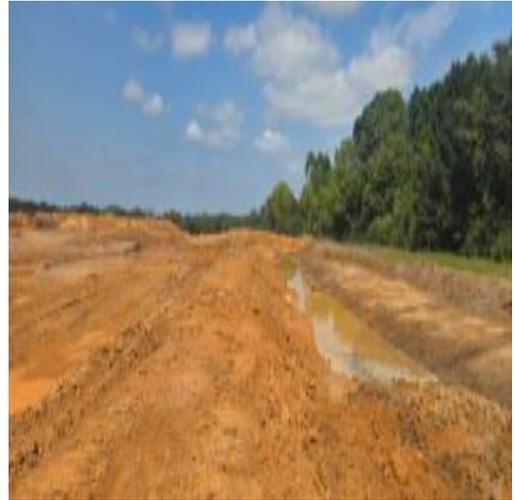
Upon arrival to the site, it was noticeable how saturated the site was from previous night's rain. There is standing water across the entire site, and large ruts from equipment.

The contractor proceeded to place fill in one lift across the approx. location of Lots #173 through #180. The lift was approx. 8 to 12 inches in thickness and compacted via a sheep-foot and a loaded off-road dump truck.

The contractor then began to place fill in the building pads of the of Lots #53 through #60. This area was a previous runoff water ditch to a temporary detention pond located on Lots #50 through #52. The technician recommended not to place the fill due to excessively high moisture contents. The contractor inquired about a bridge lift, which the soils are also too wet for.

The contractor proceeded to place approximately 4 feet of fill (in one lift) and the technician density tested this area. Test results showed a compaction rate of 79% to 80% and a far too high moisture content. The contractor stated the ground appeared to be compacted. The technician advised the contractor that this area will need to be completely excavated and redone once site conditions are back to optimum. The contractor stated they would redo this area. The contractors main concern is water management due to more rainfall scheduled for the weekend.
