ASEC Report ID : 91079
 Name of the Project : NW Unit 4 BRIDGE (Materials Testing)
 Project Location : Dallas
 Weather : sunny
 Departure Time : 03/05/2026 10:30
 ASEC Technician Name : Clyde Smith

Advanced Explosives Test Drill Log

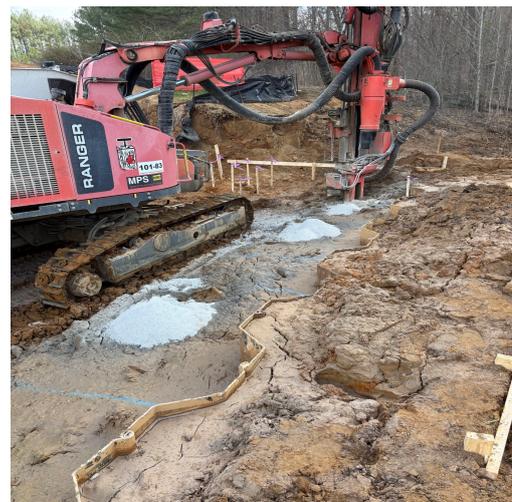
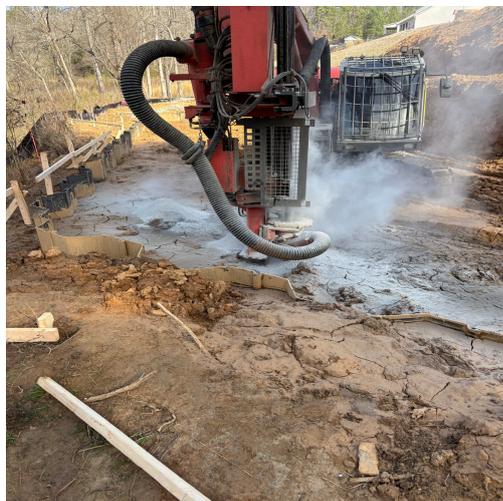
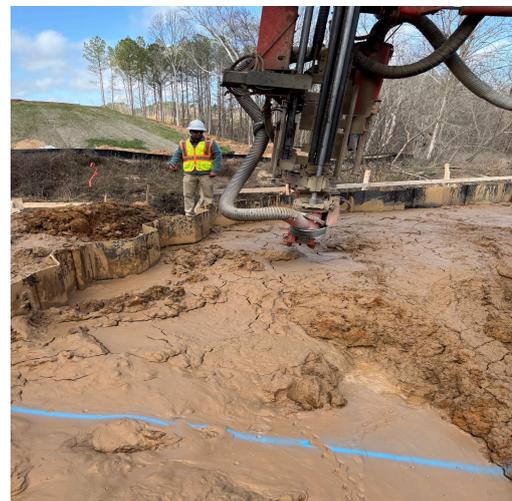
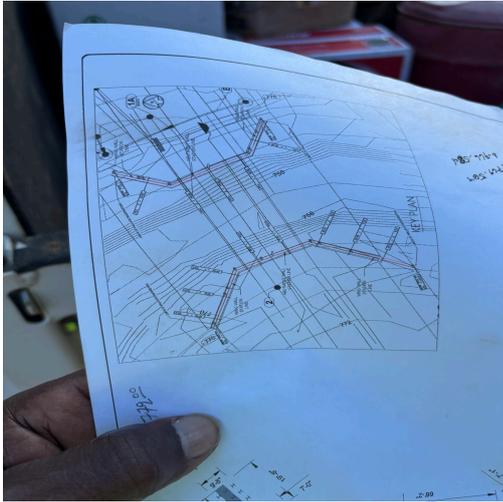
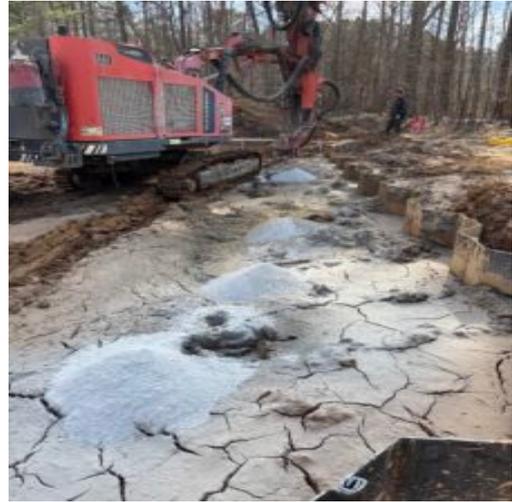
Our representative was on site to observe the blast contractor drill test holes for the north side bridge embankment (east side) at sheet piling. The contractor performed a total of seven (7) test drill holes, five feet off the east side face of sheet piles starting at the bend. The holes were drilled five feet apart to the first twenty feet then ten feet apart to forty feet with the last hole at five feet to the end of sheet piling. See attached drill log for results.
