Date : 12/15/2025  
Project No : 2025C269  
Client Company : Lewis Contracting  
Arrival Time : 12/15/2025 07:45  
Onsite Hours : 9:00

ASEC Report ID : 88682  
Name of the Project : Main St. & First Ave. - Mixed-use  
Project Location : Lilburn  
Weather : sunny  
Departure Time : 12/15/2025 16:45  
ASEC Technician Name : Samara Simha Reddy Kandi

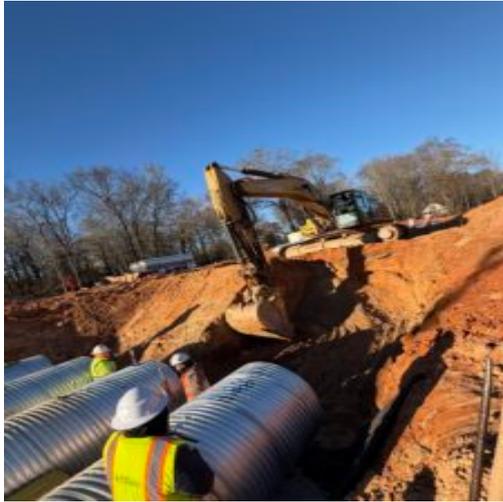
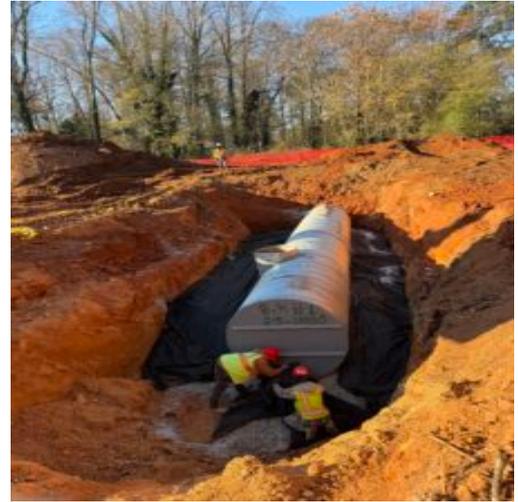
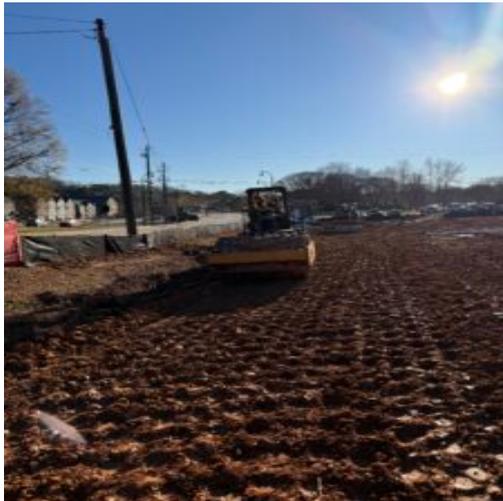
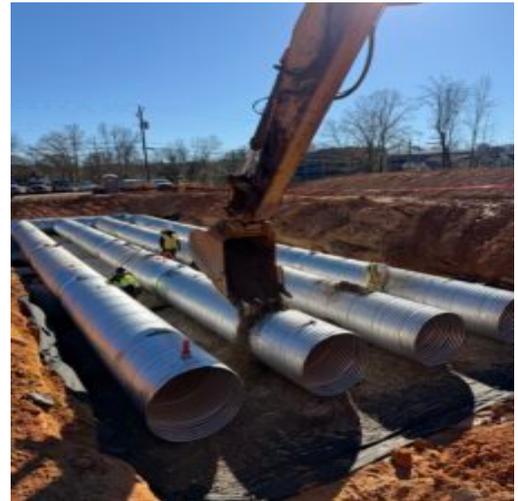
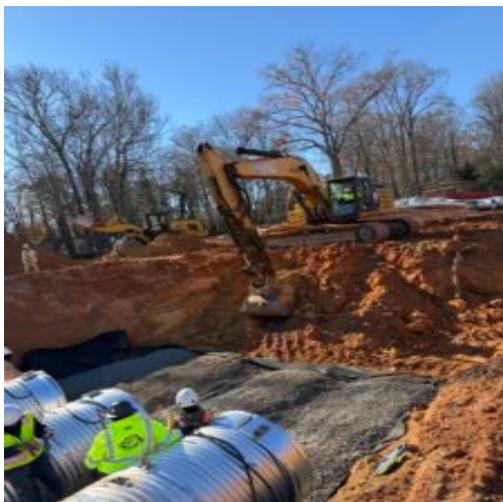
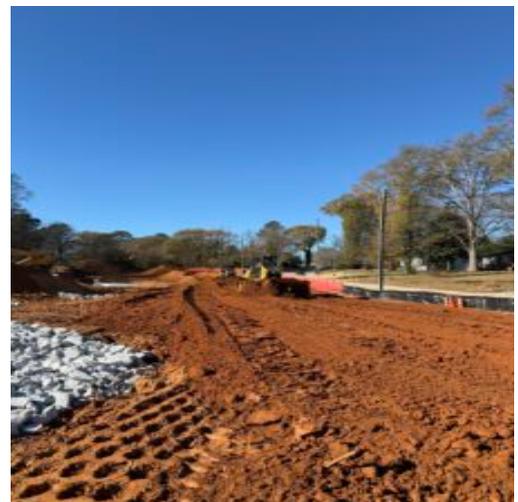
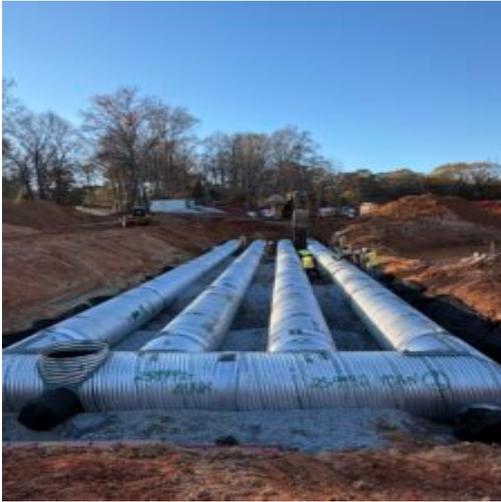
On the next working day, construction activities continued at Pond 1, where the crew advanced excavation operations to support continued installation of the underground stormwater detention system. Soil was excavated to the required design elevation using a CAT hydraulic excavator, and the excavation base was leveled and fine-graded. A non-woven geotextile fabric was placed along the bottom and sides of the excavation.

Following fabric placement, a gravel bedding layer was installed and leveled. The crew then installed additional corrugated metal pipes (CMP) in alignment with the existing detention system. Pipe installation at Pond 1 progressed to an approximate total length of 100 lineal feet. Pipe sections were positioned using chains and the excavator. Gravel was placed around and between the pipes.

At Pond 3, the crew completed detention system finishing activities by closing the open ends of the installed pipes. End caps were secured in place, and the exposed pipe ends were wrapped and covered with geotextile fabric to prevent soil infiltration into the detention system. Additional gravel was placed as needed to stabilize the pipe ends and bedding. These activities marked the completion of pipe installation work at Pond 3.

The crew shifted operations at foundation wall to sd2-p 914. Fill material was placed along the corridor between the buildings to restore site grades. The soil was placed in two controlled lifts, each approximately 6 to 8 inches thick, and compacted using compaction equipment, including a sheep-foot roller.
