Date : 01/20/2026
Project No : 2025C269
Client Company : Lewis Contracting
Arrival Time : 01/20/2026 08:30
Onsite Hours : 07:30

ASEC Report ID : 89435
Name of the Project : Main St. & First Ave. - Mixed-use
Project Location : Lilburn
Weather : sunny
Departure Time : 01/20/2026 16:00
ASEC Technician Name : Samara Simha Reddy Kandi

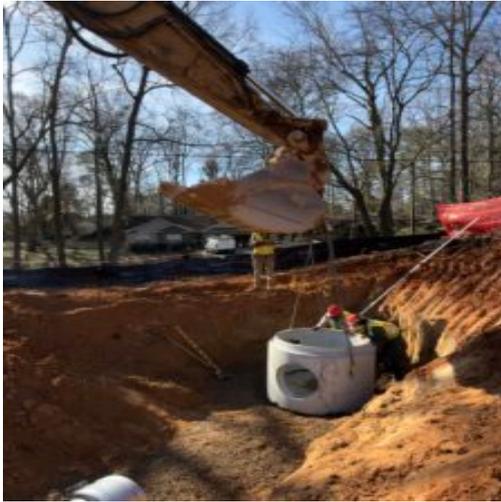
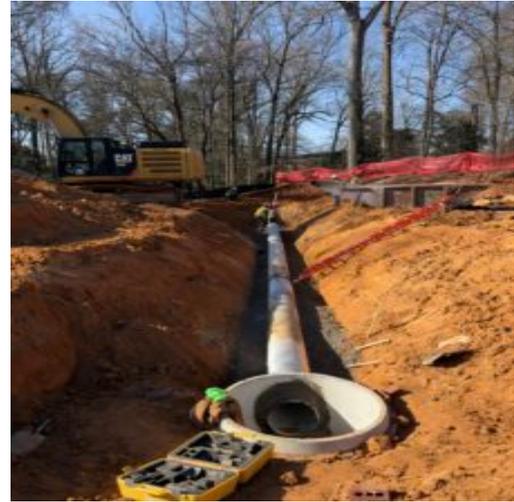
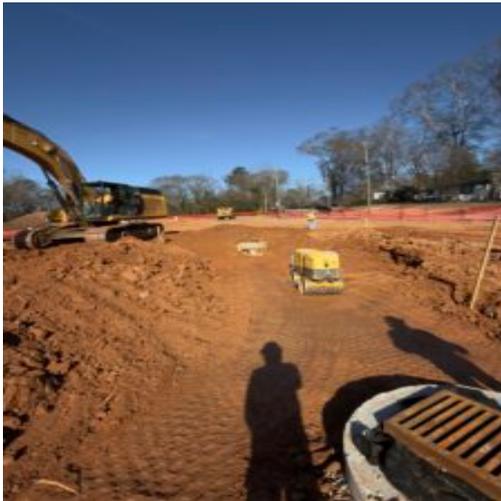
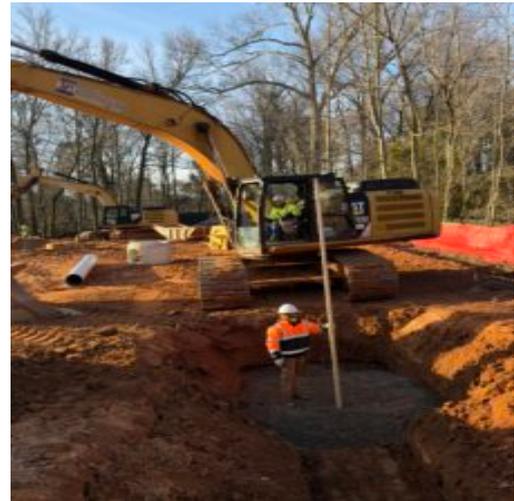
Crew 1 performed backfilling operations at locations B3-B5. Backfill material was placed around the installed manholes and storm pipes in lifts of approximately 6-8 inches. Each lift was compacted using a drum roller for the general backfill and a jumping jack plate compactor around the manholes and confined areas.

At the same time, Crew 2 began work between points C1 and B6. The crew excavated the soil to the required depth and leveled the subgrade to prepare for pipe installation. Gravel bedding was then placed and graded. Corrugated metal pipes (CMP) were installed from B6 toward C1 and aligned to the specified grade. At C1, a manhole was installed and connected to the incoming pipe. The gap between the manhole and the pipe was sealed with concrete. Following installation, backfill material was placed around the manhole and pipe in lifts of approximately 6-8 inches and compacted.

Meanwhile, Crew 3 started work at locations F2-F3. The crew excavated the soil, leveled the subgrade, and placed gravel bedding to prepare for pipe installation. Storm pipes were installed from the existing manhole outlet at F2 toward F3, and a new manhole was installed at F3. All pipe-to-manhole connections were sealed with concrete. Backfilling operations were then started; however, due to excessive moisture contents in the available soils, the material did not meet the required compaction density. The contractor indicated that no suitable dry backfill material was available at that time, and therefore backfilling activities at this location were suspended for the remainder of the day.
