Date : 02/18/2025
Project No : 2021C060
Client Company : Pulte Group
Arrival Time : 02/18/2025 07:30
Onsite Hours : 02:00

ASEC Report ID : 77525
Name of the Project : Suncity - Peachtree
Project Location : Griffin, GA
Weather : sunny
Departure Time : 02/18/2025 09:30
ASEC Technician Name : Vamsi Polisetty

Footings Inspection (Lot #154-Pod 14)

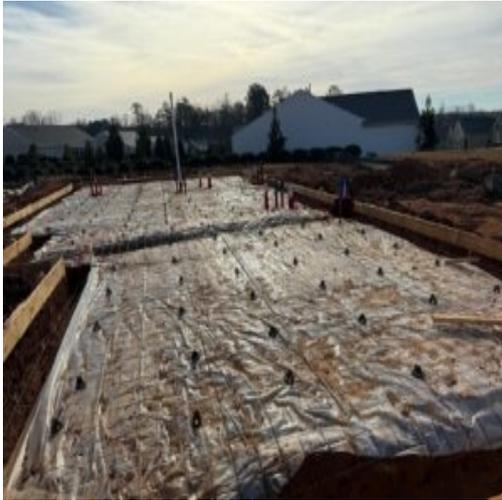
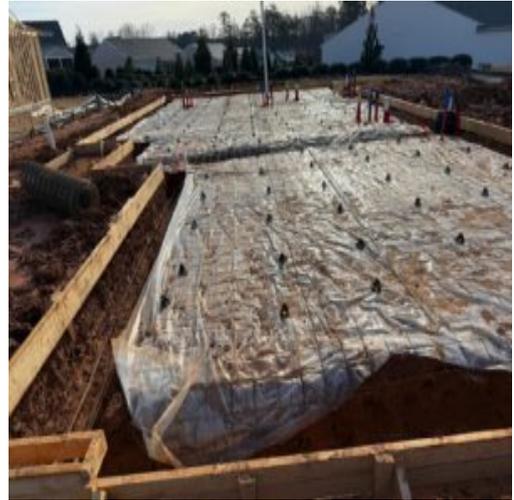
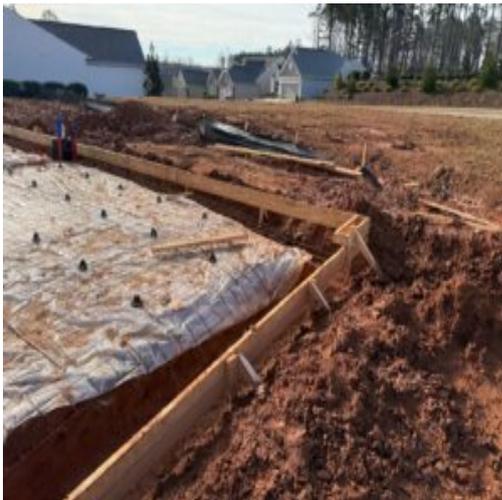
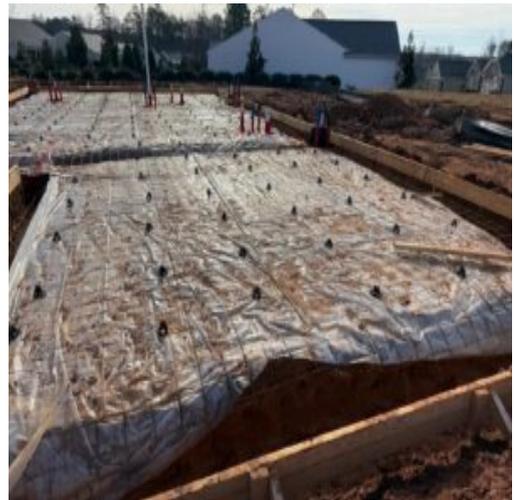
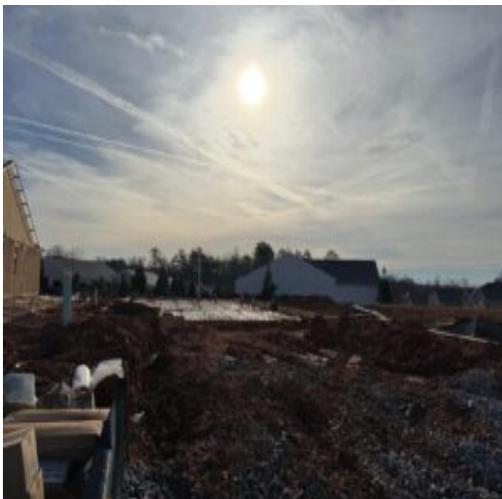
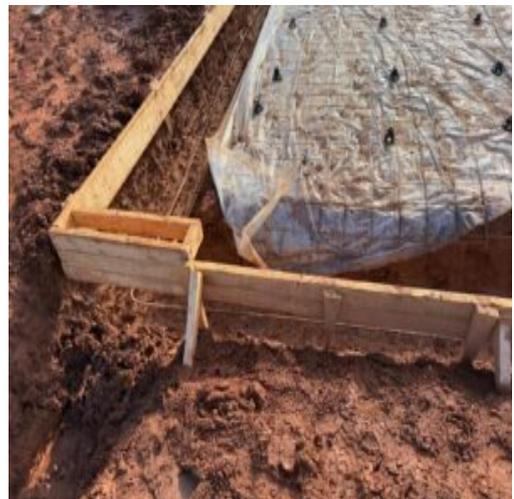
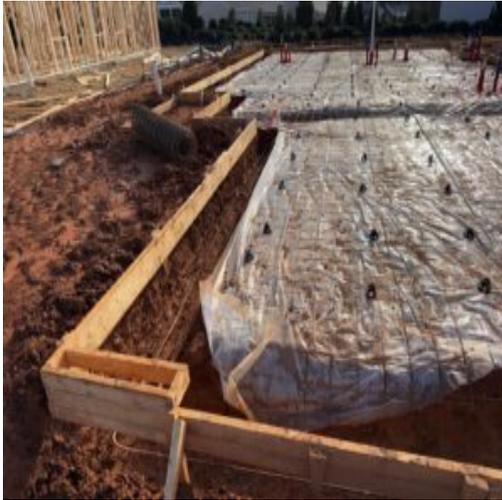
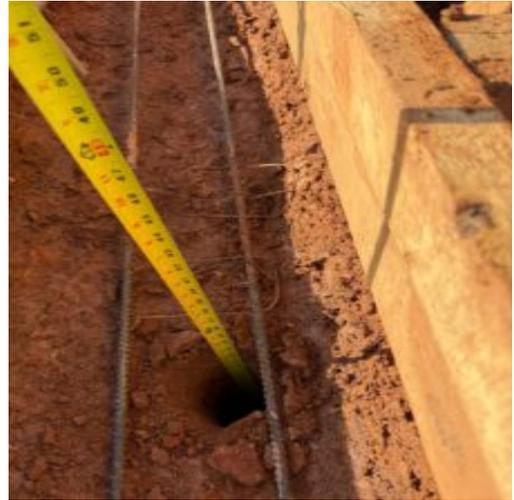
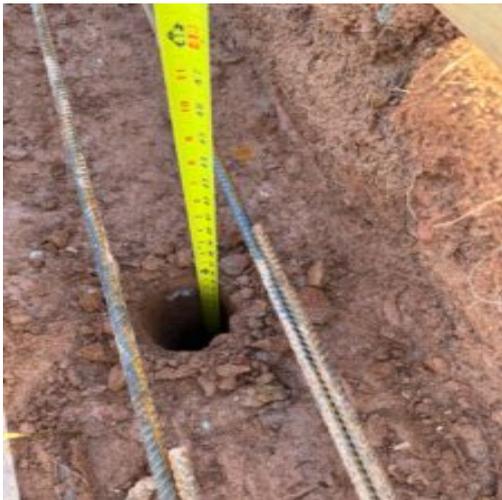
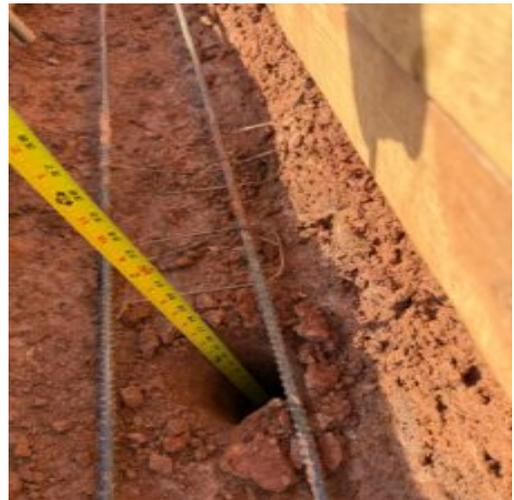
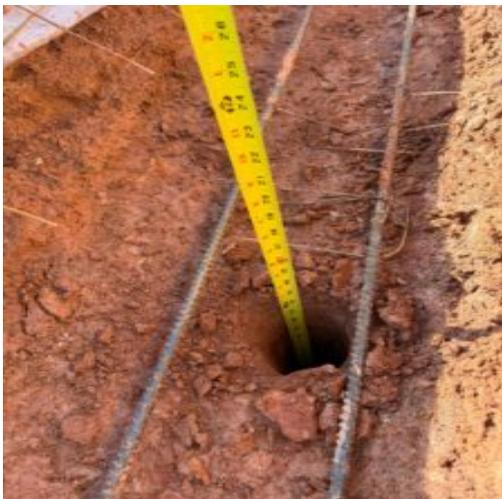
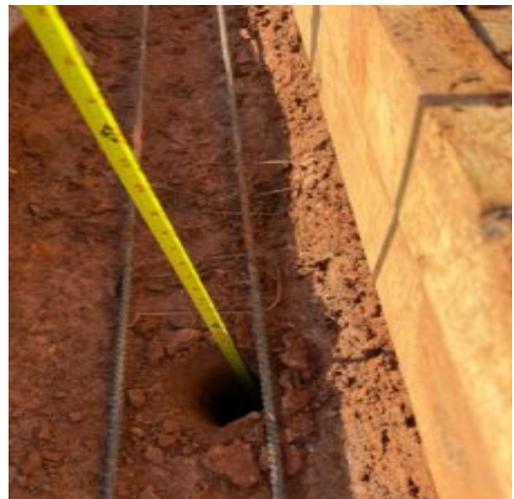
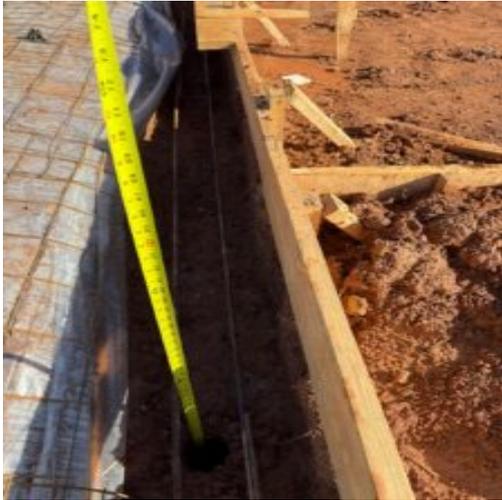
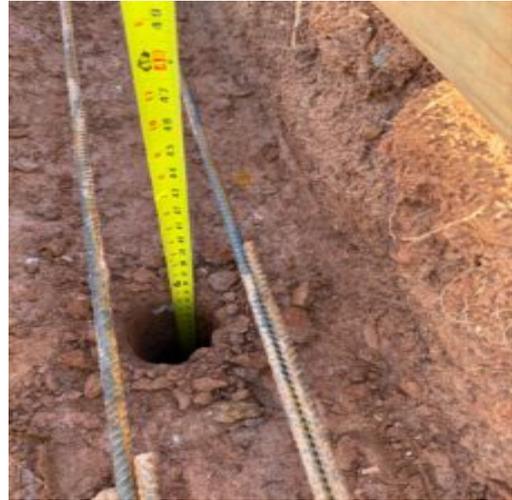
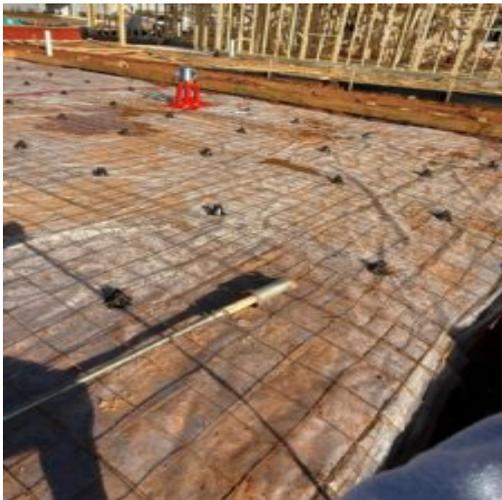
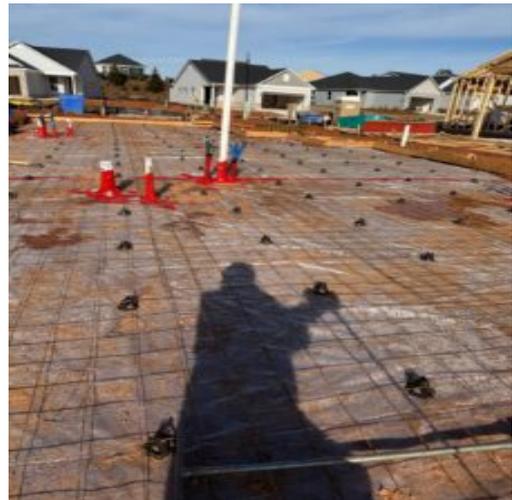
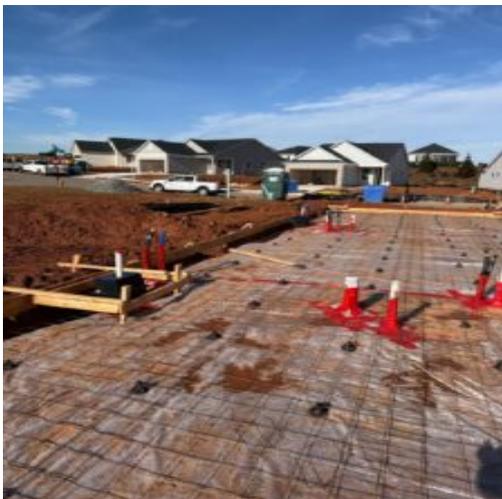
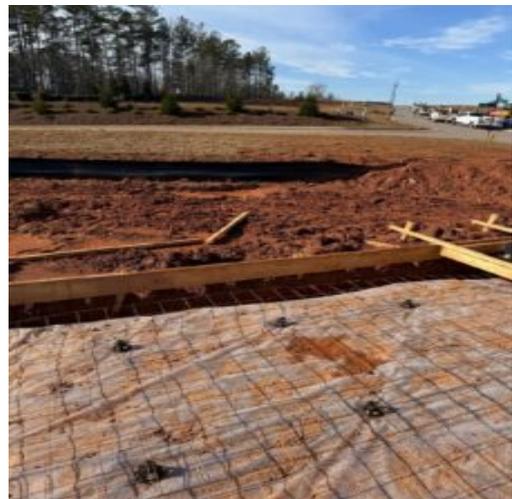
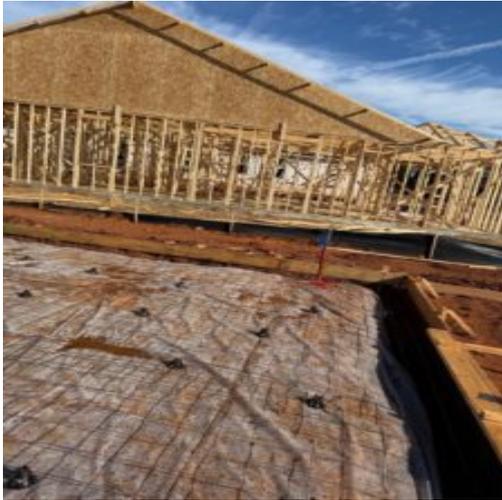
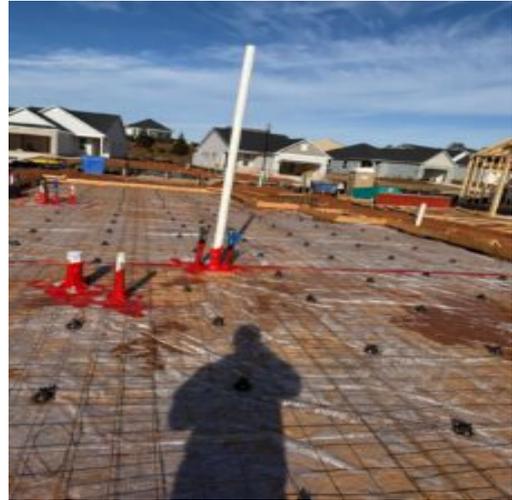
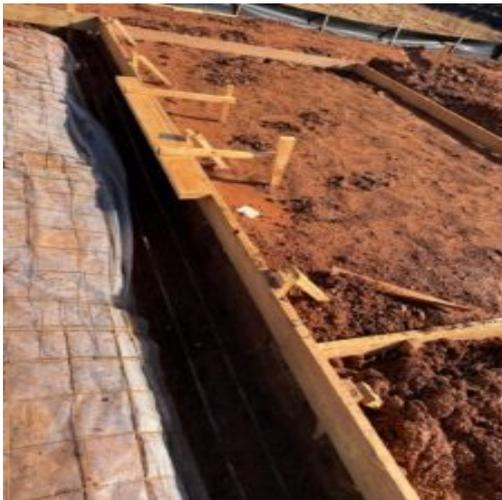
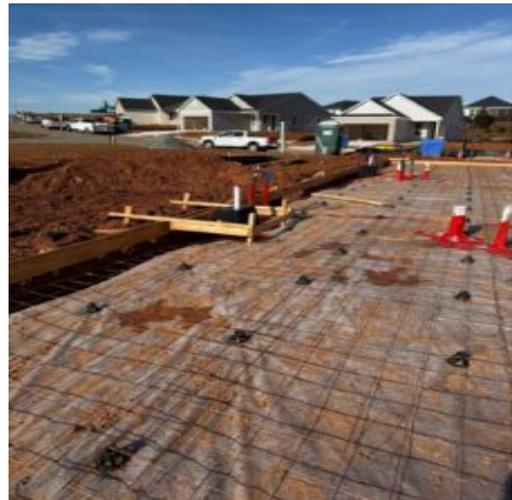
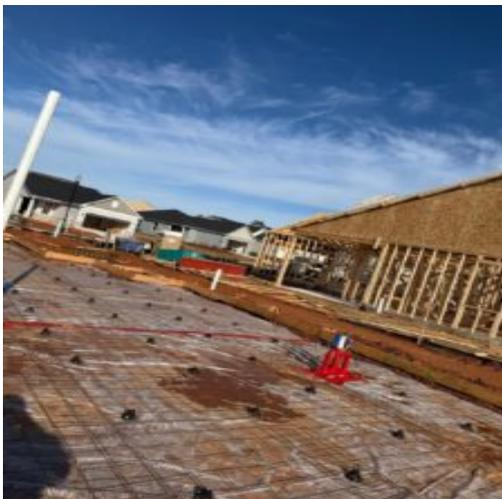
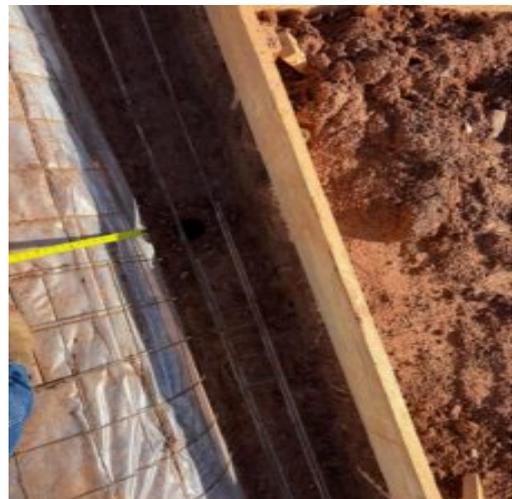
A Dynamic Cone Penetrometer (DCP) test was performed on two sides of Lot #154, revealing the presence of small stones and rocks.

General probing shows that the subgrade appears to be stable. Minor recommendations included removing loose soils from the footing. The reinforcement appears to meet job specifications for size, spacing and quantity.
