ASEC Report ID : 73430
Name of the Project : Northfield @ Polo Fields - Phase2
Project Location : Pittman Road, Cumming, GA
Weather : overcast
Departure Time : 11/18/2024
ASEC Technician Name : Russell Hendrix

Location: Northfields Lot #4 (off Pittman Road)
Requested By: Larry Gunter (Site Superintendent)

Inspection Details:

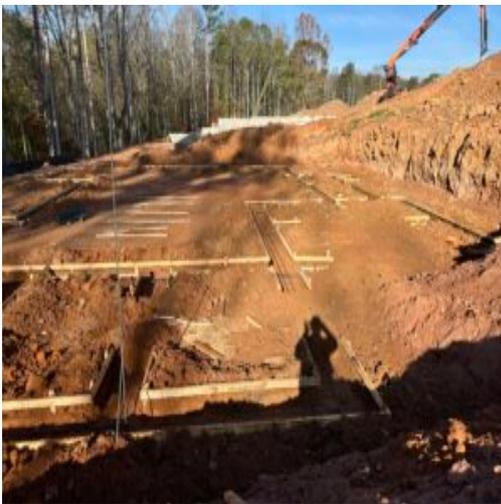
Lot 4 side of lot

During the inspection, the footing was observed to include two rows of #4 rebar with 2 inches of concrete cover on all sides, in compliance with design requirements. No organic material was present in the footing.

Mr. Gunter was notified, and the footing was deemed acceptable for concrete placement. Concrete was placed the same day.
