Date : 02/24/2025  
Project No : 2022C205  
Client Company : Pulte  
Arrival Time : 02/24/2025 12:00  
Onsite Hours : 02:00

ASEC Report ID : 77918  
Name of the Project : Enclave at Parkway Village  
Project Location : Union City  
Weather : sunny  
Departure Time : 02/24/2025 14:00  
ASEC Technician Name : Vamsi Polisetty

#### Footings Inspection (Lot #68)

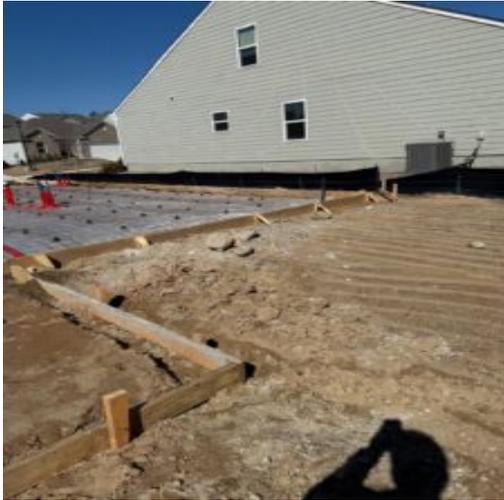
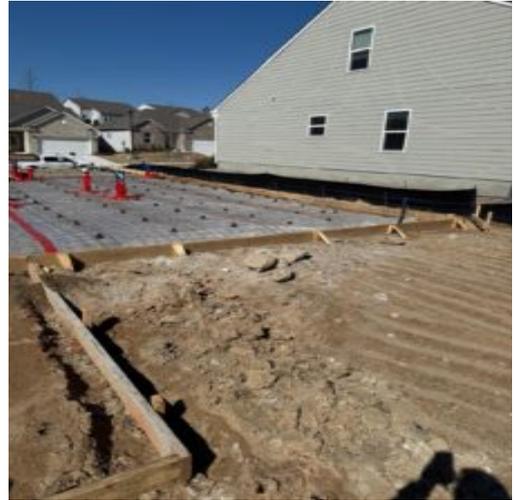
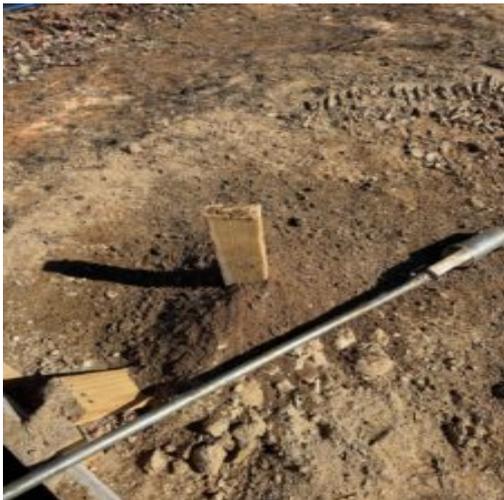
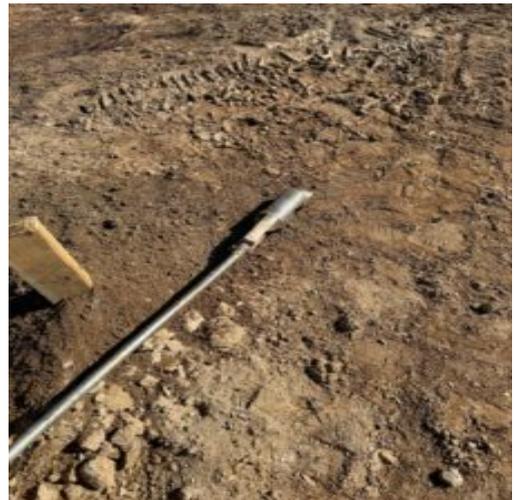
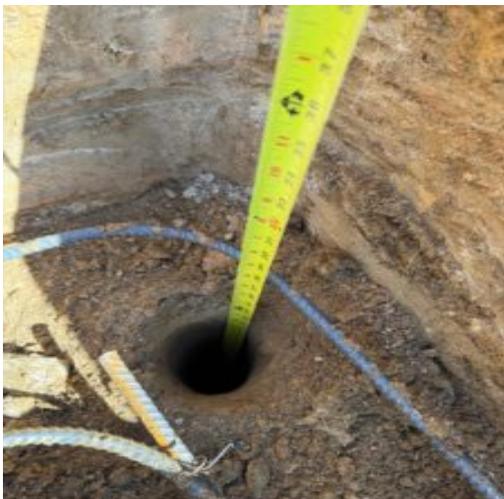
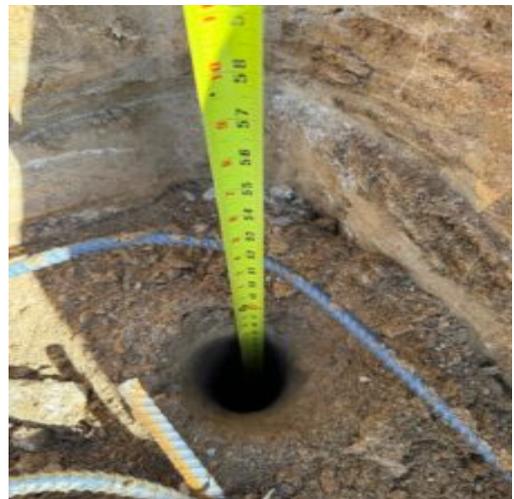
A Dynamic Cone Penetrometer (DCP) test was performed on two sides of Lot #68, revealing the presence of small stones and rocks.

- At 1 foot: 09 blows (Soft Brown sandy soil with small stones is Observed)
- At 2 feet: 08 blows (Mix of Soft Brown and white sandy soil with small stones is Observed)
- At 3 feet: 07 blows (Mix of Soft Brown and white sandy soil with small stones is Observed)
- At 4 feet: 08 blows (Mix of Soft Brown and white sandy soil with small stones is Observed)

- At 1 foot: 06 blows (Soft Brown sandy soil with small stones is Observed)
- At 2 feet: 08 blows (Mix of Soft Brown and white sandy soil with small stones is Observed)
- At 3 feet: 09 blows (Mix of Soft Brown and white sandy soil with small stones is Observed)
- At 4 feet: 07 blows (Mix of Soft Brown and white sandy soil with small stones is Observed)

General probing shows that the subgrade appears to be stable. Minor recommendations included removing loose soils from the footing. The reinforcement appears to meet job specifications for size, spacing and quantity. Rock boulders were observed in the job site.
