Date : 09/05/2025
Project No : 2024C195
Client Company : CWM
Arrival Time : 09/04/2025 22:30
Onsite Hours : 9:00

ASEC Report ID : 85934
Name of the Project : Ramp 21 Replacement
Project Location : HJALA
Weather : Clear
Departure Time : 09/05/2025 07:30
ASEC Technician Name : Austin Coleman

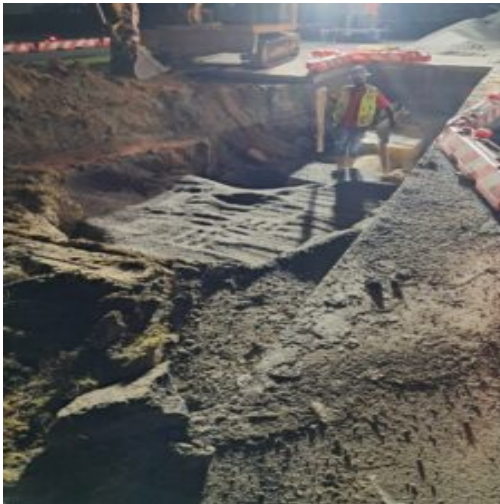
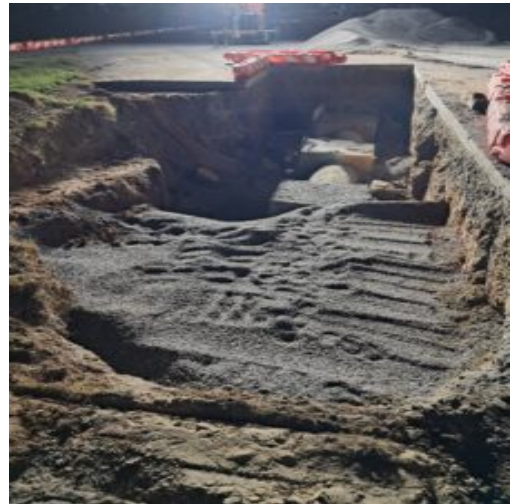
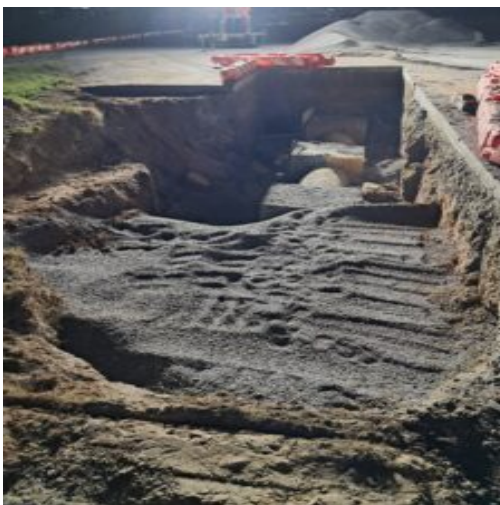
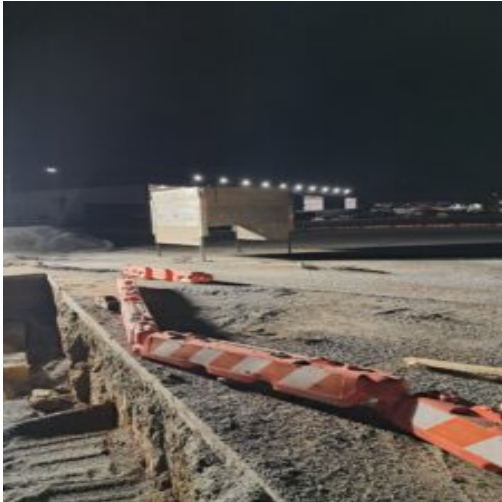
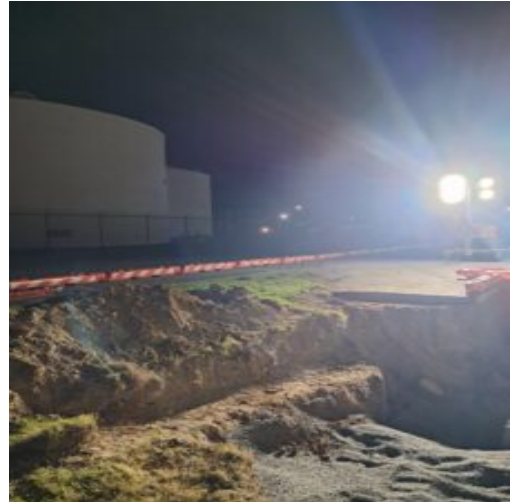
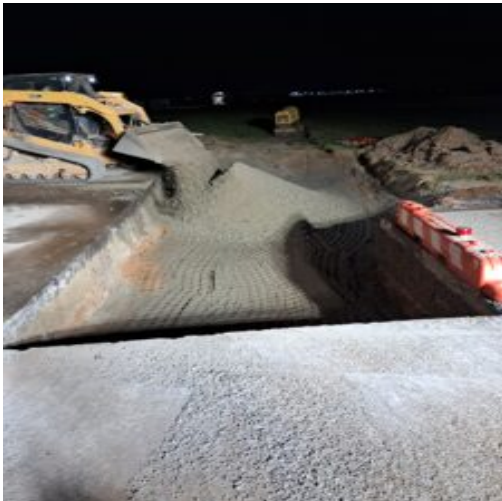
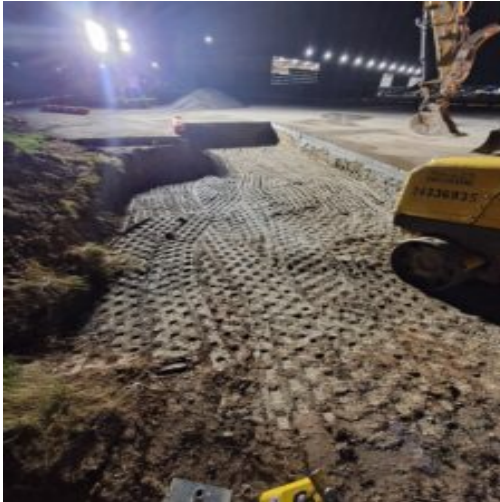
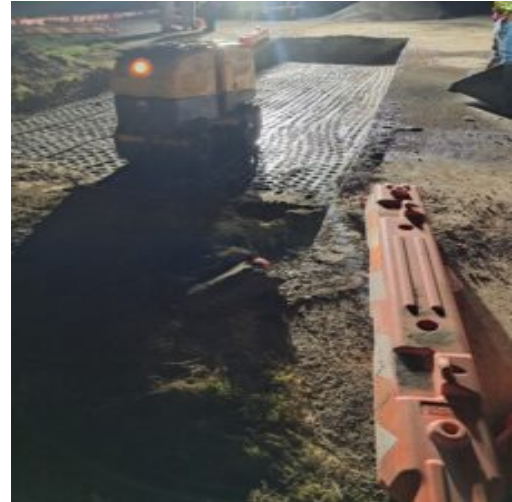
Our ASEC representative arrived on site and found that the placement of Graded-Aggregate-Base (GAB) was underway. The third layer placed was compaction tested using a nuclear density gauge with the QA technician present. Test results met job specifications for compaction.
