Date : 02/03/2025
Project No : 2024C202
Client Company : CCG
Arrival Time : 02/03/2025 07:30
Onsite Hours : 9:00

ASEC Report ID : 76905
Name of the Project : Old Griffin Rd - Hawthorne Reserve
Project Location : Dallas
Weather : Sunny
Departure Time : 02/03/2025 16:30
ASEC Technician Name : Solomon Cherie

Our AS Engineering & Consulting (ASEC) representative arrived on site to observe field activities. The following tasks were performed:

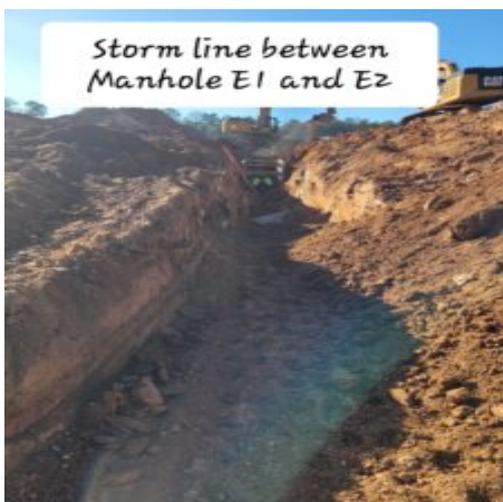
Storm line between Manhole E1 & E2 was excavated and installed. Sewer line between E2 & E3 was installed. Both lines will be backfilled tomorrow.

Picture showing dip storm line, not backfilled

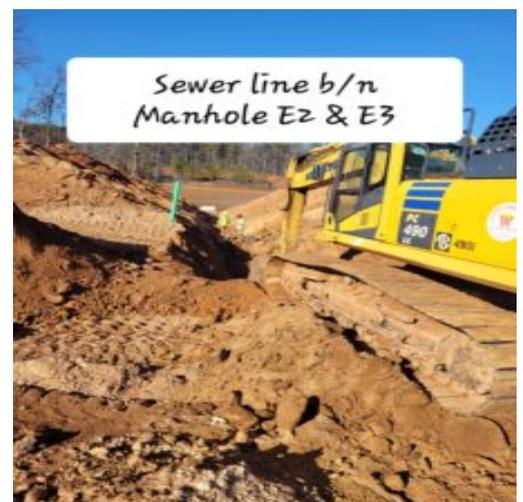
Photo depicting unfilled Sewer line

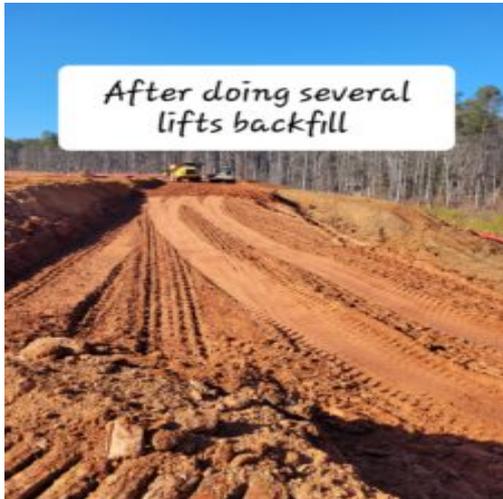
Fill was spread by a 61Pxi Komatsu Bulldozer for a thin strip behind Lots #28 and #29, specifically on the temporary pond at the back of Lot #30.

Thin strip on the backside of lots, specially at the temporary pond

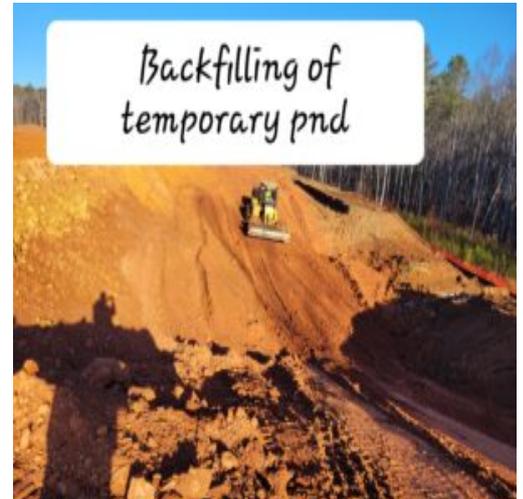
Compaction was performed using a 815F CAT Roller. Density tests results indicate that several areas fell just short of 95% compaction of a standard proctor, however, these areas were proof-rolled and found to be stable (no severe pumping/rutting was observed).

After backfilling of several lifts
