Date : 06/18/2025
Project No : 2024C202
Client Company : CCG
Arrival Time : 06/18/2025 07:30
Onsite Hours : 02:00

ASEC Report ID : 82325
Name of the Project : Old Griffin Rd - Hawthorne Reserve
Project Location : Dallas
Weather : cloudy
Departure Time : 06/18/2025 09:30
ASEC Technician Name : Clyde Smith

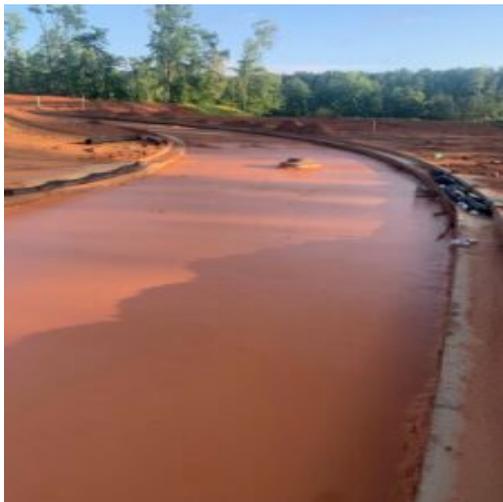
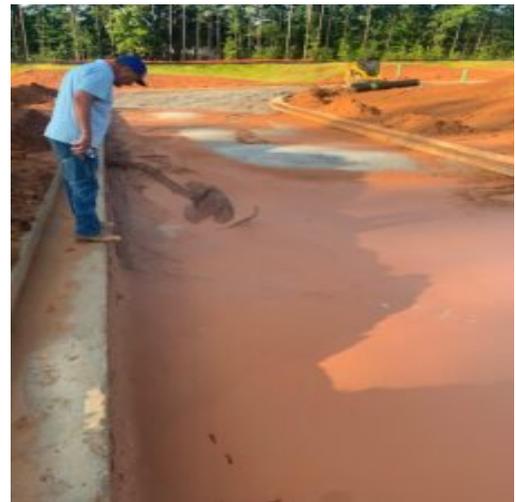
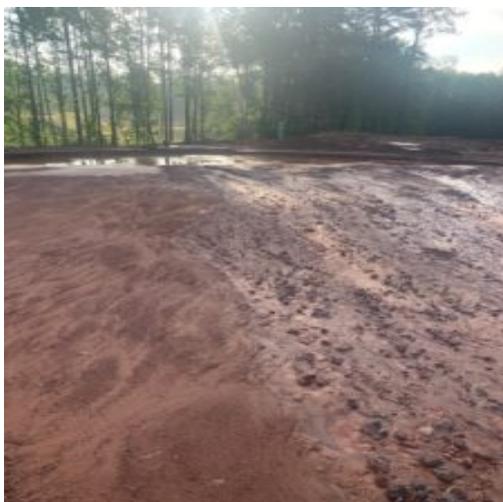
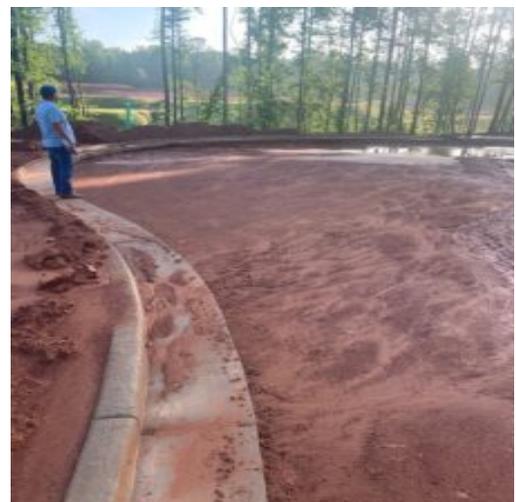
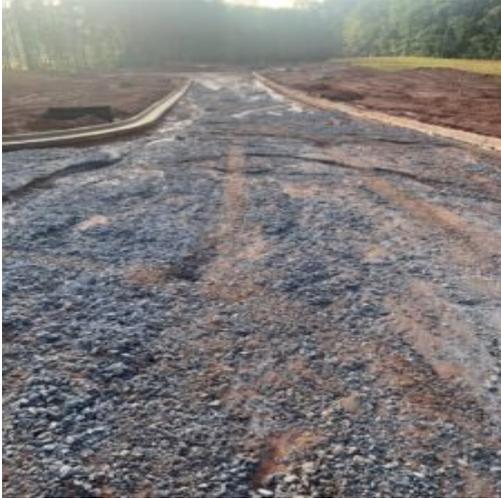
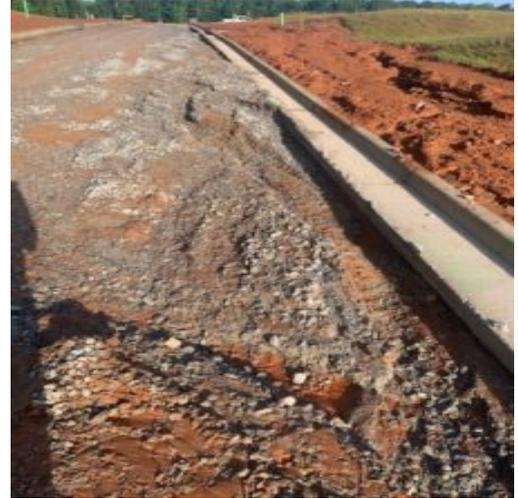
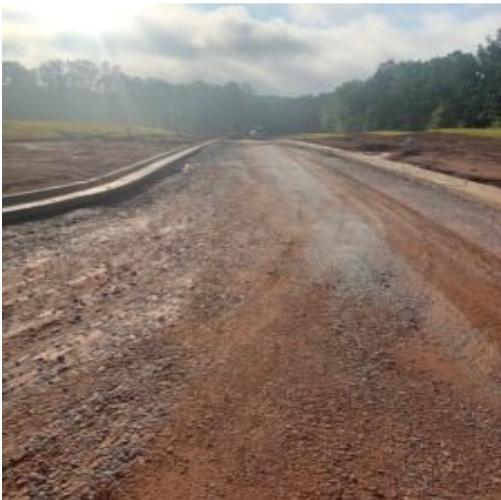
Our ASEC representative visited the above site as requested to continue observations of roadway subgrade soils and recommended repairs. It appears that an overnight rain event delivered between 1" to 1.5" of water which caused severe eroding over previous placed base stone. In some areas washed silt was observed over the previously repaired areas (base stone and tensor fabric in place) which will require remediation to remove the washed silt from the base stone to continue. See pictures below.
