ASEC Report ID : 78375  
Name of the Project : Covington Town Center PH II  
Project Location : Covington  
Weather : sunny  
Departure Time : 03/03/2025  
ASEC Technician Name : Russell Hendrix

### **Proof-roll Assessment**

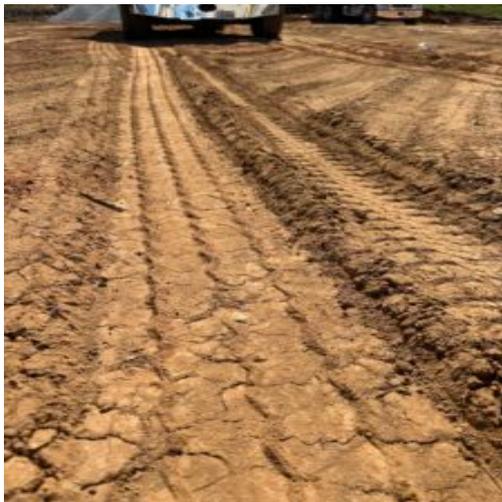
During the assessment, the majority of the site was found to be not suitable for continued grading activities (fill placement) as significant movement and deflection were observed under the trucks load. The subgrade conditions failed to meet the required stability criteria.

Impressions

- **Scarification** of the site to a depth sufficient to **reduce excessive moisture** and improve soil stability. We estimate that up to two feet of upper wet soils will require discing and scarification followed by aeration to bring these soils within operable moisture contents.

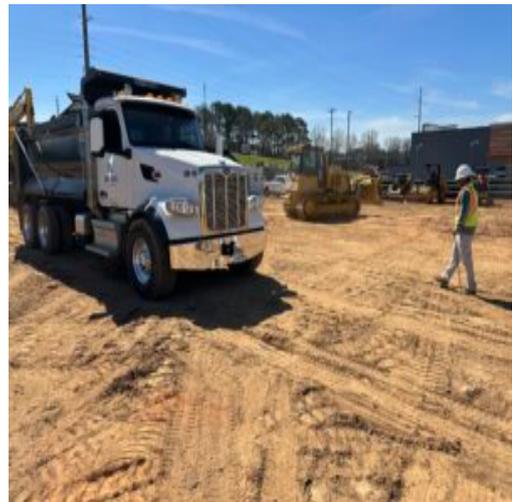
proof rolling/issues

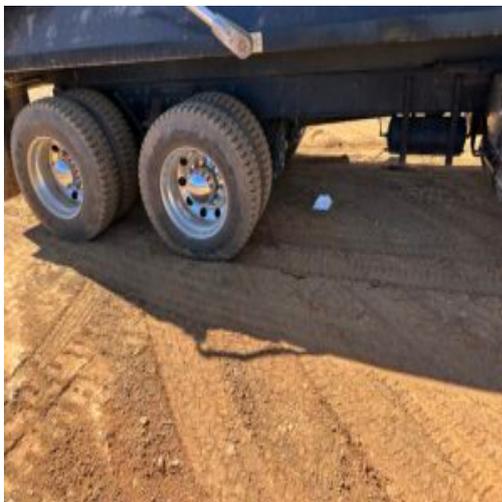
- Excessive moisture content in the soil, located **1 to 2 feet** below the current elevation.
- Poor subgrade stability due to the high moisture levels, contributing to surface deflections.

soil problems

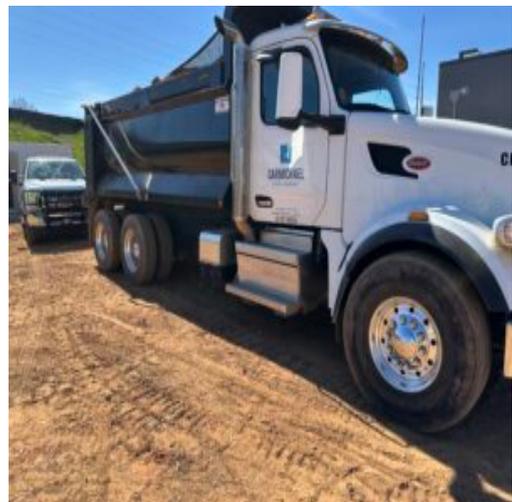
proof rolling
