Date : 03/21/2025  
Project No : 2024C213  
Client Company : WDG  
Arrival Time : 03/21/2025 12:00  
Onsite Hours : 01:30

ASEC Report ID : 78997  
Name of the Project : Covington Town Center PH II  
Project Location : Covington, GA  
Weather :  
Departure Time : 03/21/2025 13:30  
ASEC Technician Name : Clyde Smith

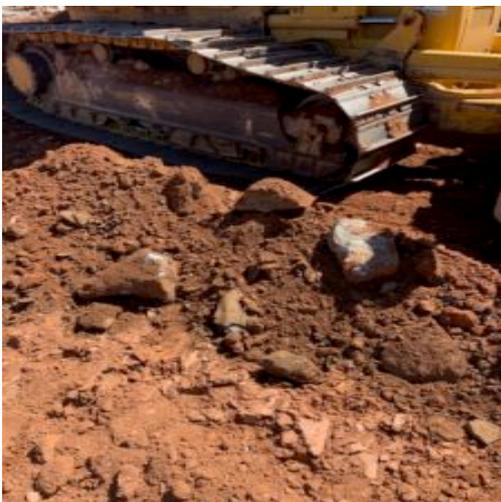
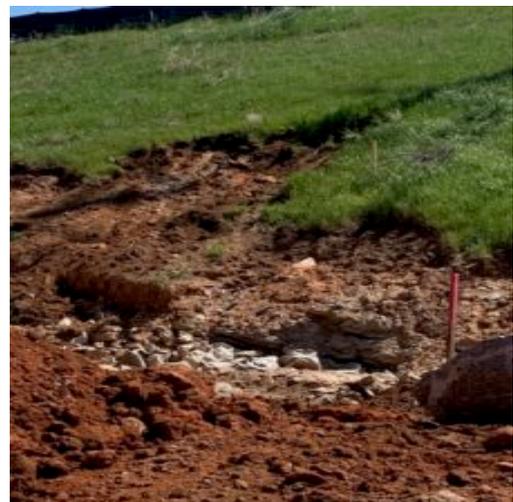
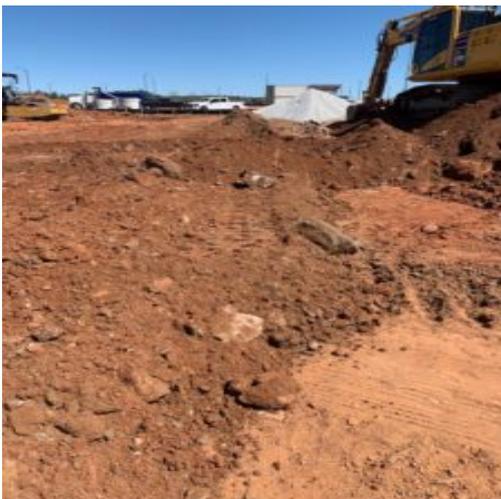
On the above date our AS Engineering & Consulting representative was on site as requested and observed the grading contractor (Hodges) continue placing fill for the building pad. The contractor was running short on suitable fill for placement of the top two feet. The contractor excavated borrow materials from the toe of the east side slope embankment and began placement upon arrival to the site. This material was observed having oversized rocks (6" to over 16" in diameter) during placement with some trash debris and high moisture which would not be suitable for structural fill for building pad's top two feet. This material was recommended to be pushed out and not used in the building pad. The contractor is seeking an additional fill source to complete placement to finished subgrade.
