Date : 09/23/2024  
Project No : 2024C217  
Client Company : Artisan  
Arrival Time : 09/23/2024 07:30  
Onsite Hours : 07:30

ASEC Report ID : 70930  
Name of the Project : Naturewalk - 7 Hills Amenities  
Project Location : Dallas  
Weather : sunny  
Departure Time : 09/23/2024 15:00  
ASEC Technician Name : Vamsi Polisetty

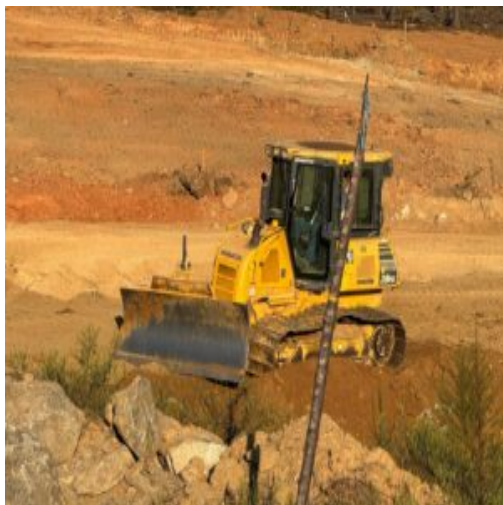
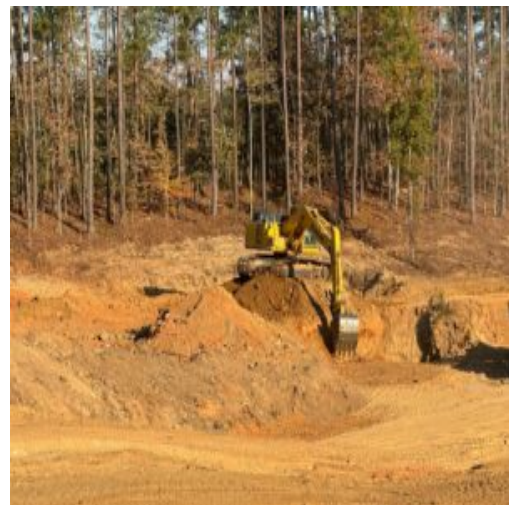
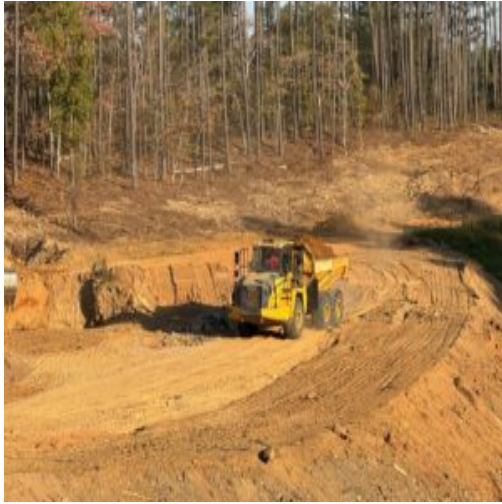
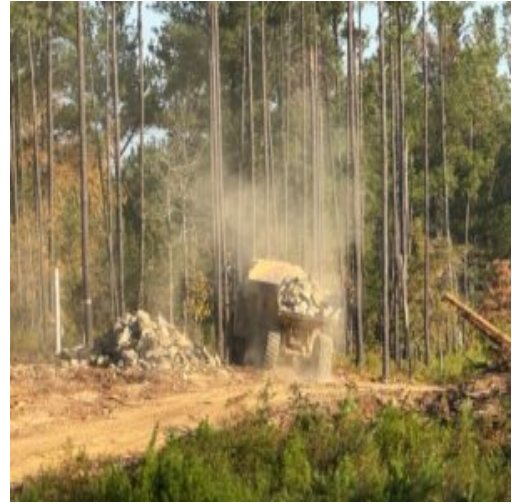
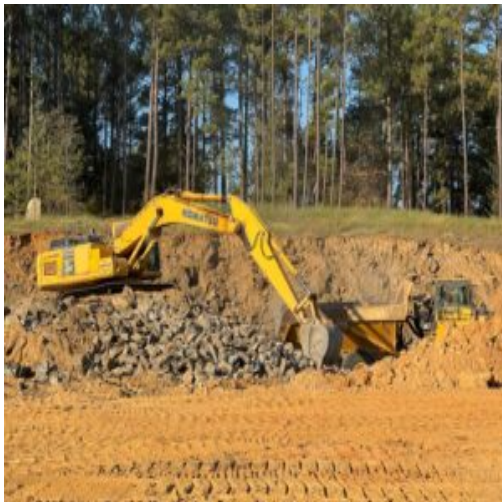
- Upon arrival, the contractor was engaged in excavating using a Komatsu PC 360LC in the west of the project site. They were also cutting and clearing trees with a Komatsu PC210LC. Fill was being transported with two tandem-axled dump trucks, while dozing was performed using a Komatsu 39PX and a D85EX. Compaction work was carried out using a CAT 563 E.
- Boulder fill was used in backfilling under the tennis court. Proof-rolling was used to verify stability in lieu of density testing.
