Date : 04/24/2025  
Project No : 2024C217  
Client Company : Artisan  
Arrival Time : 04/24/2025 08:00  
Onsite Hours : 03:00

ASEC Report ID : 80495  
Name of the Project : Naturewalk - 7 Hills Amenities  
Project Location : Dallas  
Weather : cloudy  
Departure Time : 04/24/2025 11:00  
ASEC Technician Name : Clyde Smith

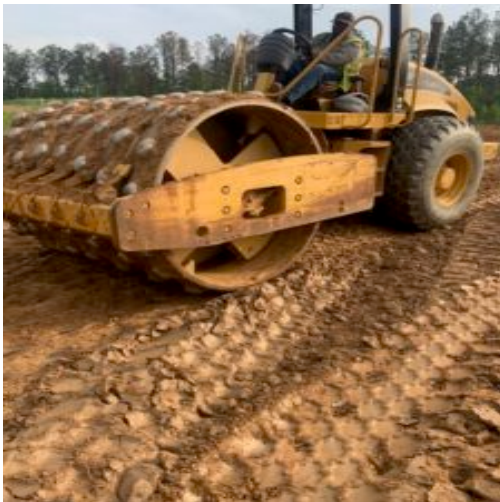
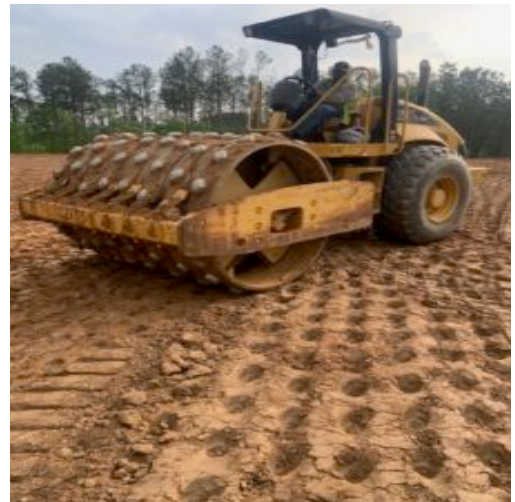
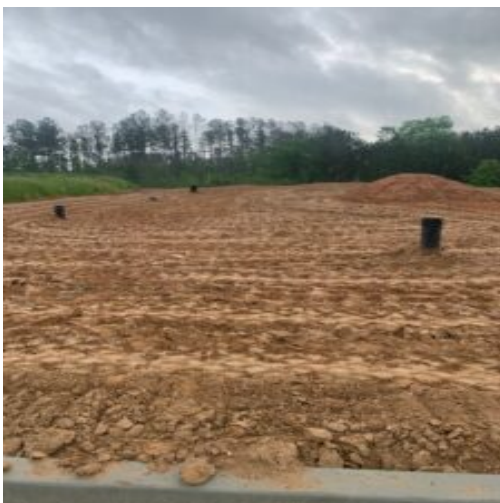
Our ASEC representative was on site as requested and observed in-place fill conditions for the Pickle ball court. The soils in place continue to be saturated with additional rain expected in the near future. Chemical additives maybe required to dry in place soils and complete additional fill placement of one foot to two feet for timely completion.
