Date : 10/06/2025  
Project No : 2024C217  
Client Company : Artisan  
Arrival Time : 10/06/2025 08:00  
Onsite Hours : 02:30

ASEC Report ID : 86534  
Name of the Project : Naturewalk - 7 Hills Amenities  
Project Location : Dallas  
Weather : cloudy  
Departure Time : 10/06/2025 10:30  
ASEC Technician Name : Clyde Smith

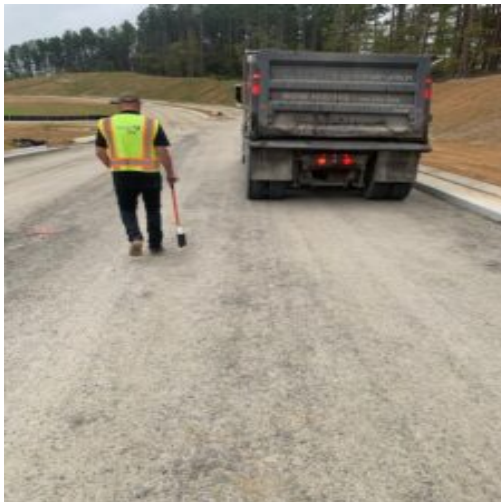
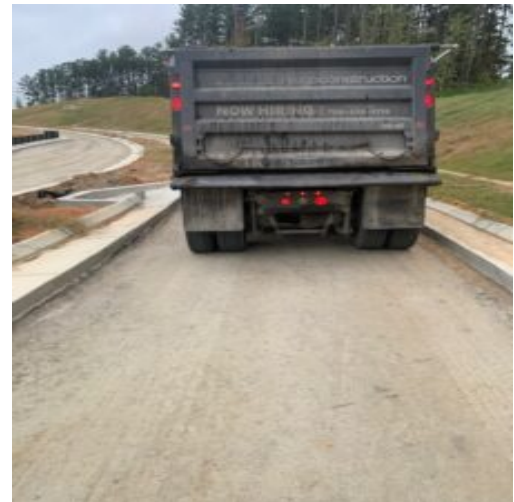
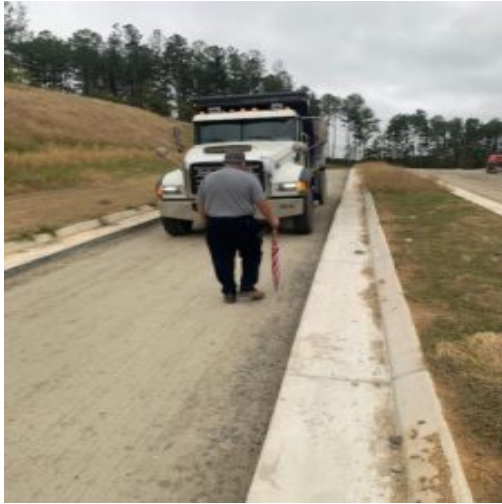
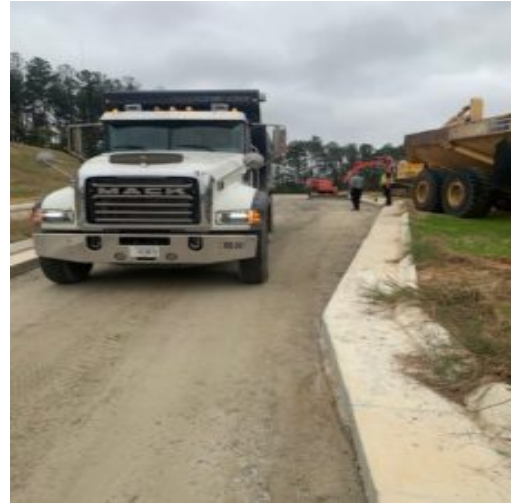
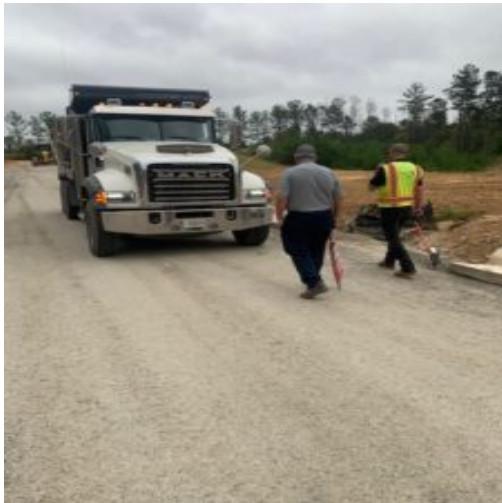
On the above date our representative visited the above site to observe proof-rolling of the subbase stone at the drive entrance and exit lanes. The proof-roll was observed by using a loaded tandem dump truck making two passes over all areas. The writer along with a member from NWGP and Paulding County observed the proof-roll. No severe pumping/rutting was observed under truck traffic.
