Date : 02/05/2025
Project No : 2024C297
Client Company : Artisan
Arrival Time : 02/05/2025 08:00
Onsite Hours : 04:00

ASEC Report ID : 77079
Name of the Project : Nature Walk - Footing Inspections
Project Location : Dallas
Weather : cloudy
Departure Time : 02/05/2025 12:00
ASEC Technician Name : Vamsi Polisetty

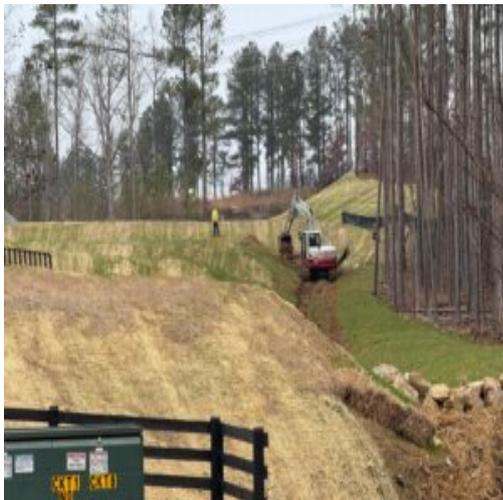
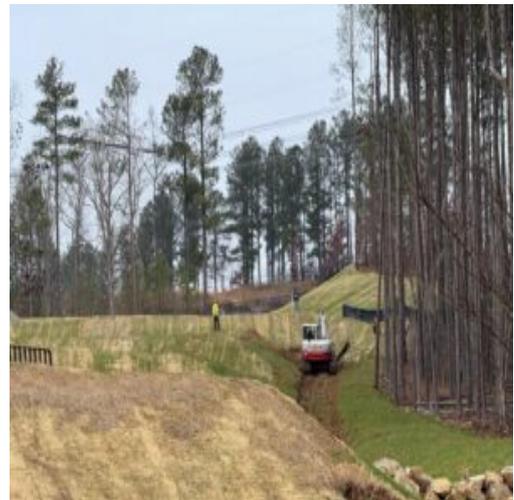
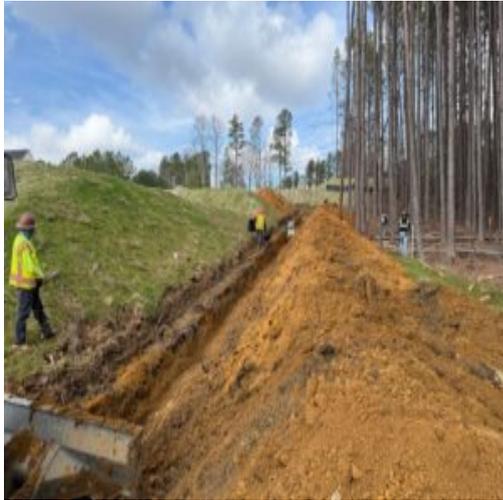
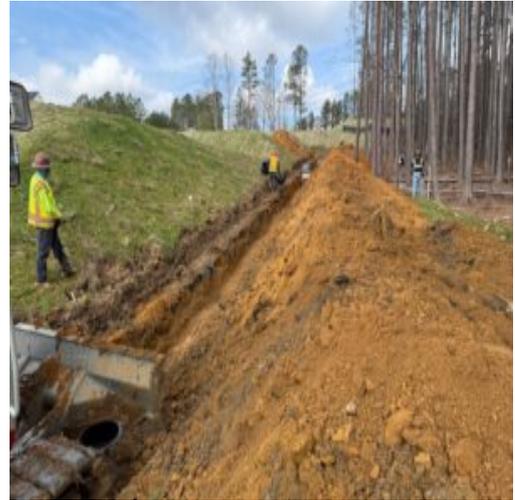
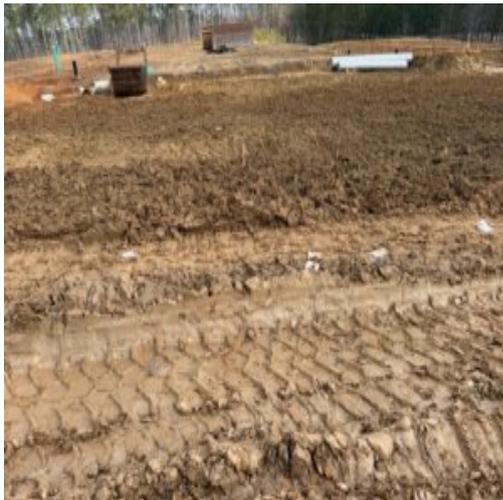
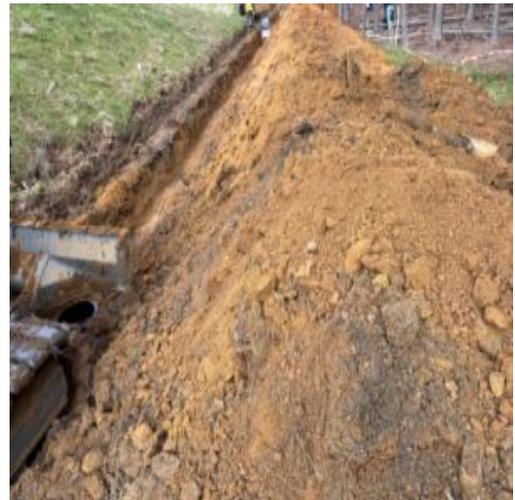
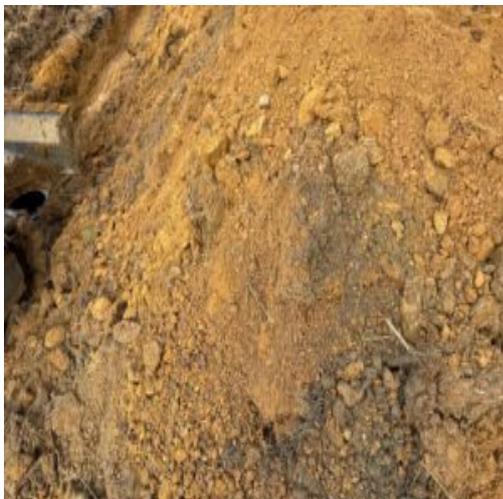
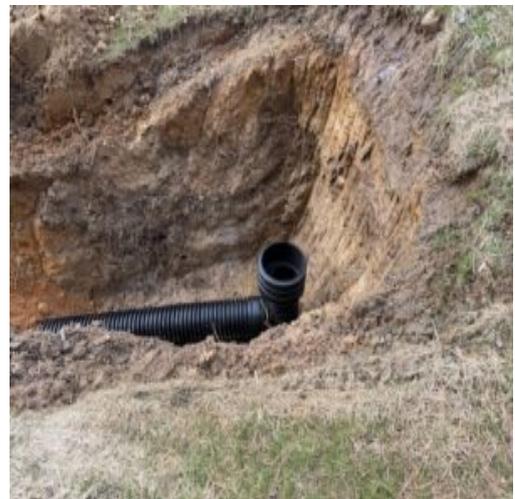
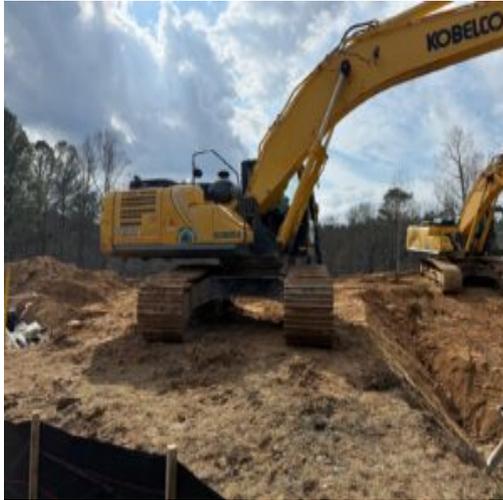
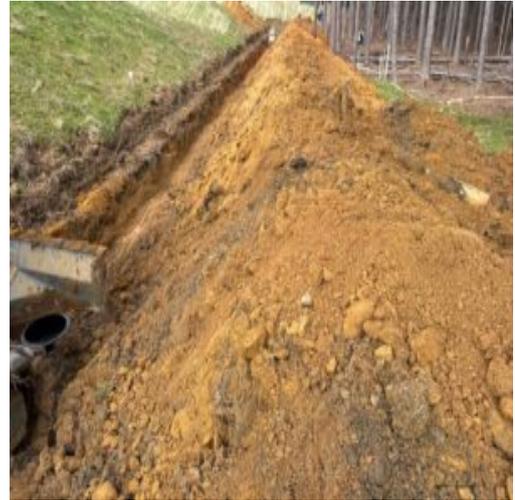
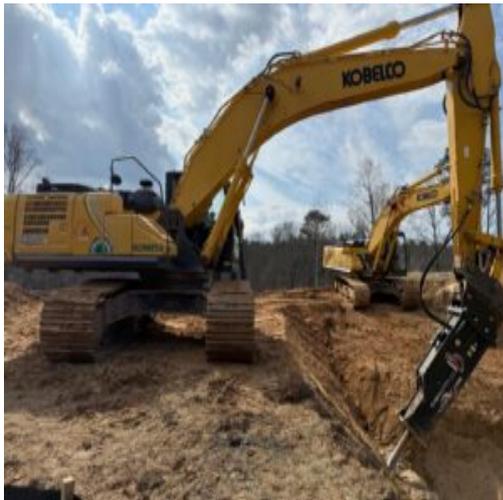
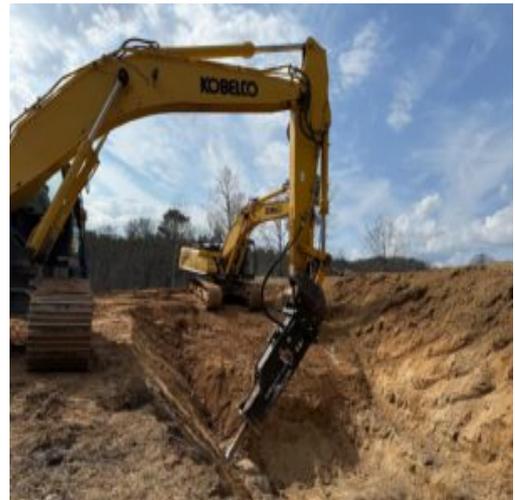
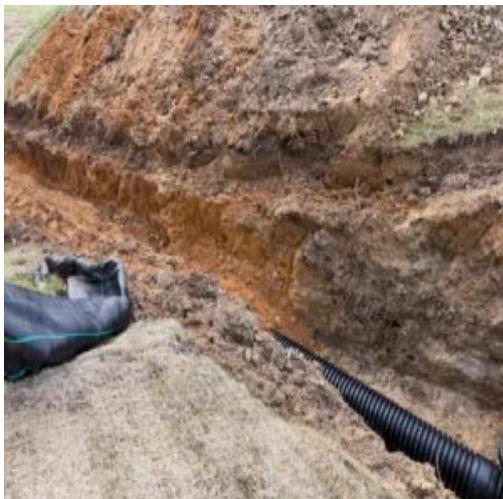
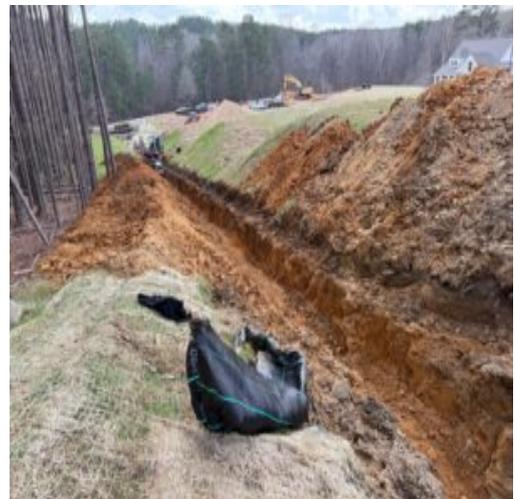
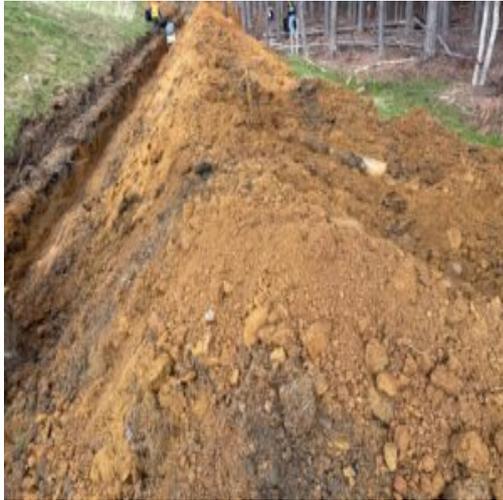
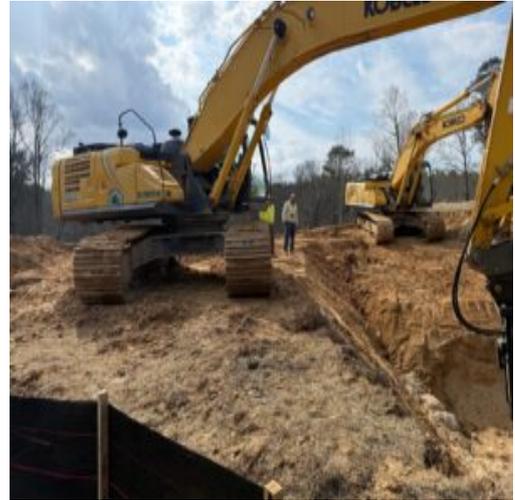
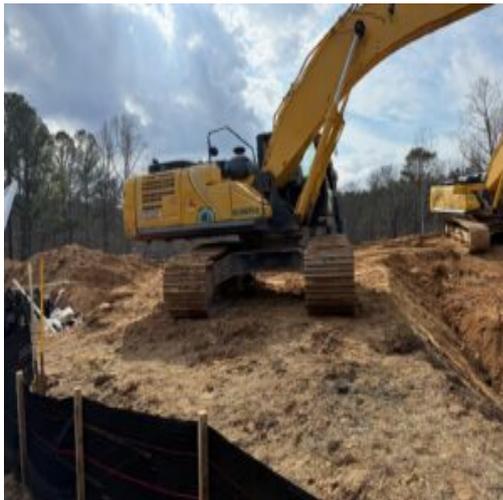
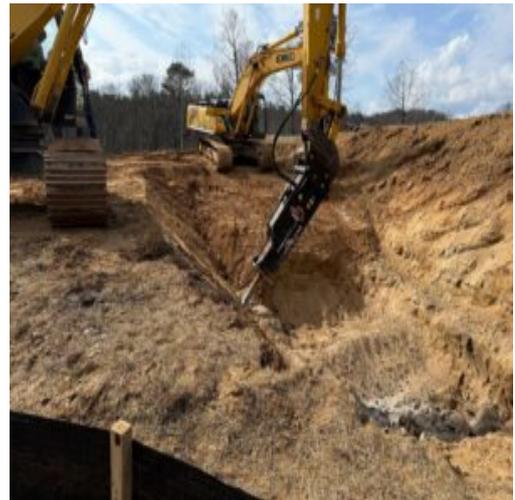
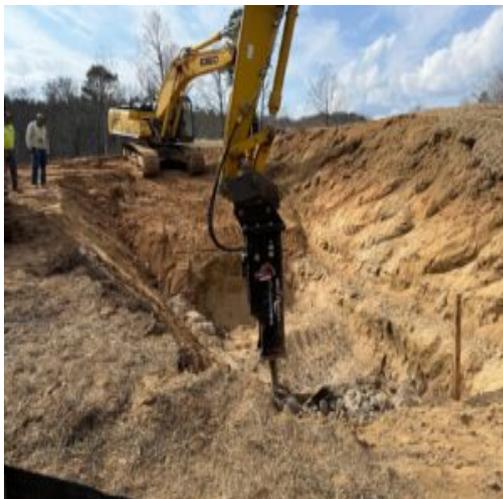
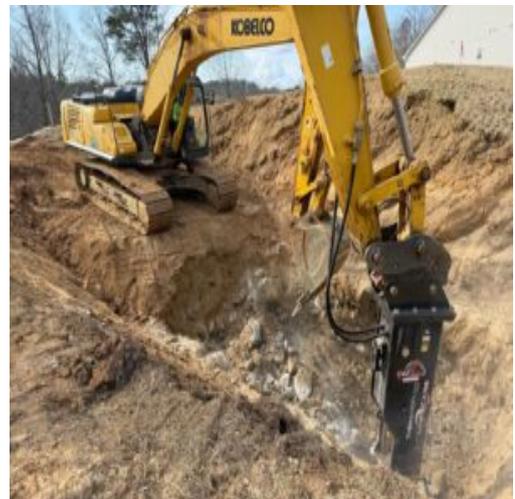
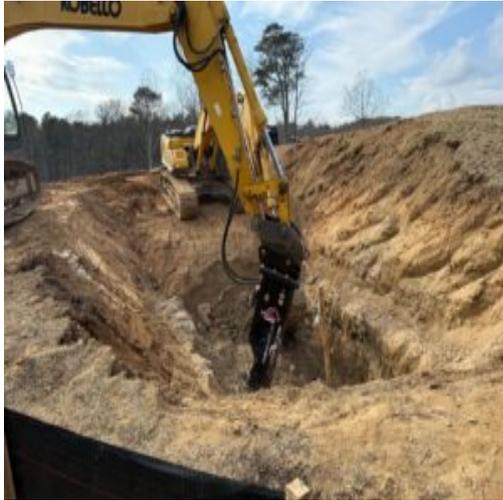
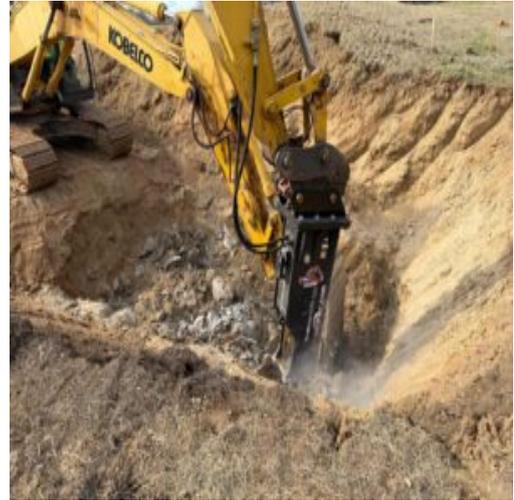
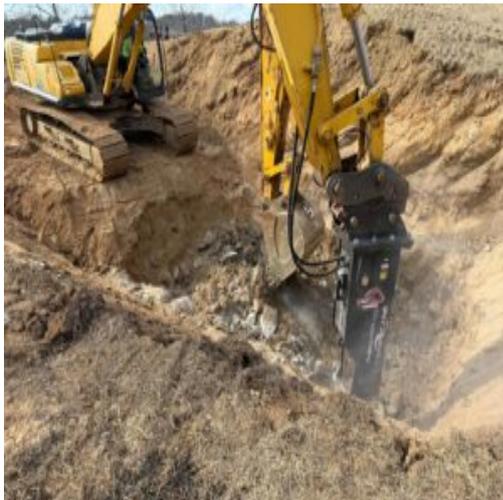
- Savanna Excavation: Next to Lot #995, the contractor resumed work from the previous day and began addressing the rock encountered in the trench. Despite utilizing the Kobelco SK 350LC excavator, the contractor had difficulty breaking up the rock. As a result, the contractor started breaking the rock with a Kobelco Sk 350LC Breaker, to manage the rock removal. By the end of the day the contractor finished cutting the trench a size approximately 7' x 28' x 12'6". The excavation and site activities were carried out for storm water lines behind the previously numbered lots (#1000 through #1005). Some organic materials were encountered and recommended for removal.
