Date : 01/15/2025  
Project No : 2024C315  
Client Company : J. Chapman Const.  
Arrival Time : 01/15/2025 8:00  
Onsite Hours : 08:30

ASEC Report ID : 75866  
Name of the Project : Cottages at Villa Rica - Rock Blasting  
Project Location : Villa Rica  
Weather : cold  
Departure Time : 01/15/2025 16:30  
ASEC Technician Name : Mahendra Mylabathula

**Drilling Report:**

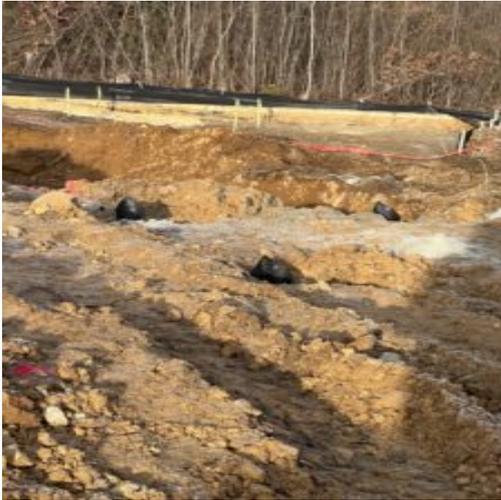
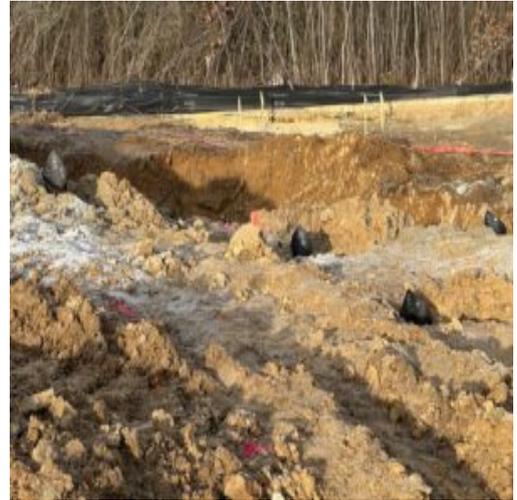
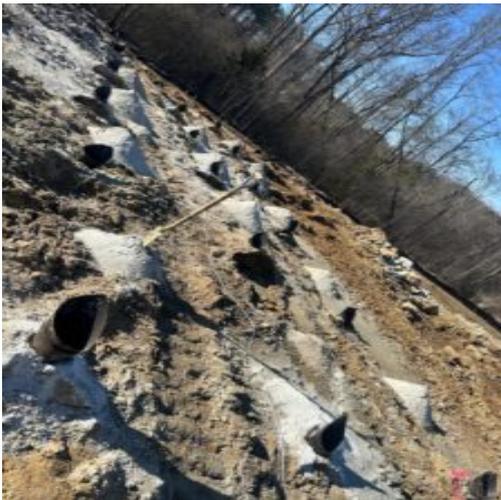
These holes were drilled south of Lot #41 and #42, and west of the manhole A1 (SS MH A1).

Attached to this report you will find a layout drawing showing the approximate area where drilling was performed on this day.
