Date : 01/20/2025
Project No : 2024C315
Client Company : J. Chapman Const.
Arrival Time : 01/20/2025 08:30
Onsite Hours : 9:00

ASEC Report ID : 76169
Name of the Project : Cottages at Villa Rica - Rock Blasting
Project Location : Villa Rica
Weather : cold
Departure Time : 01/20/2025 17:30
ASEC Technician Name : Mahendra Mylabathula

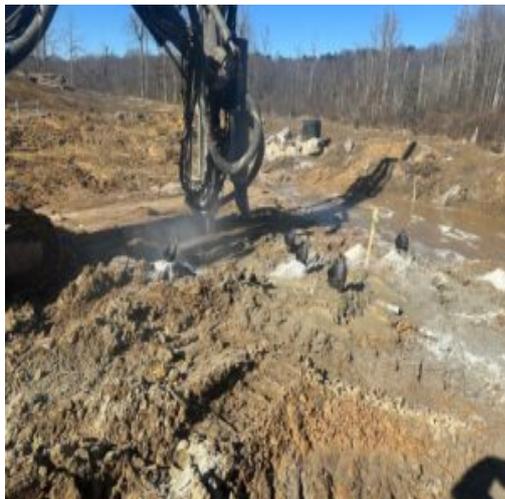
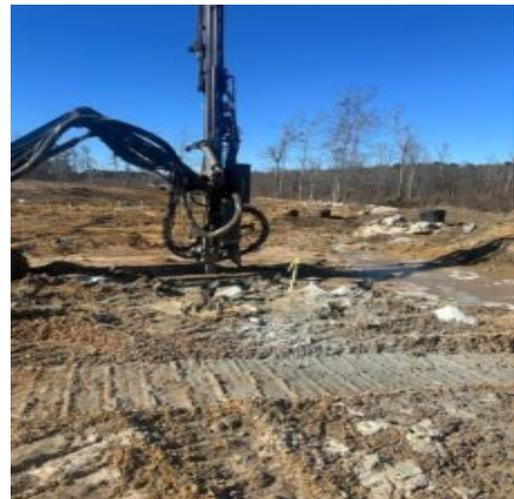
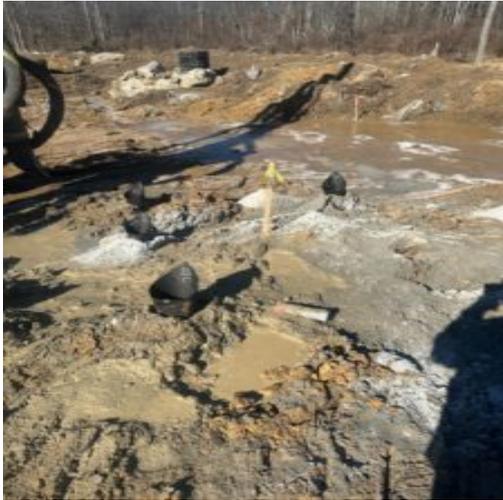
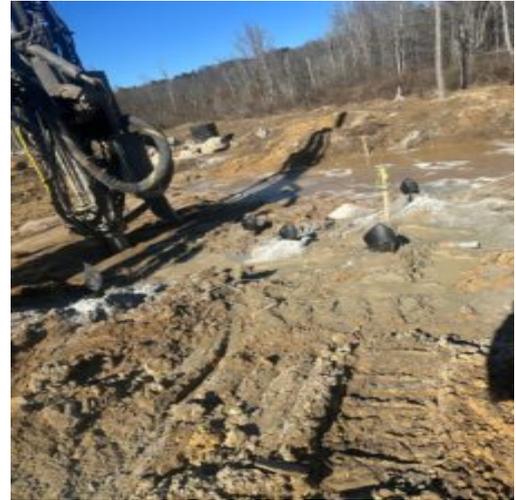
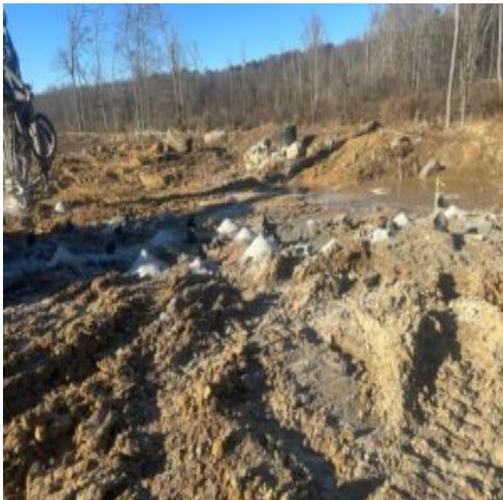
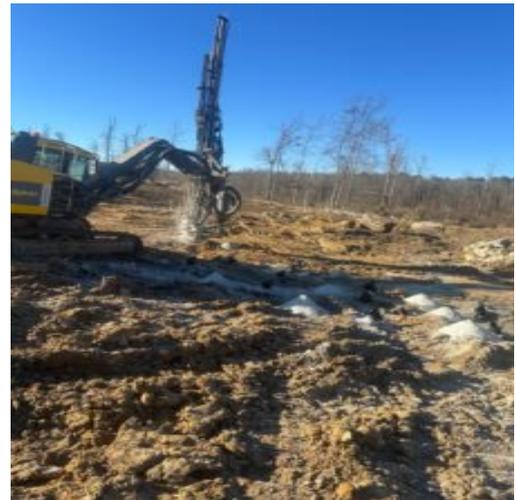
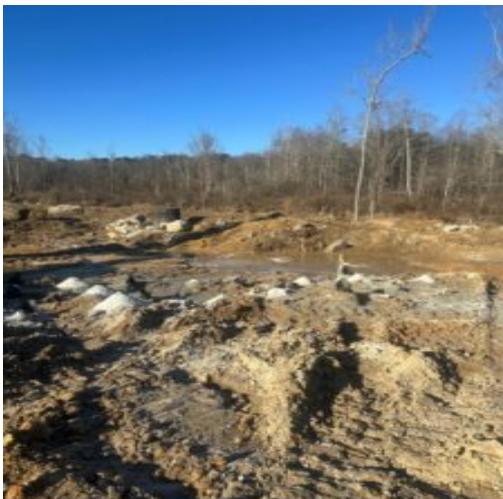
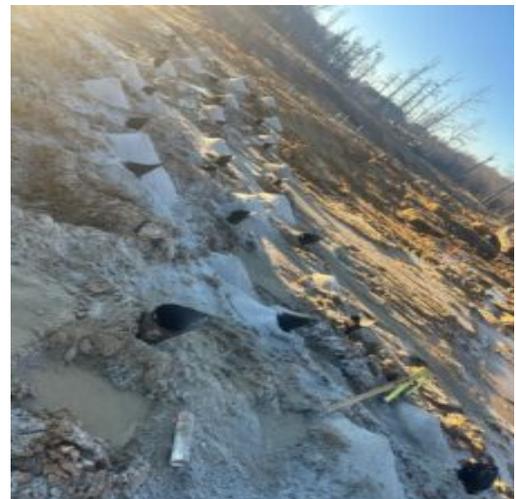
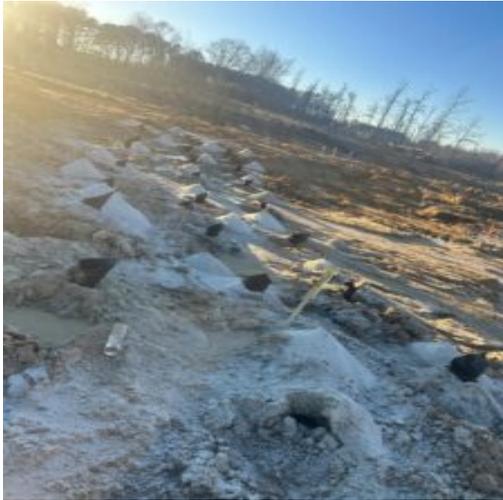
The drilling team inspected the area east of Lots 37 and 36 and west of Lots 120 and 121 to determine the presence of rock. If rock is encountered, its type must be identified to evaluate the land and plan the trenching pattern. Drilling in this area was conducted in three rows, with approximately 8 feet between rows and 7 feet between drilling locations within each row.

The drilling work began at manhole A2 and proceeded westward. A total of 23 holes were drilled to a depth of 17 feet. Groundwater was detected in some of the holes. All holes drilled thus far were checked at the end of the workday and remain in good condition. Since the holes have not been closed, drilling will continue the following day, as they are still viable. These lots are located west of manhole A2, along the proposed road indicated in the project plan.
