Date : 06/12/2025
Project No : 2025C146
Client Company : Davidson Homes, LLC
Arrival Time : 06/12/2025 10:00
Onsite Hours : 04:30

ASEC Report ID : 82260
Name of the Project : Greene Farms Subdivision
Project Location : 1451 Highway 113, Cartersville, Georgia
Weather : Sunny
Departure Time : 06/12/2025 14:30
ASEC Technician Name : Clyde Smith

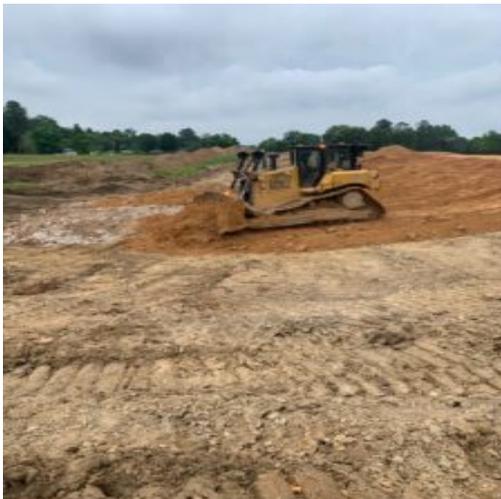
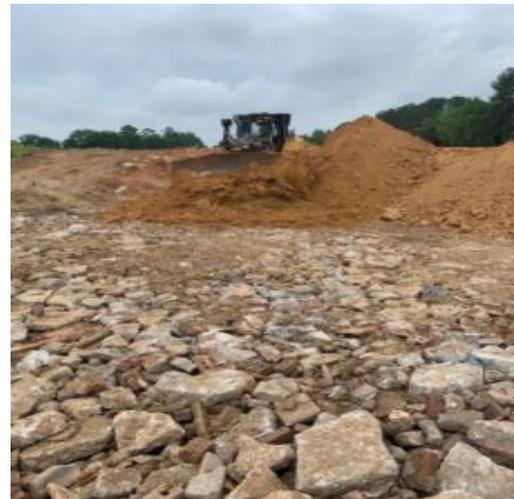
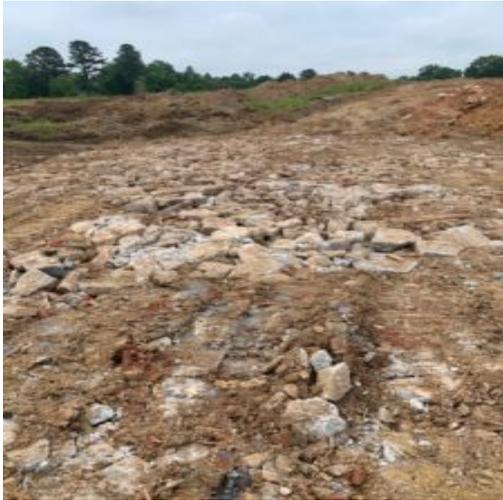
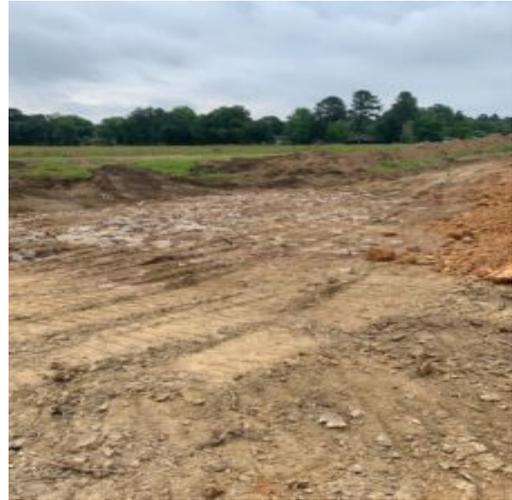
- The grading contractor was observed performing **undercut operations** at the bottom of the **former detention pond** area.
- As part of the stabilization procedure, **six (6) truckloads of broken concrete debris** were placed in the bottom of the excavation.
- This stabilization work was completed in preparation for placing **structural fill** to support **Lots 95 and 96**, in accordance with the project recommendations.
