Date : 03/05/2026  
Project No : 2025C146  
Client Company : Davidson Homes, LLC  
Arrival Time : 03/05/2026 15:30  
Onsite Hours : 02:30

ASEC Report ID : 91087  
Name of the Project : Greene Farms Subdivision  
Project Location : 1451 Highway 113, Cartersville, Georgia  
Weather : sunny  
Departure Time : 03/05/2026 18:00  
ASEC Technician Name : Clyde Smith

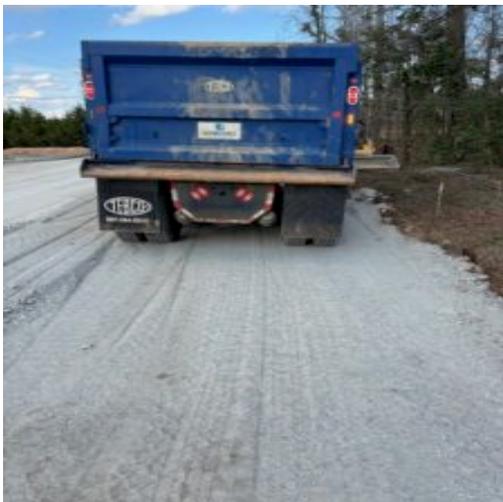
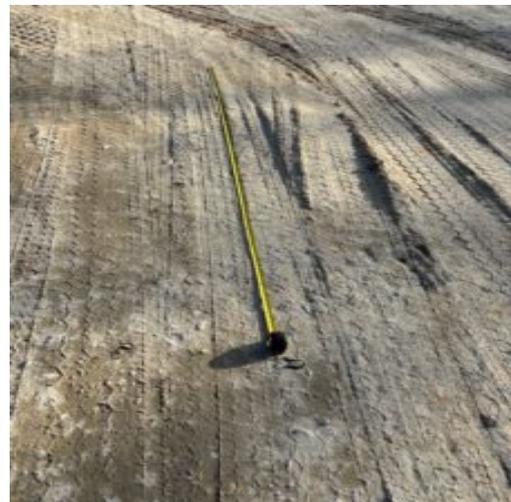
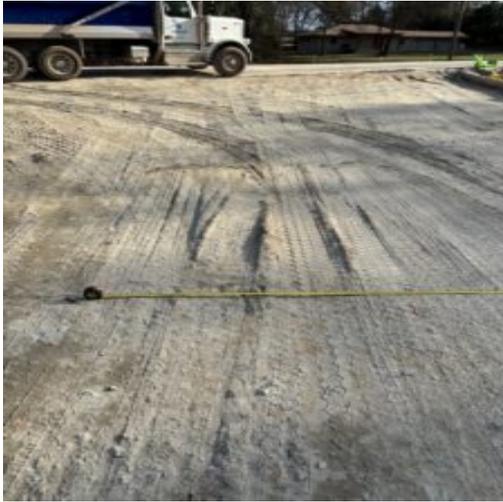
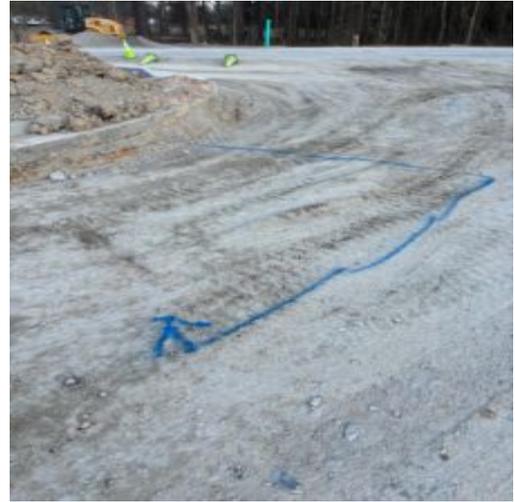
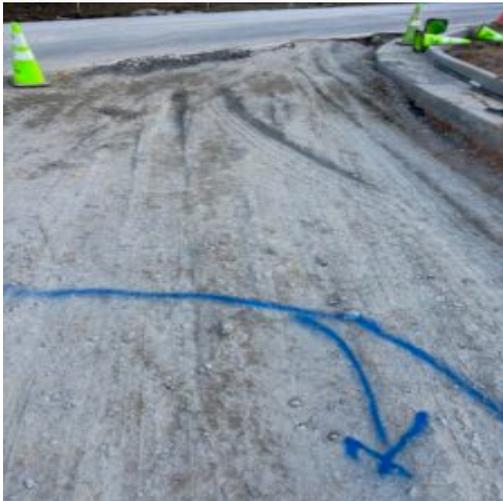
On the above date the writer was onsite as requested and observed proof rolling on sub grade base stone after repairs was supposedly completed. The writer observed the east, west lane addition using a loaded tandem dump truck making two passes over all areas. The proofroll at the added lane appeared stable under traffic and was approved for additional base stone placement. Also the deceleration lane and drive entrance was observed which four isolated were observed to have moderate to severe movement under traffic with previous recommendations made that was followed. At east half decel lane it was recommended to remove in place base stone and undercut saturated in place sub grade soils and replace with additional base stone. The contractor attempted to air dry the saturated sub grade soils which did not work also along curb line at drive exit lane. The areas listed below was marked with paint and recommended for repair.

1. 11'x8' -right side of entrance drive

2. 13'x11' =right side at exit turn

3. 4'x 40' -along curb line at exit drive

4. 70'x 12' - east half of decel. lane
